South Tunnel Heading Just East of Shield after Flooding of Tunnel of April 3,  
1924, New York.

South Tunnel (after flooding of tunnel of April 3, 1924) New York

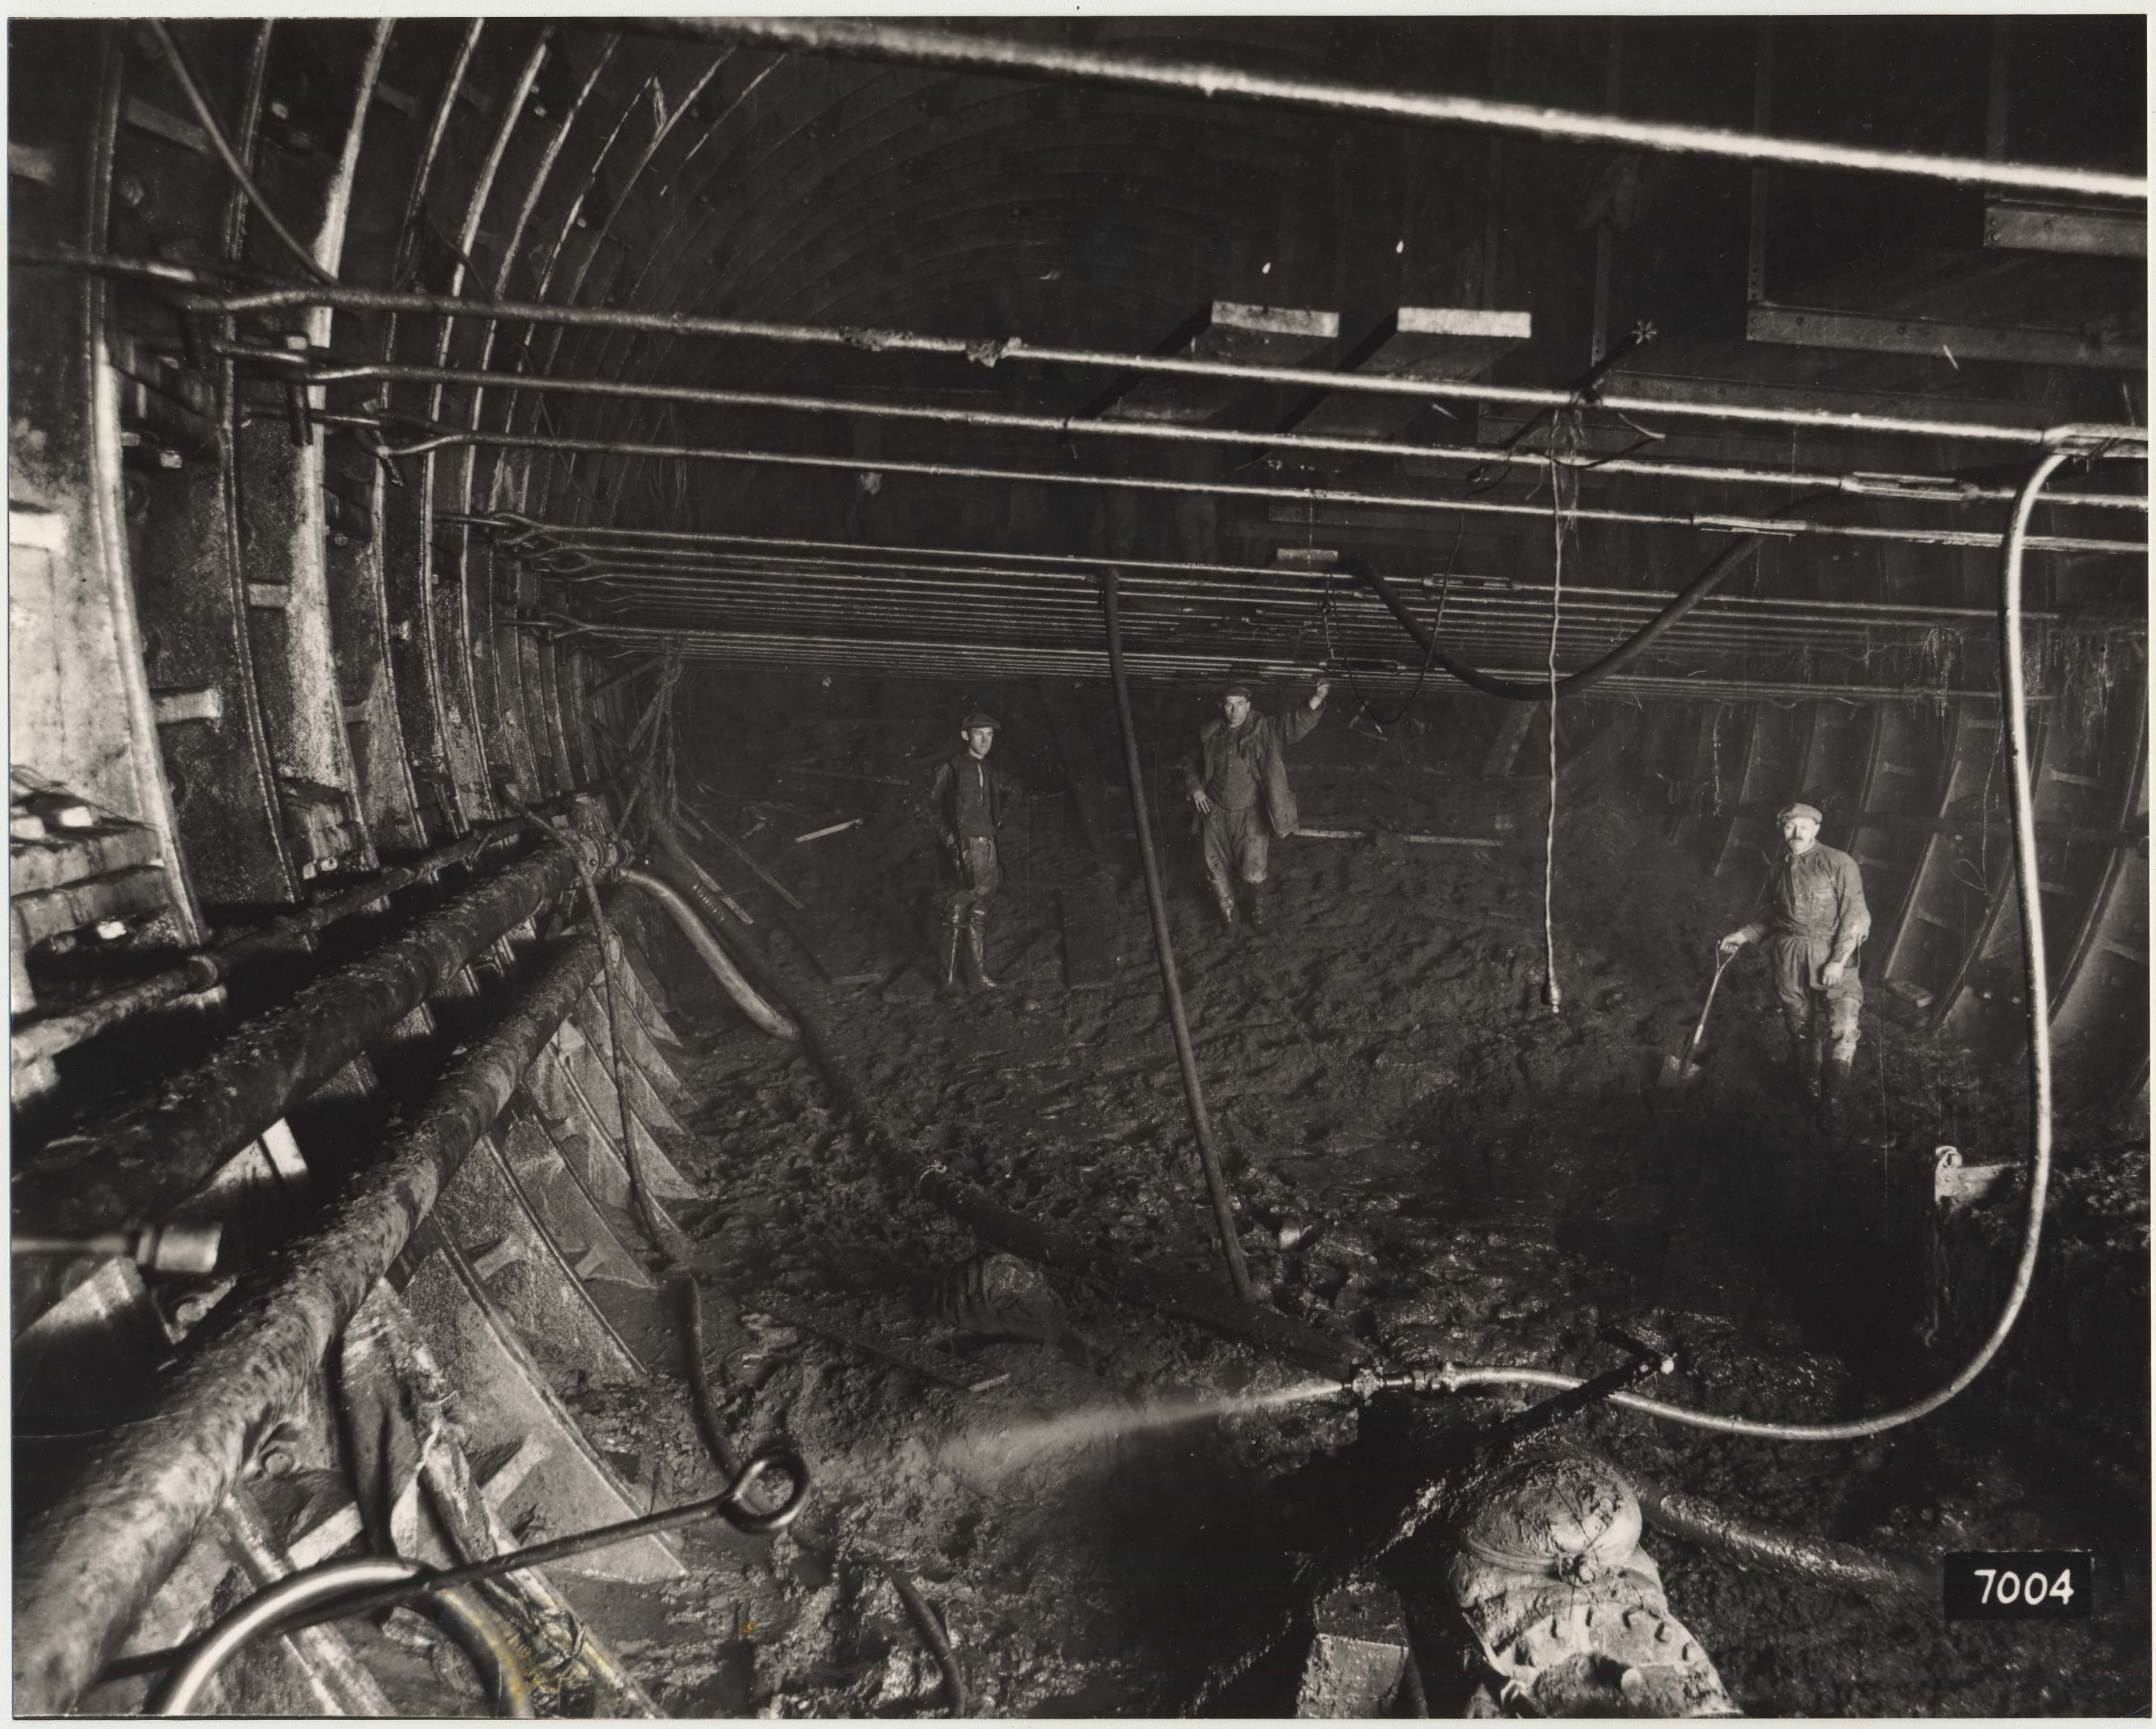
7004

Photograph showing the material which had flowed in the south tunnel just behind the shield during the flooding of the tunnel. The picture was taken after the water had been pumped from the tunnel. Booth & Flinn, Ltd. Contractors. Camera was set up on a low platform on the south side of the tunnel at Ring 542, facing west, air pressure 29 lbs.

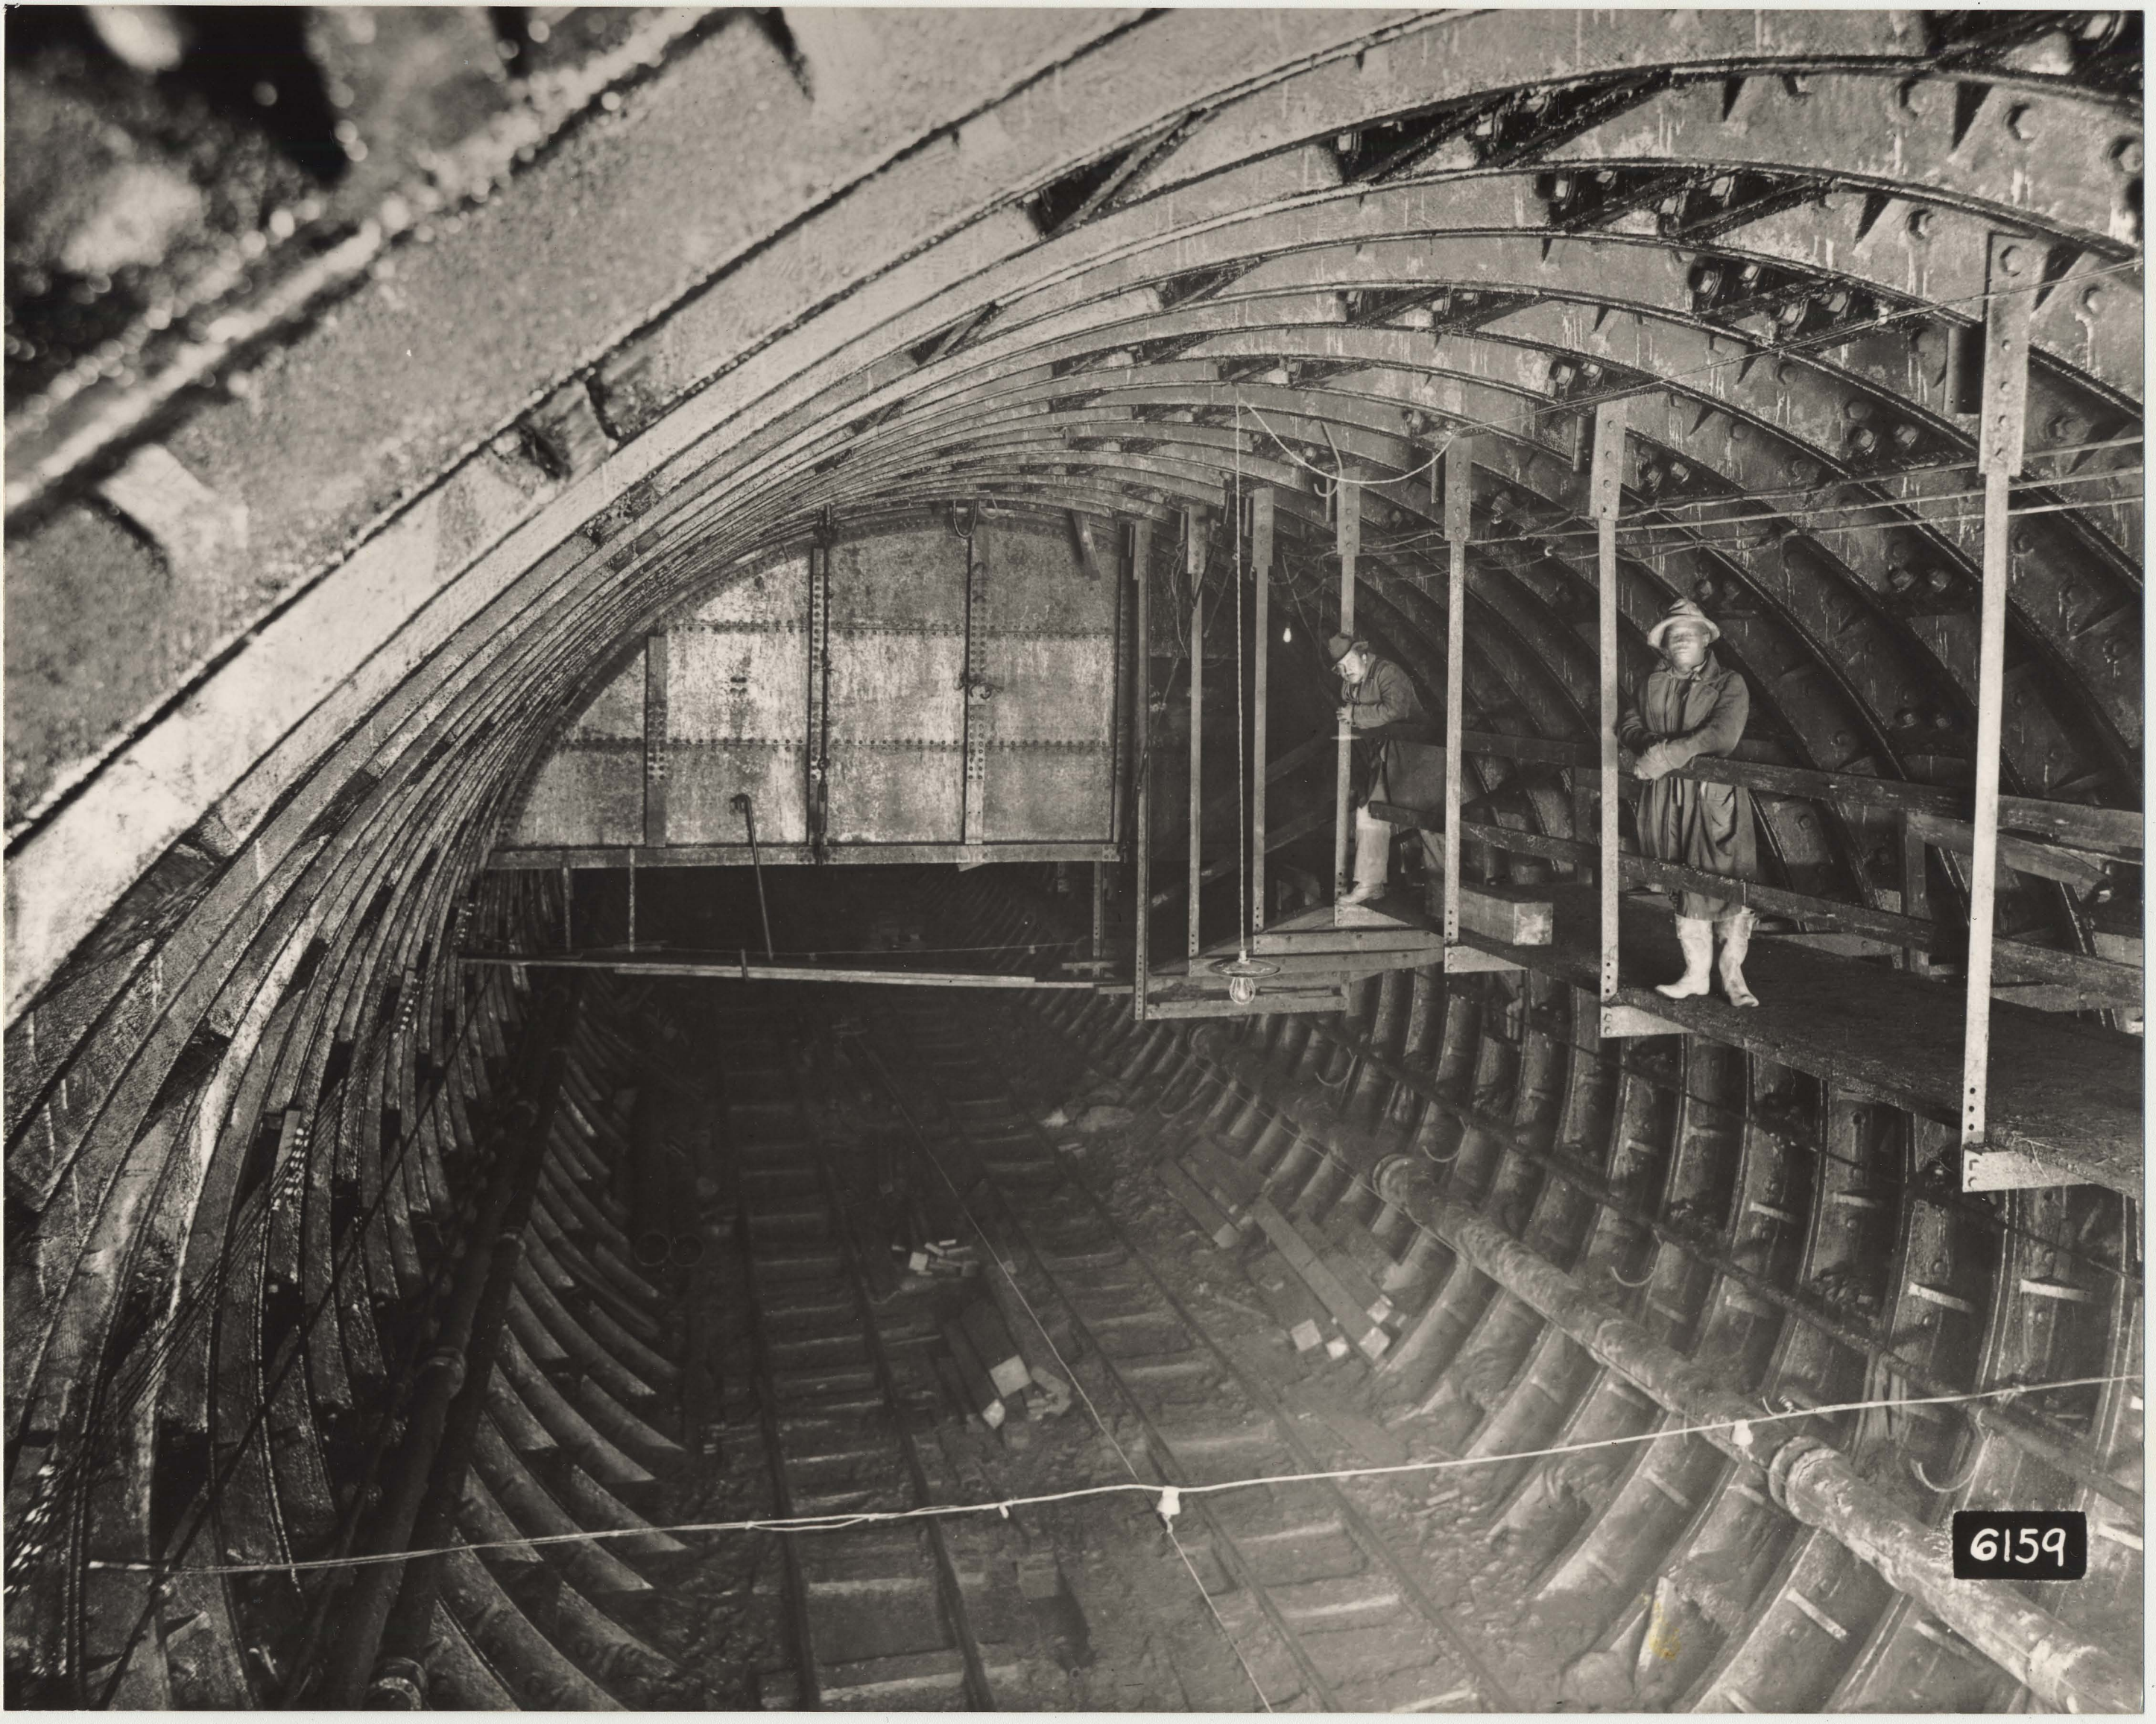
6159

View of south tunnel just east of safety screen which is at Ring 445.

Picture taken after the water was pumped out. (Taken from same position as Photo. No. 6158 which was taken of the flooded tunnel on Apr. 3, 1924).

Booth & Flinn, Ltd., Contractors. Camera set up on transit platform at Ring 425 and facing west; air pressure 29 lbs.
