## Technical Note

To: Blake Perkins, Hoboken Historical Museum and Cultural Center  
From: Saad Cheema; Dane Pehrman  
CC: File  
Date: January 7, 2011  
Re: Geotechnical Condition and Water Quality Analysis for Sybil's Cave

The purpose of this Technical Note (TN) is to present a geotechnical condition evaluation associated with the reopening of Sybil's Cave located in Hoboken, New Jersey. This man-made cave has been in existence for several hundred years. The location of Sybil's Cave is presented on Figure 1.

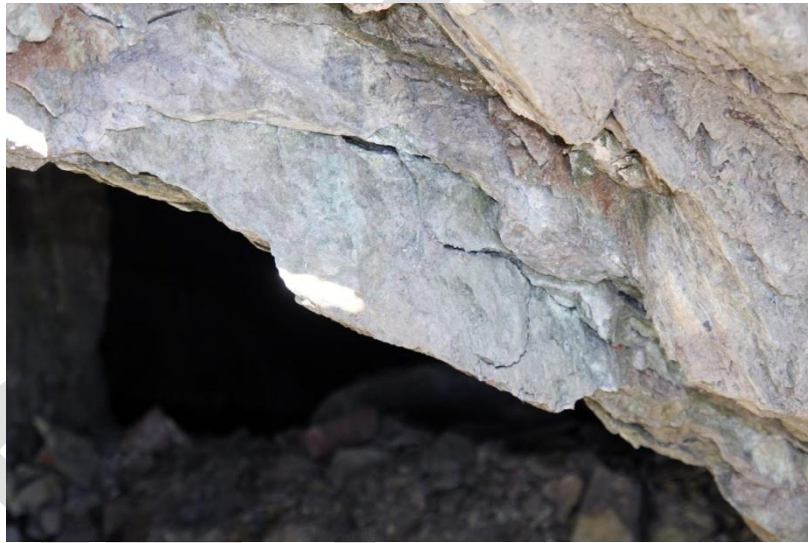
**Figure 4: Highly fractured bedrock (steeply dipping) around the cave portal.**

1. The rock around the opening of the cave is dipping at a high angle (60 to 70 degrees) and is highly fractured as shown in Figure 4 and Figure 5.
2. The pillars that are supporting the roof of the cave appeared to be under stress and show evidence of spalling at the roof/pillar interface as shown in Figure 6.

Based on the observations made during the site visit Black & Veatch recommends that Sybil's Cave remains closed for public access. The rock conditions within the cave need to be stabilized to ensure additional spalling and rock block instability does not occur in future.

1. The cave should be renovated by providing internal and external rock support such as rock bolts and shotcrete.
2. A local geotechnical firm (Jenny Engineering Corporation – 2 Edison Pl, Springfield NJ 07081 Tel:973-379-6699, or Dawn Underground Engineering INC – 10 Village Court, Hazlet NJ 07730 Tel:732-739-8840) should be hired to monitor the rock stability conditions of the cave over

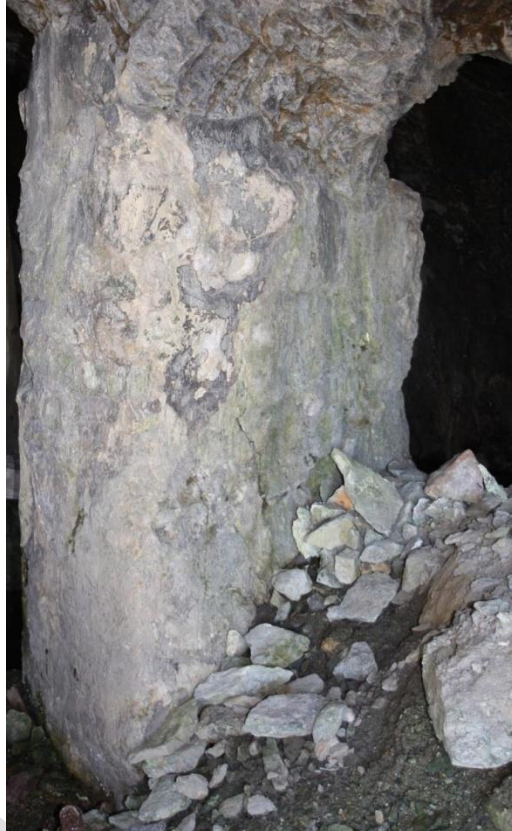
**Figure 7: Rock debris/spalling on the floor near rock pillar**

3. The rock debris present on the floor indicates that roof of the cave has been spalling over time as shown in Figure 7.
4. The rock samples collected during the site visit indicate the presence of a serpentine rock type which is sometimes associated with asbestos content. This rock character may warrant further investigation.
5. The rock face at the cave portal comprises of highly weathered fractured rock including soil that was highly unstable and wet at the time of site visit. Figure 8 shows the rock face at the cave entrance in a dry condition (photo not taken during site visit).
