THE DEVELOPMENT OF . . .

Avro Canada's Orenda

The paper which follows was given by D. W. Knowles, Chief Development Engineer of Avro Canada's Gas Turbine Engineering Division, before the semi-annual meeting of the The American Society of Mechanical Engineers, held in Toronto, June 11-14. It concerns the development history of the Avro Canada Orenda jet engine, the first aircraft engine to be put into quantity production in Canada. The rated thrust of the Orenda is revealed in the paper as being over 6,000 lbs., and its fuel consumption is about 1.00 lbs./lb. thrust/hr., both of the forgoing ratings being under sea level static conditions. The engine has been brought from the initial design stage to production in a period of 4½ years, during which time 5,000 hours of bench testing and 150 hours of flying have been completed.

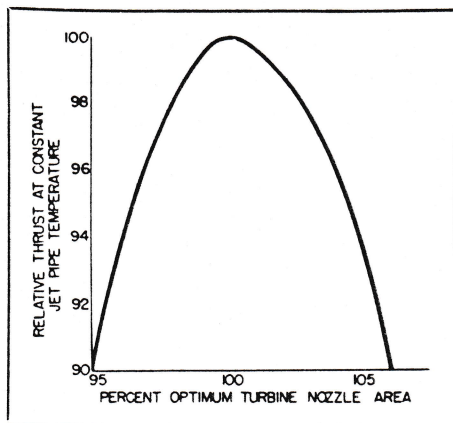
FIG. 11: VARIATION OF THRUST WITH TURBINE NOZZLE AREA, CHINOOK ENGINE.

This was done quickly on the Orenda, which proved to be much less sensitive in this regard than the Chinook, where small variations caused considerable change in output as shown in Fig. 11.

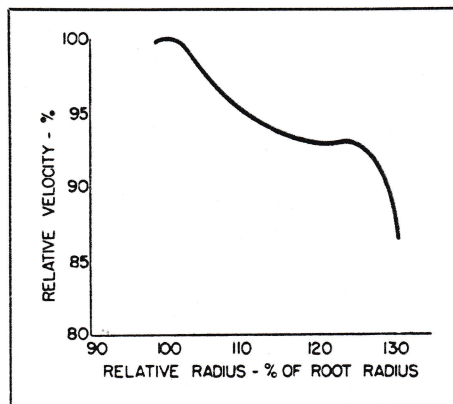
FIG. 13: VELOCITY TRAVERSE BEHIND FIRST ROTOR BLADES, CHINOOK ENGINE.

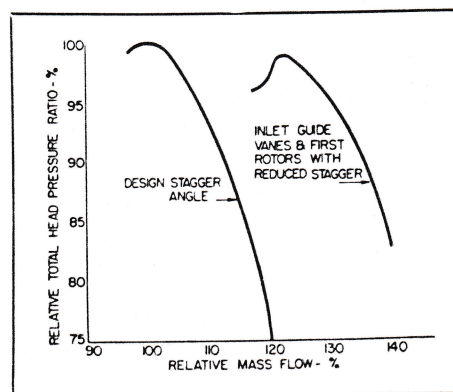
FIG. 14: MASS FLOW—PRESSURE RATIO CURVES—CHINOOK TWO STAGE TESTS.

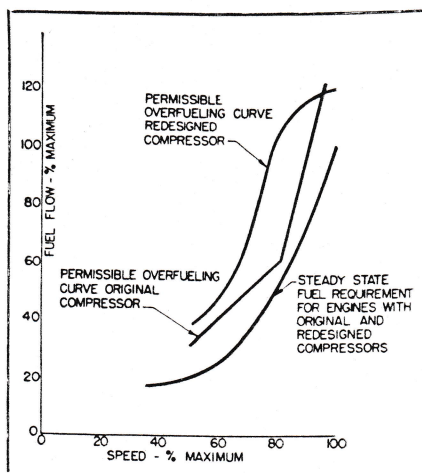
FIG. 15: OVERFUELING CURVES

Desired Effect: The first two stages of the engine were then redesigned, using radial equilibrium principles to get a better velocity distribution. This had the desired effect of improving the matching of the front and back stages of the compressor considerably. In consequence the acceleration was greatly improved. For purposes of assessing the acceleration potential of an engine an overfueling curve is plotted on a speed basis. This shows the ability of the engine to accept fuel over that required for steady state operation at any speed, without surging the compressor or exceeding jet pipe temperature limitations. The extra fuel represents, of course, the energy that is available for acceleration. Typical overfueling curves for engines incorporating the original and revised compressors are shown in Fig. 15.

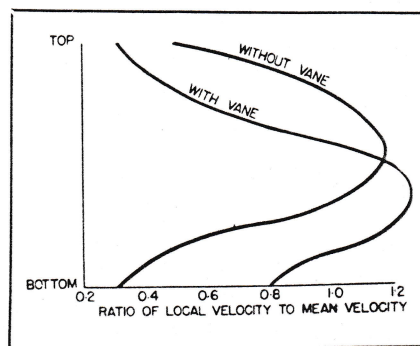
FIG. 17: VELOCITY DISTRIBUTION — DIFFUSER OUTLET

splitters is shown in Fig. 17. Considerable difficulty was experienced in designing an aerodynamically acceptable splitter which did not suffer fatigue failures due to buffeting of the air stream consequently this feature was deleted. Although some combustion chambers have failed due to buckling it has been after very long periods of engine running and is not considered to be a limitation on the engine.
