The Orenda Story—

COMPLEX PROBLEMS SOLVED IN ORENDA DEVELOPMENT

By **D. W. KNOWLES**

Chief Development Engineer
Gas Turbine Engineering Division
A. V. Roe Canada Ltd.

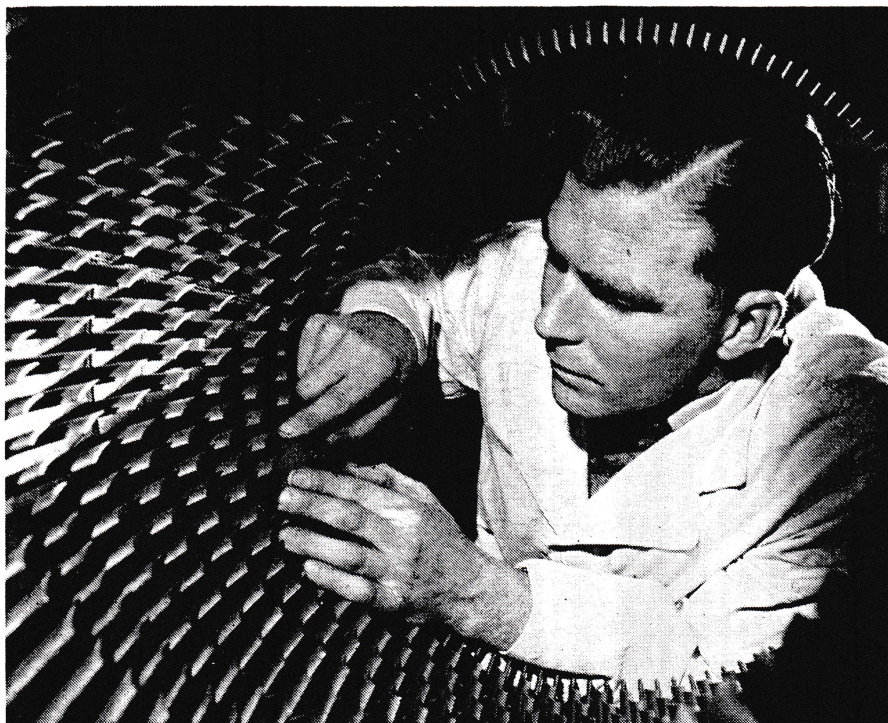
LEFT—Blades have raised the most difficult problems in development of the Orenda jet engine at Avro. John Howlett, engine fitter, is shown scraping and deburring a stator blade.
