A REVIEW OF THE  
MAINTENANCE AND RELIABILITY ASPECTS  
OF THE ARROW CONTROL SURFACE  
AND TRAILING EDGE COMPONENTS

**A REVIEW**  
OF THE  
**MAINTENANCE AND RELIABILITY ASPECTS**  
OF THE  
**ARROW CONTROL SURFACE AND**  
**TRAILING EDGE COMPONENTS**

71/MAINT/15/3

JANUARY 1958

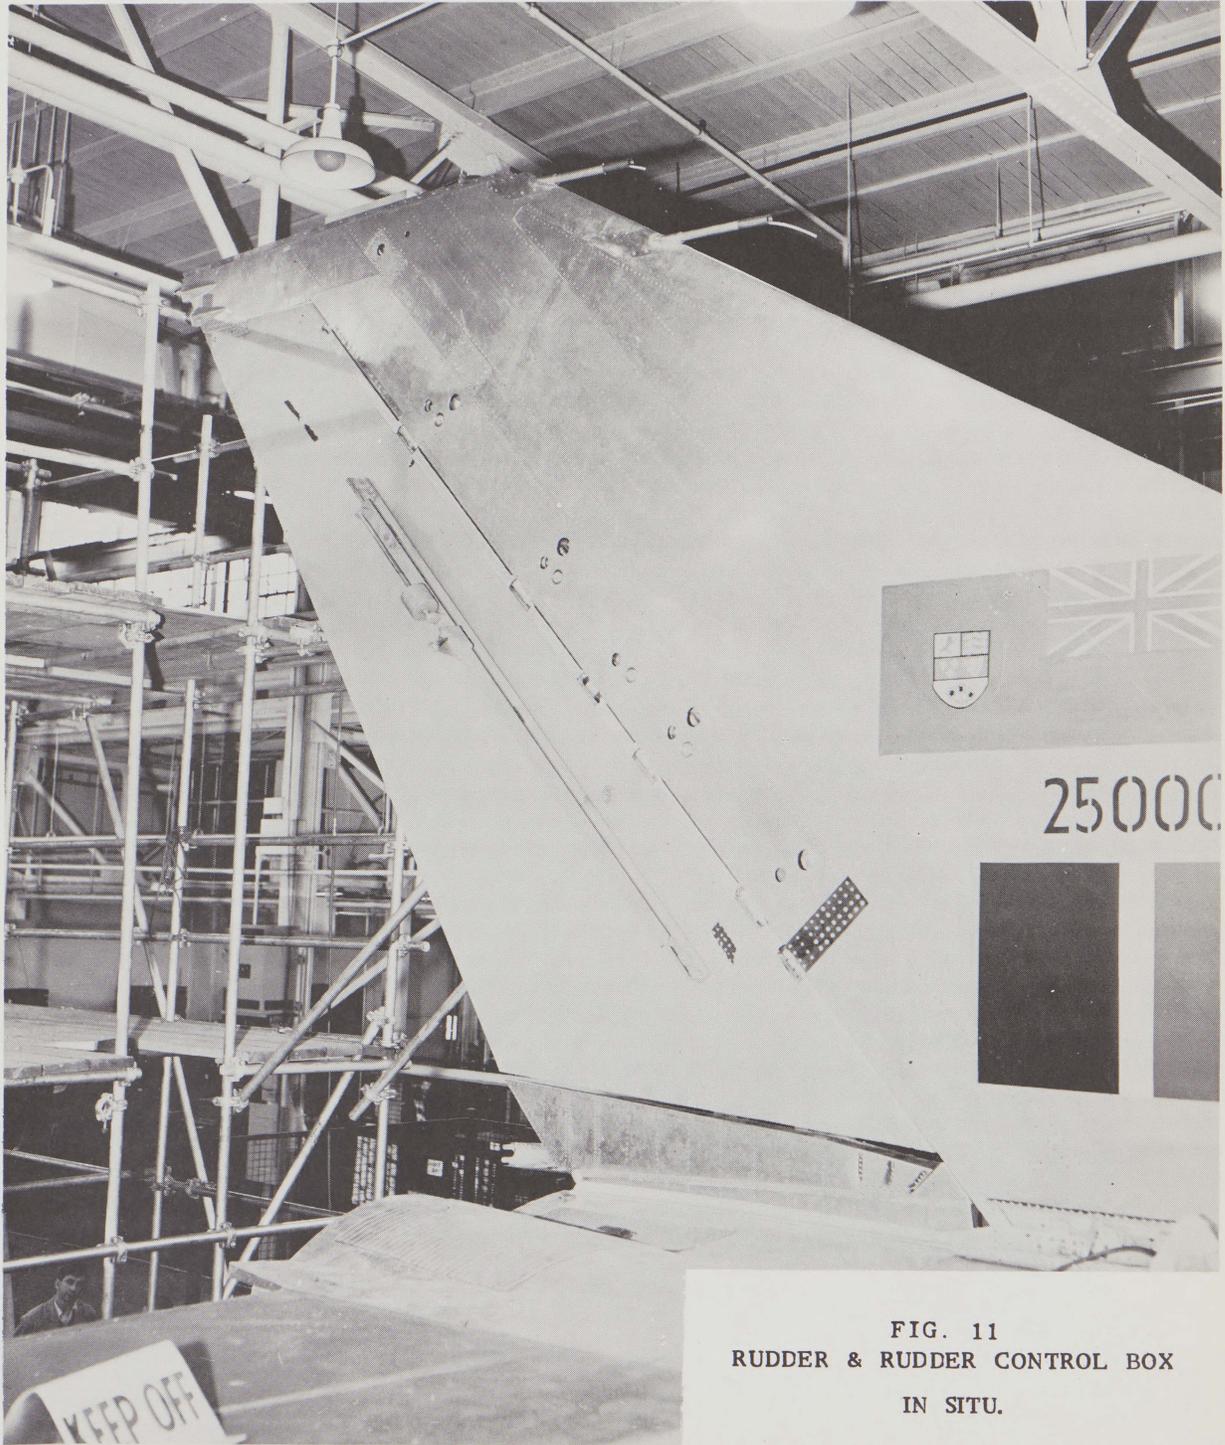
FIG. 11  
RUDDER & RUDDER CONTROL BOX  
IN SITU.

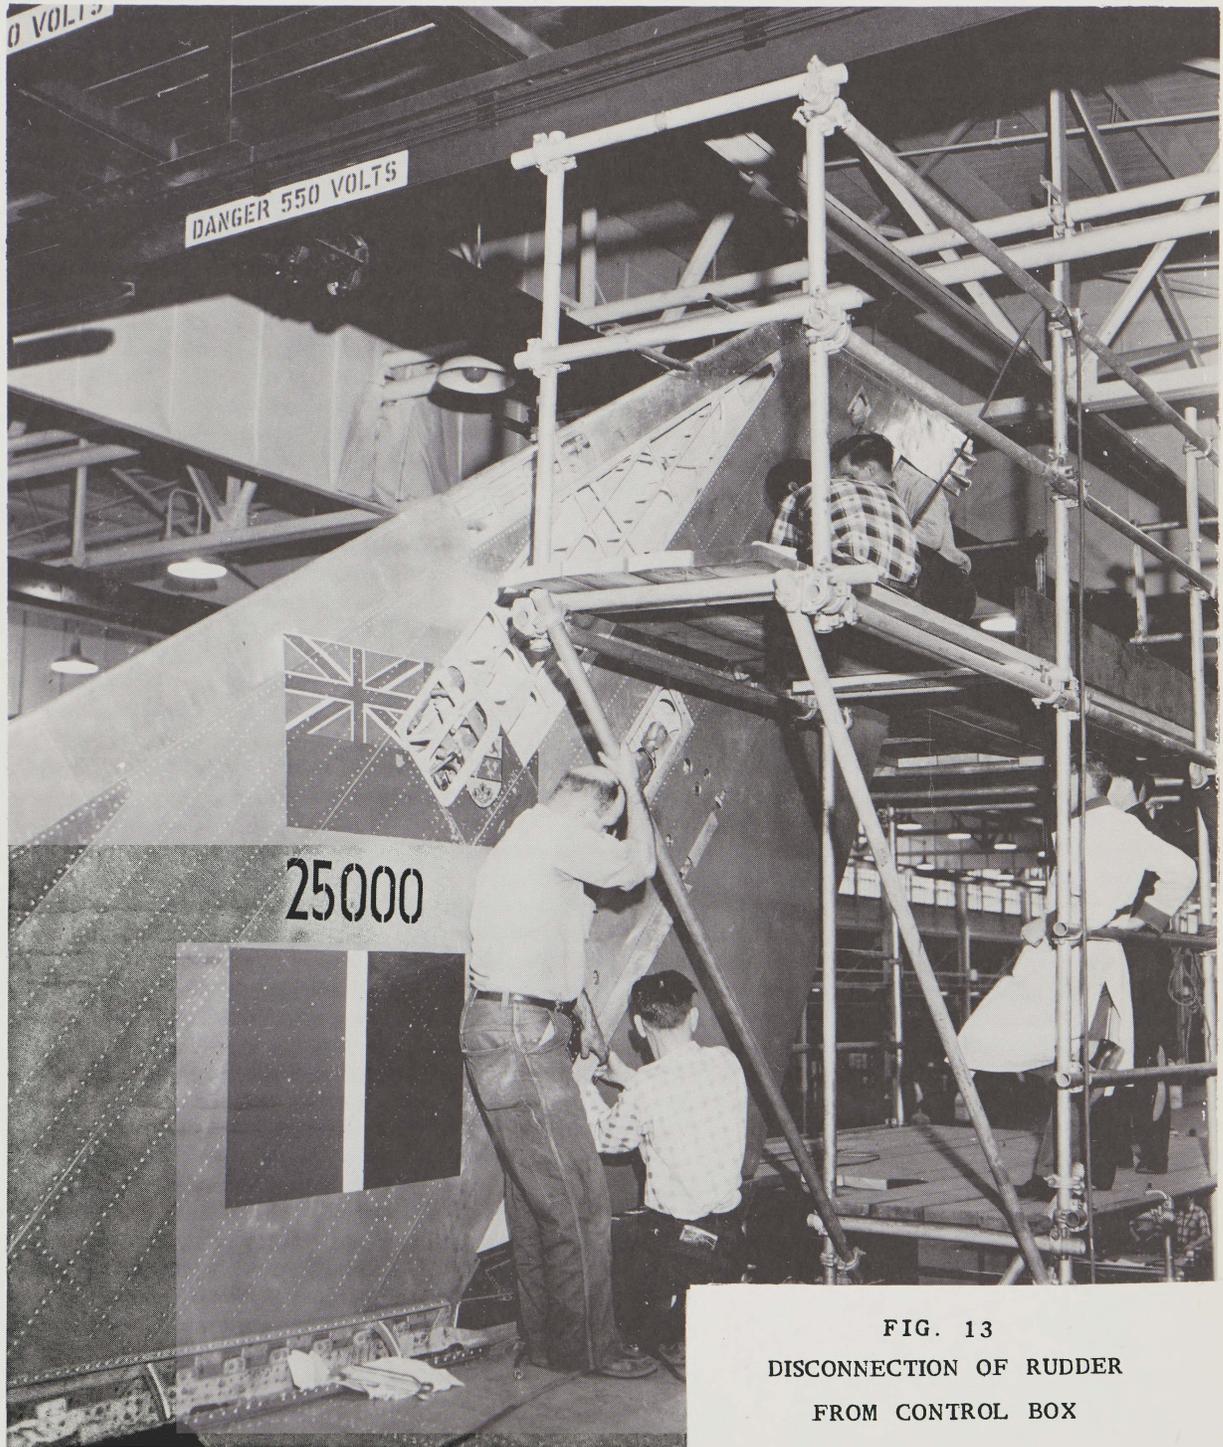
FIG. 13  
DISCONNECTION OF RUDDER  
FROM CONTROL BOX

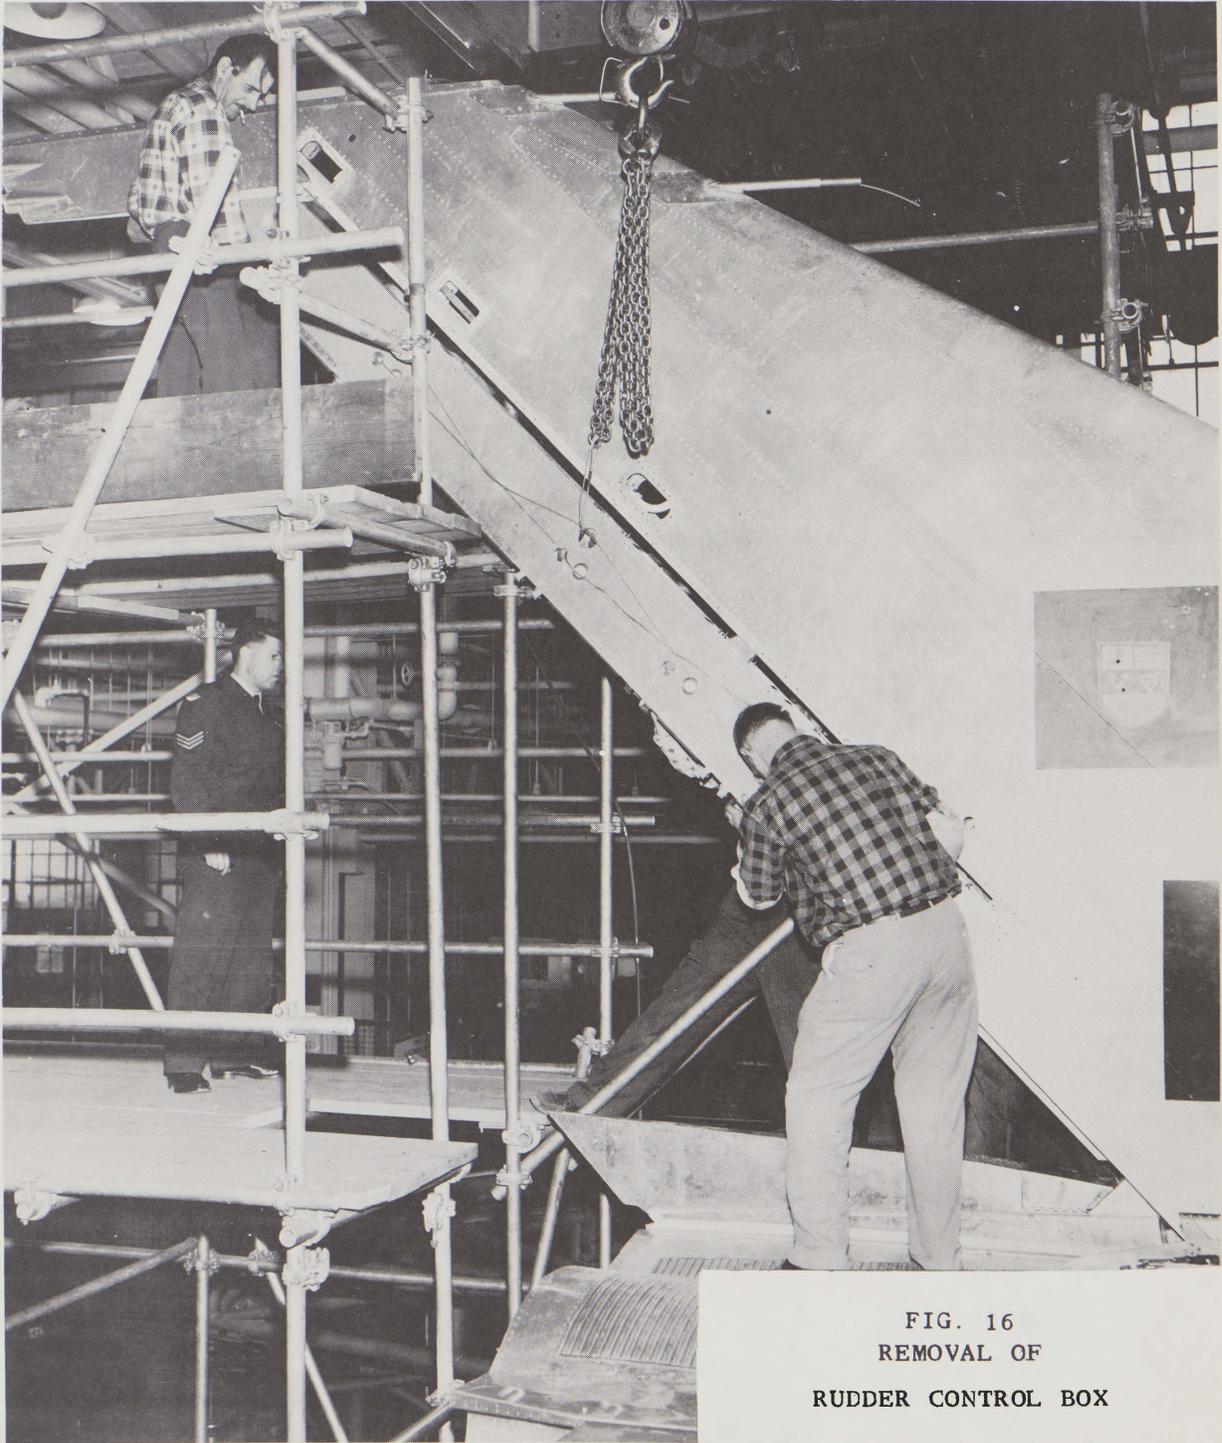
FIG. 16  
REMOVAL OF  
RUDDER CONTROL BOX

- (g) It was found that the rudder jack had to be removed to obtain access to four of the bolts attaching the control box to the fin. While this was accomplished in ten minutes during the demonstration, the same operation on a production aircraft would entail three to four hours labour since the hydraulic system and the electrical system must be disrupted in addition to the control linkage.
- (h) The upper three removable shrouds were fitted prior to the link bolts because the rudder had to be held hard over to the right to permit access to the shroud bolts.

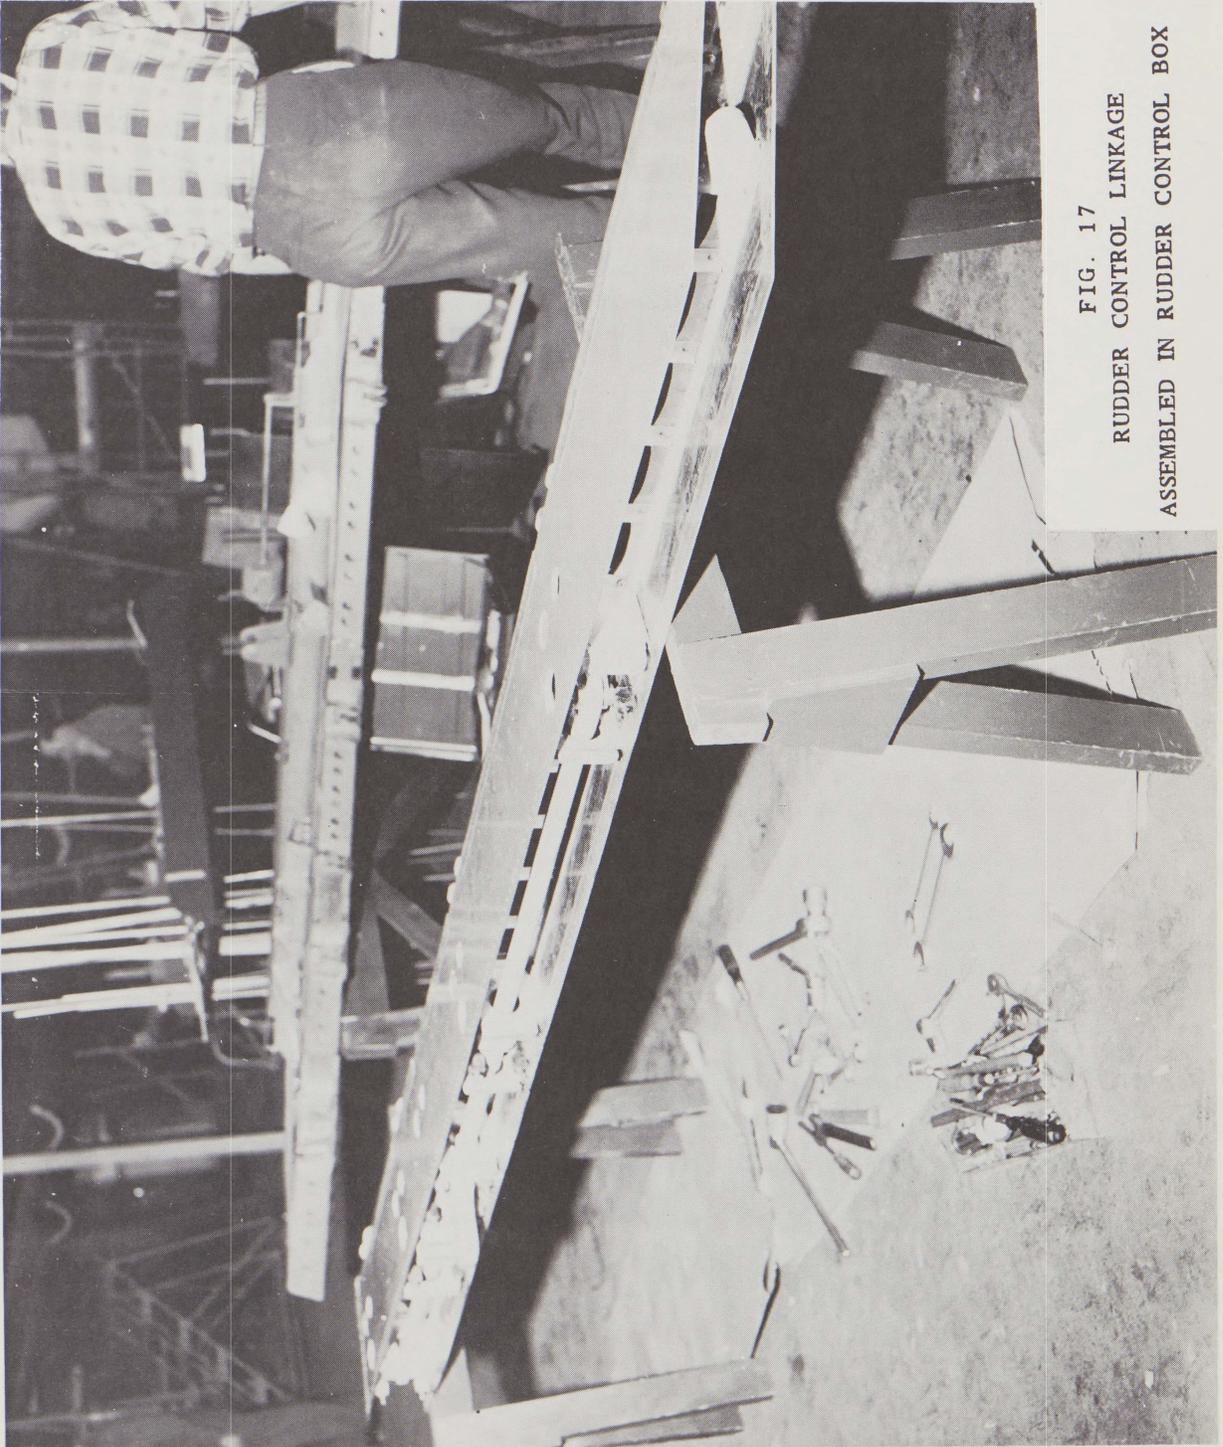
FIG. 17  
RUDDER CONTROL LINKAGE  
ASSEMBLED IN RUDDER CONTROL BOX

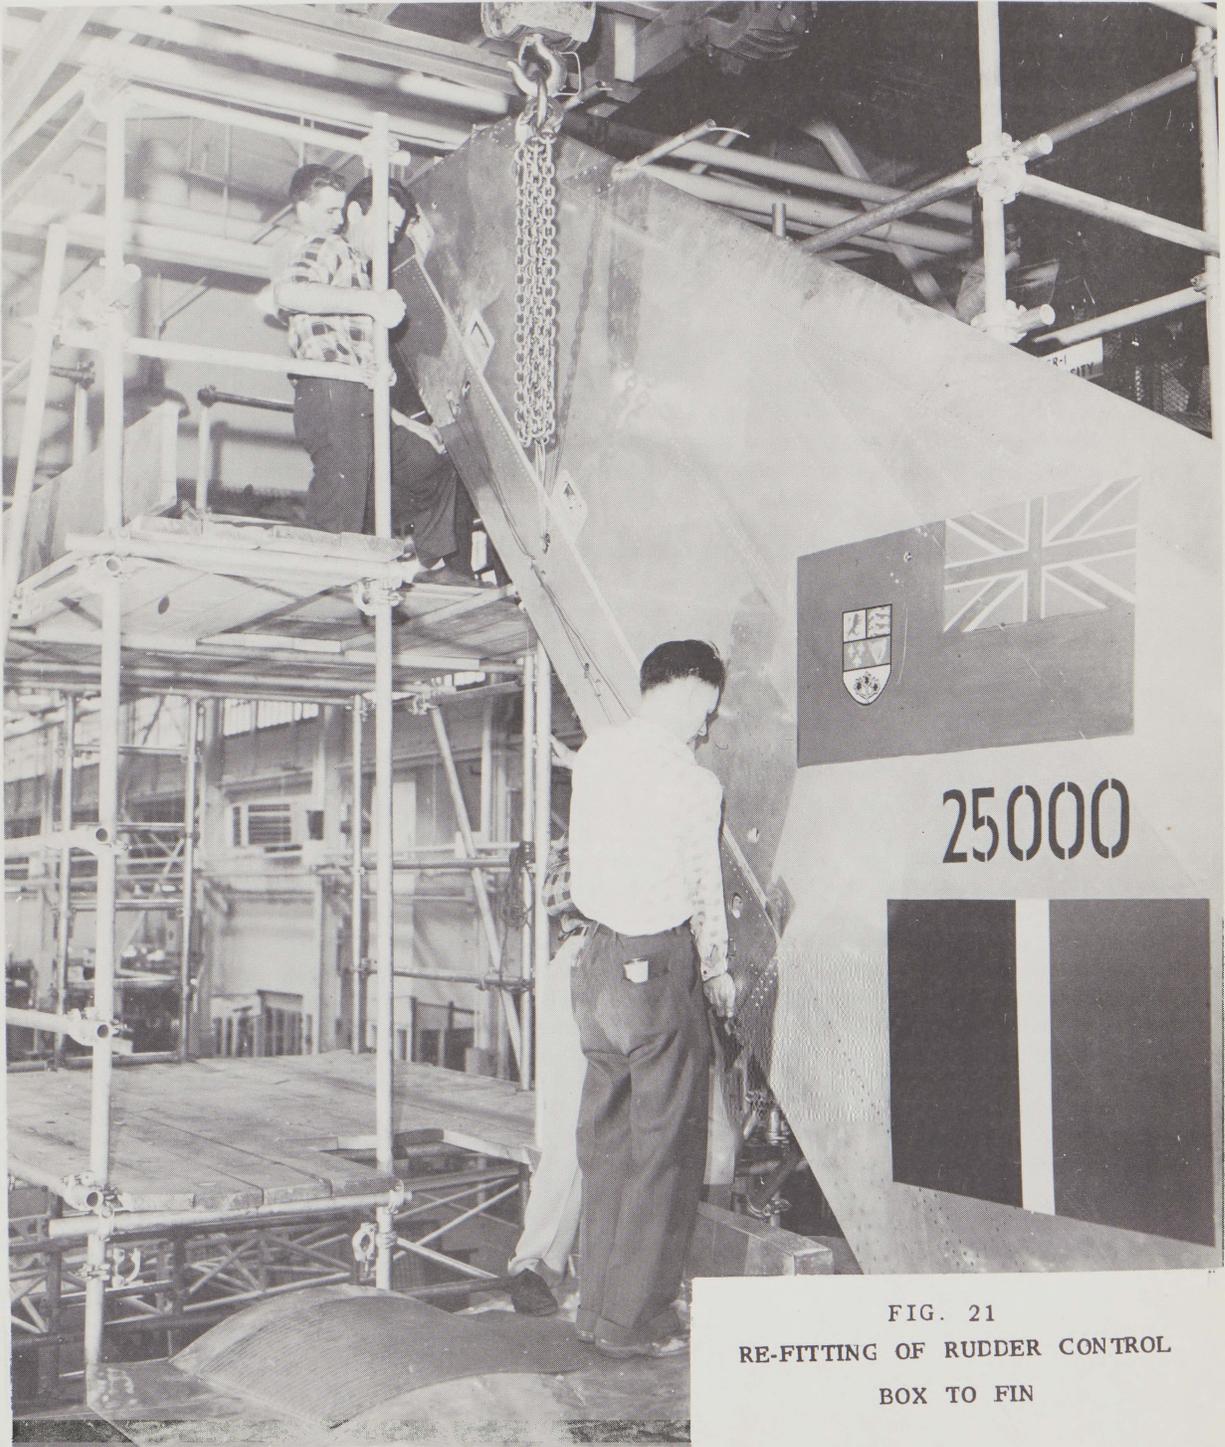
FIG. 21  
RE-FITTING OF RUDDER CONTROL  
BOX TO FIN

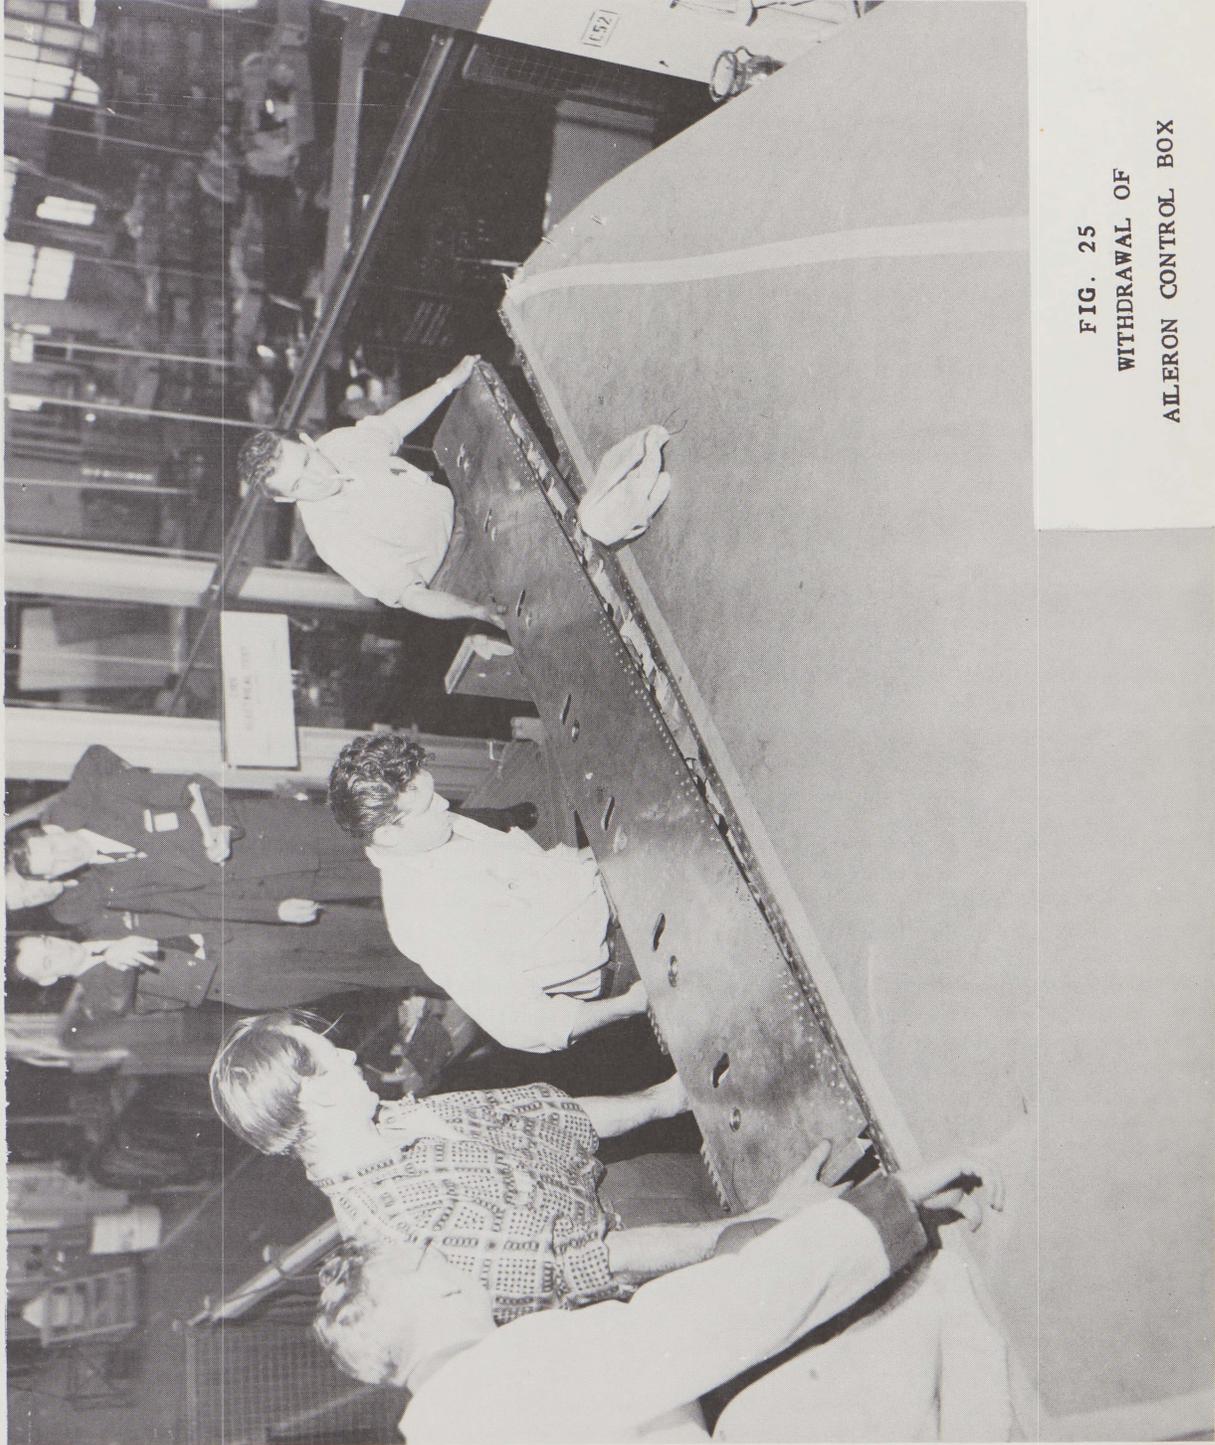
FIG. 25  
WITHDRAWAL OF  
AILERON CONTROL BOX

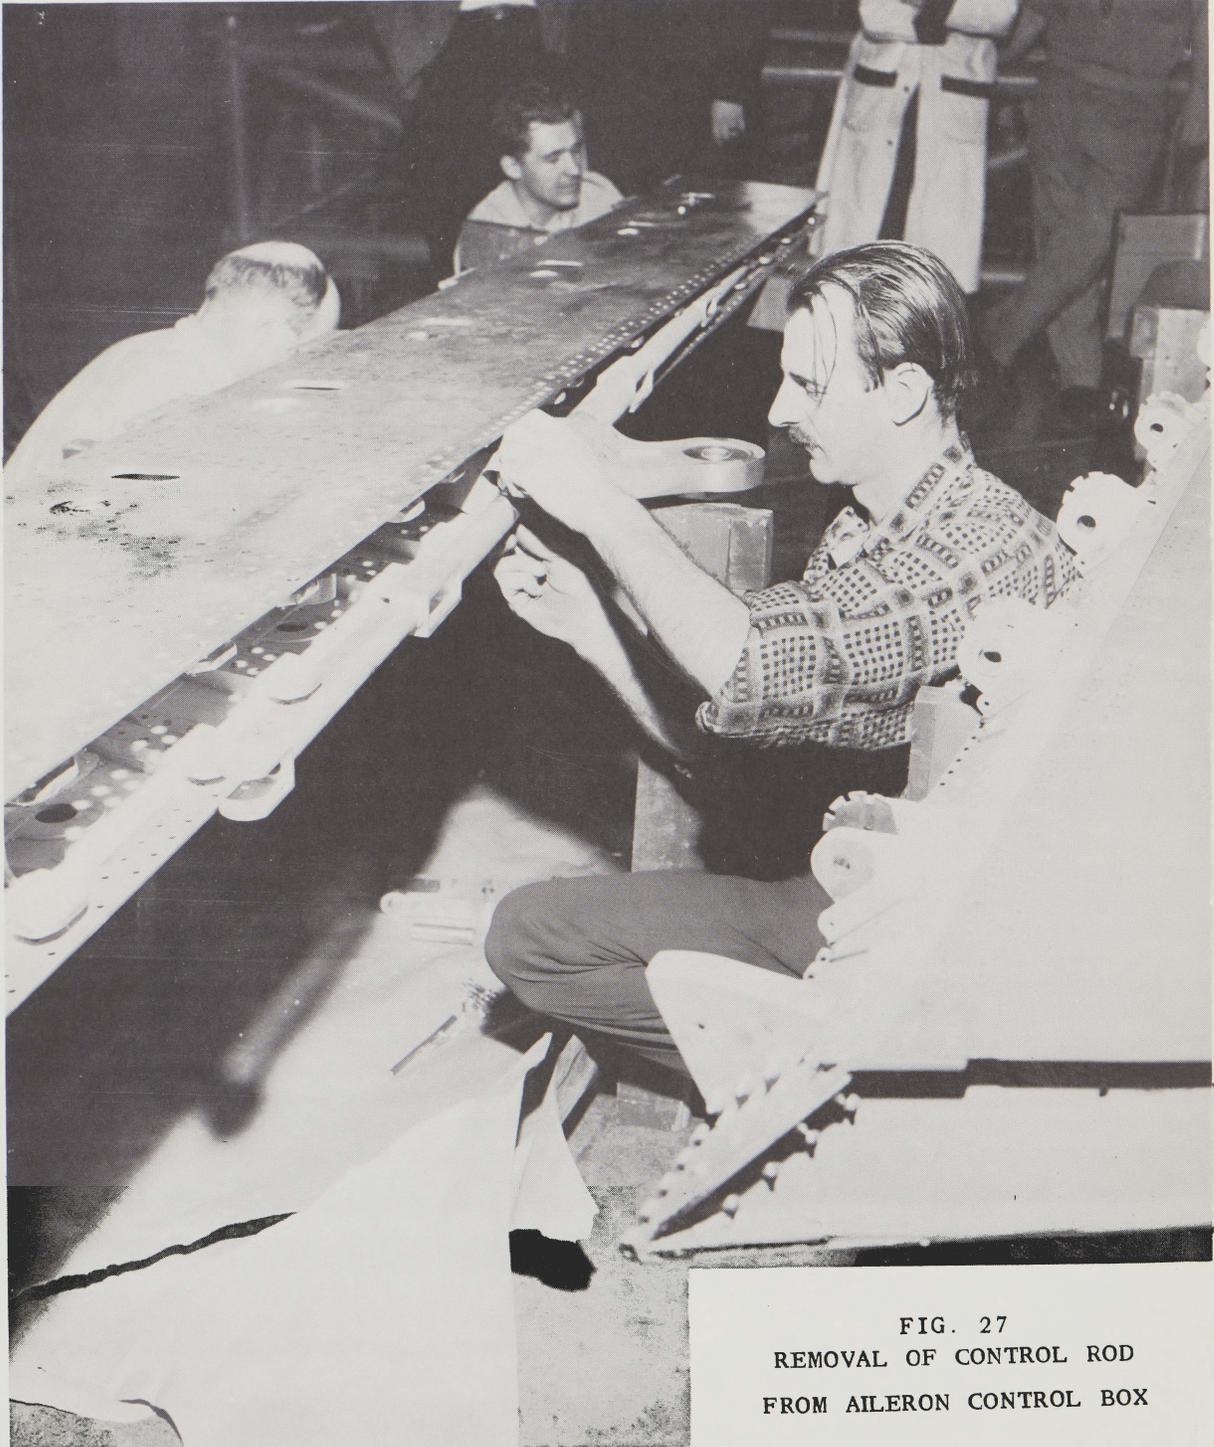
FIG. 27  
REMOVAL OF CONTROL ROD  
FROM AILERON CONTROL BOX

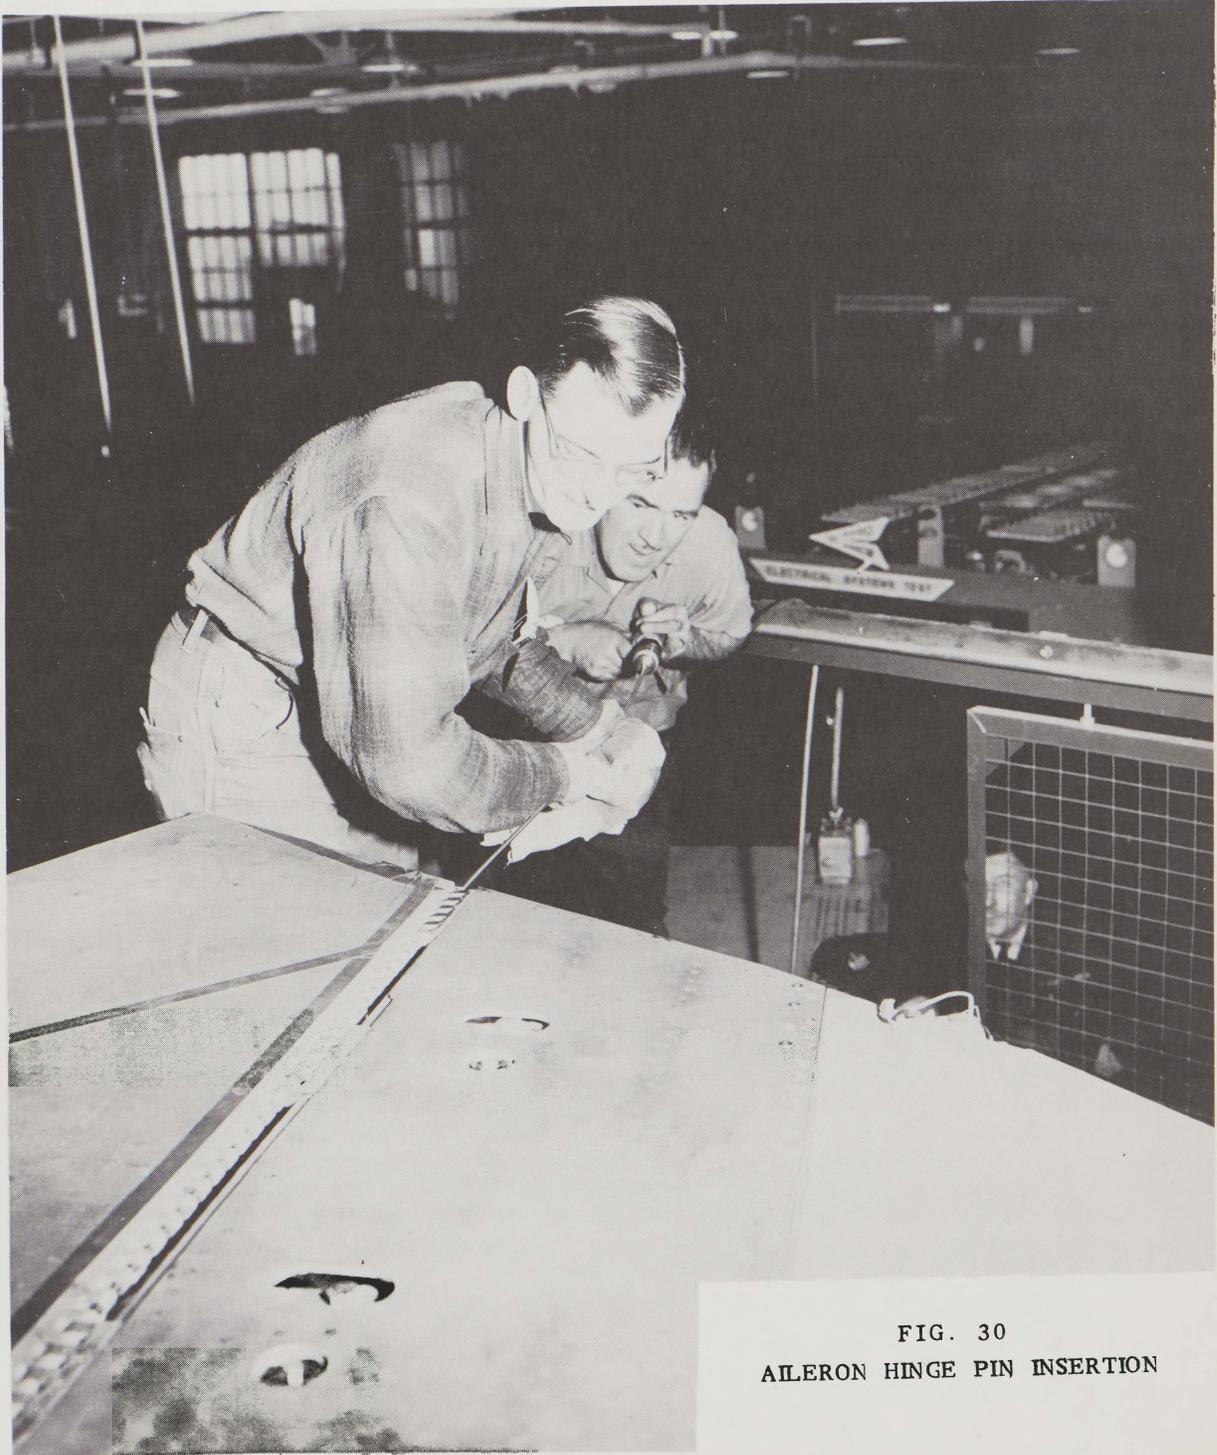
FIG. 30  
AILERON HINGE PIN INSERTION

- (e) Considerable difficulty was encountered during the hinge pin removal. An air driven 3/8" drill gun failed in an attempt to pull the pin and a 1/2" electric drill gun had to be used to accomplish the task. Upon investigation, it was found that a discrepancy existed in the alignment of the aileron box and the wing torsion box causing a deformation in the aileron hinge. In addition, the aileron hinge had not been lubricated on installation. Subsequently it was proven on the B1 rig tests, as described in Chapter 6 Paragraph 6.1.4, that it was possible to remove the elevator hinge with a 3/8 diameter shop air gun with no difficulty. The elevator had been subjected to 200 hours of endurance testing and the control surface hinge was properly lubricated and structurally representative.

- (f) Oildag (O. D. 200) the prescribed lubricant, should be used on the hinge pin as recommended. In the case of these demonstrations, the hinge pins had not been lubricated and this accounted for some of the difficulty of removing the aileron hinge pin. In addition, hexagonal ends on the pins, which will be provided on production aircraft, will further assist the removal of the pin. It is interesting to note here that a proper length hinge pin was inserted and removed from the
