**A REVIEW**  
OF THE  
**MAINTENANCE AND RELIABILITY ASPECTS**  
OF THE  
**ARROW CONTROL SURFACE AND**  
**TRAILING EDGE COMPONENTS**

71/MAINT/15/3

JANUARY 1958

**AVRO AIRCRAFT LIMITED**

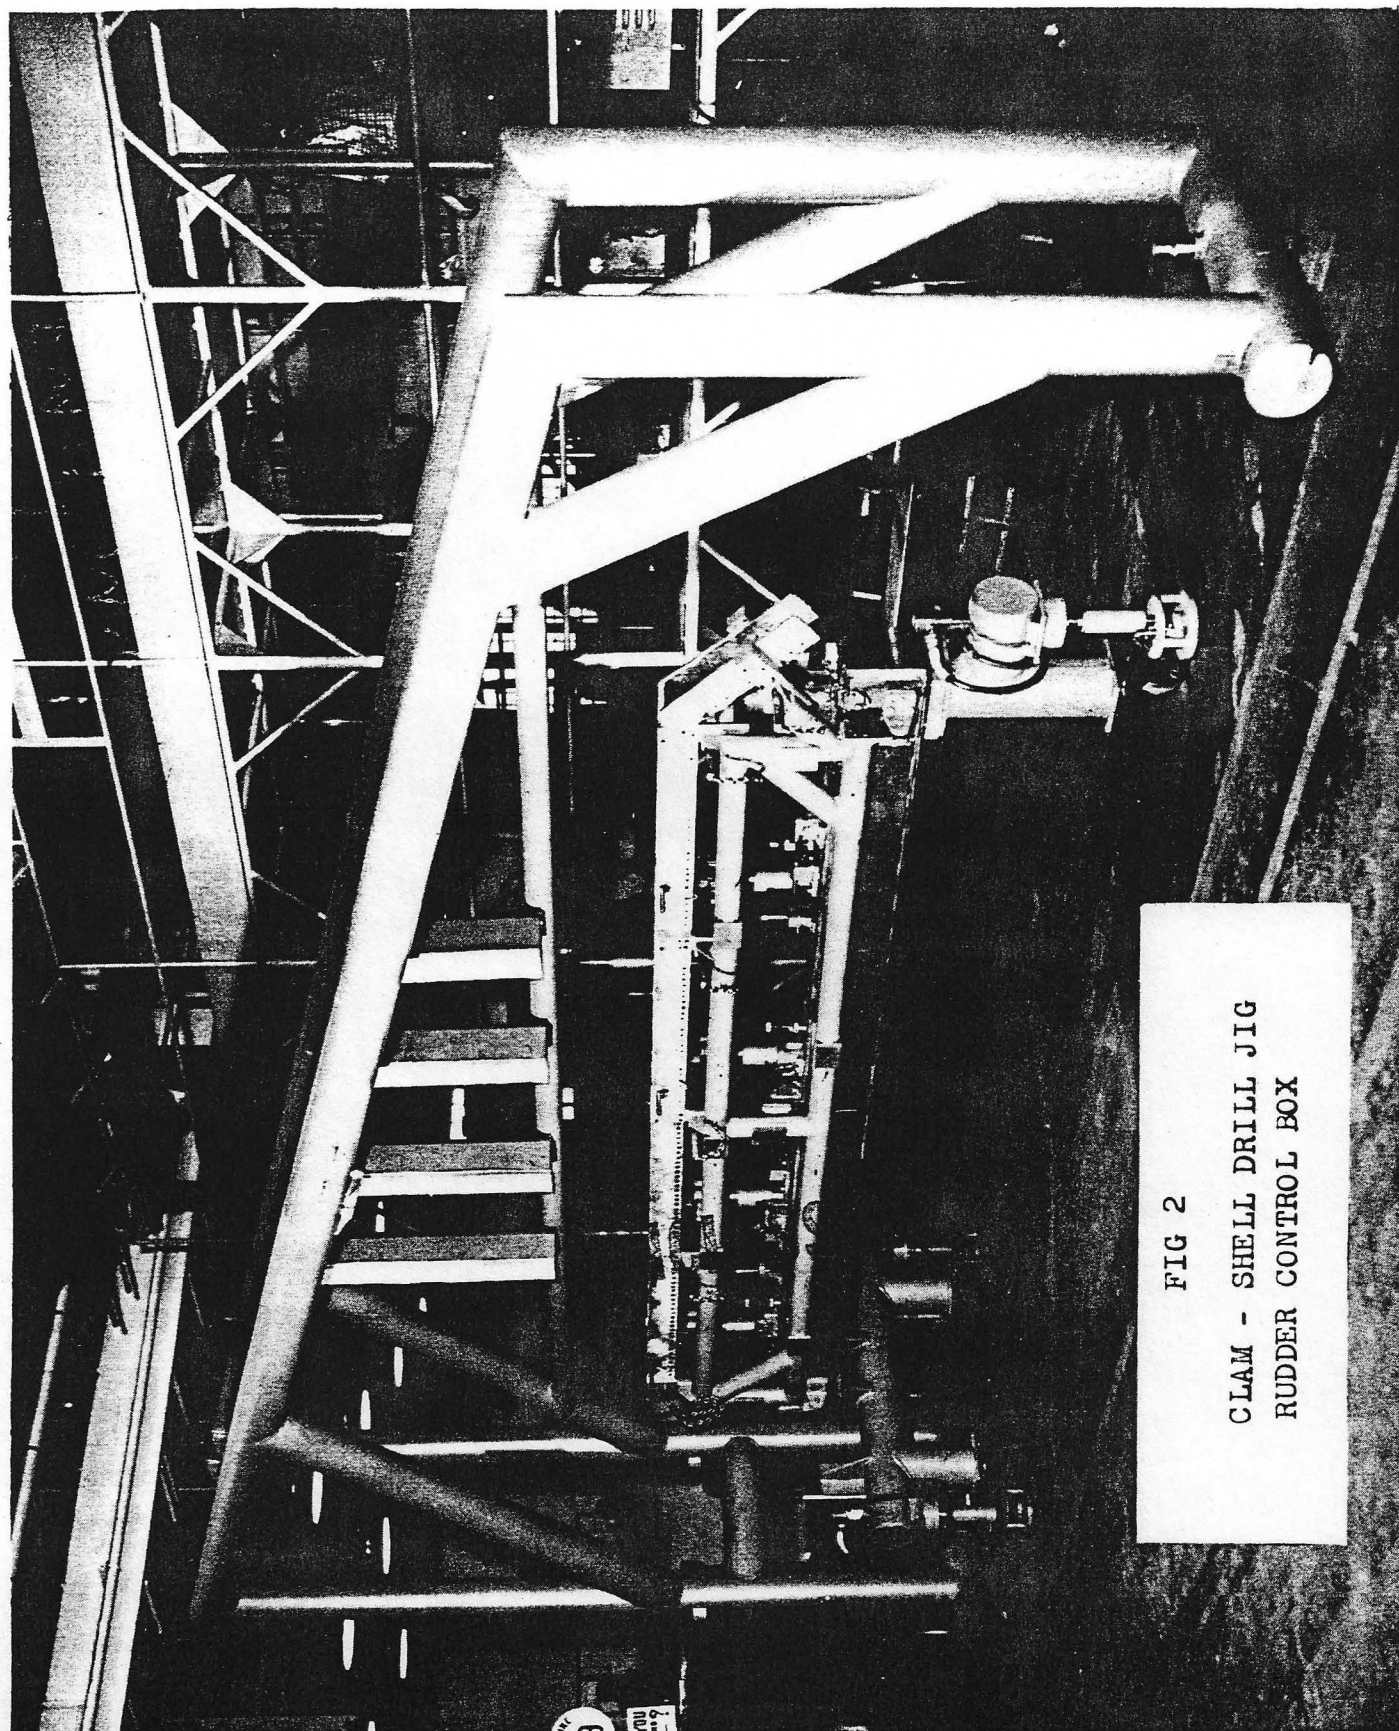
FIG 2  
CLAM - SHELL DRILL JIG  
RUDDER CONTROL BOX

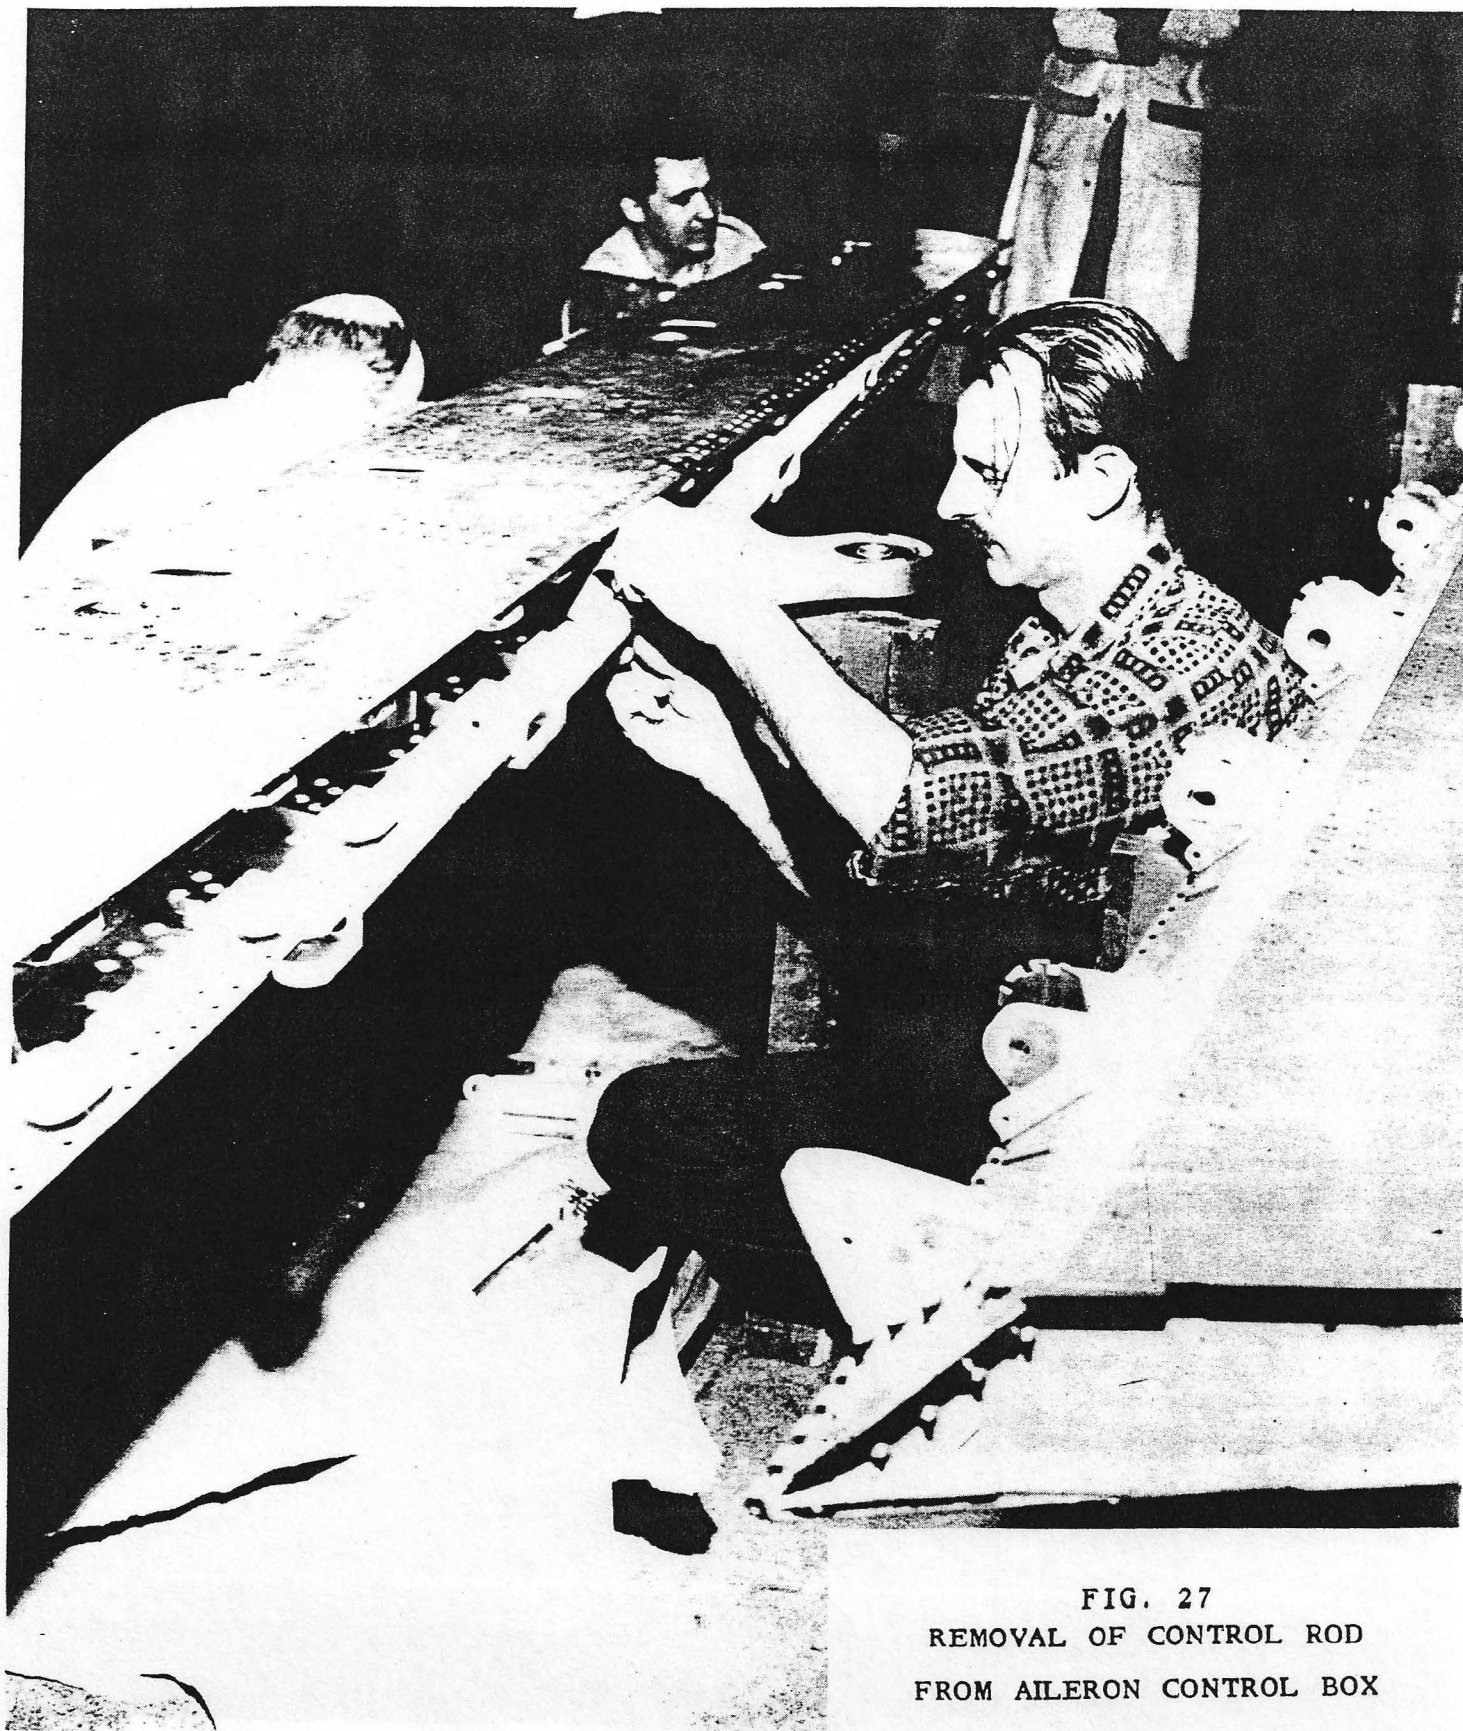
FIG. 27  
REMOVAL OF CONTROL ROD  
FROM AILERON CONTROL BOX

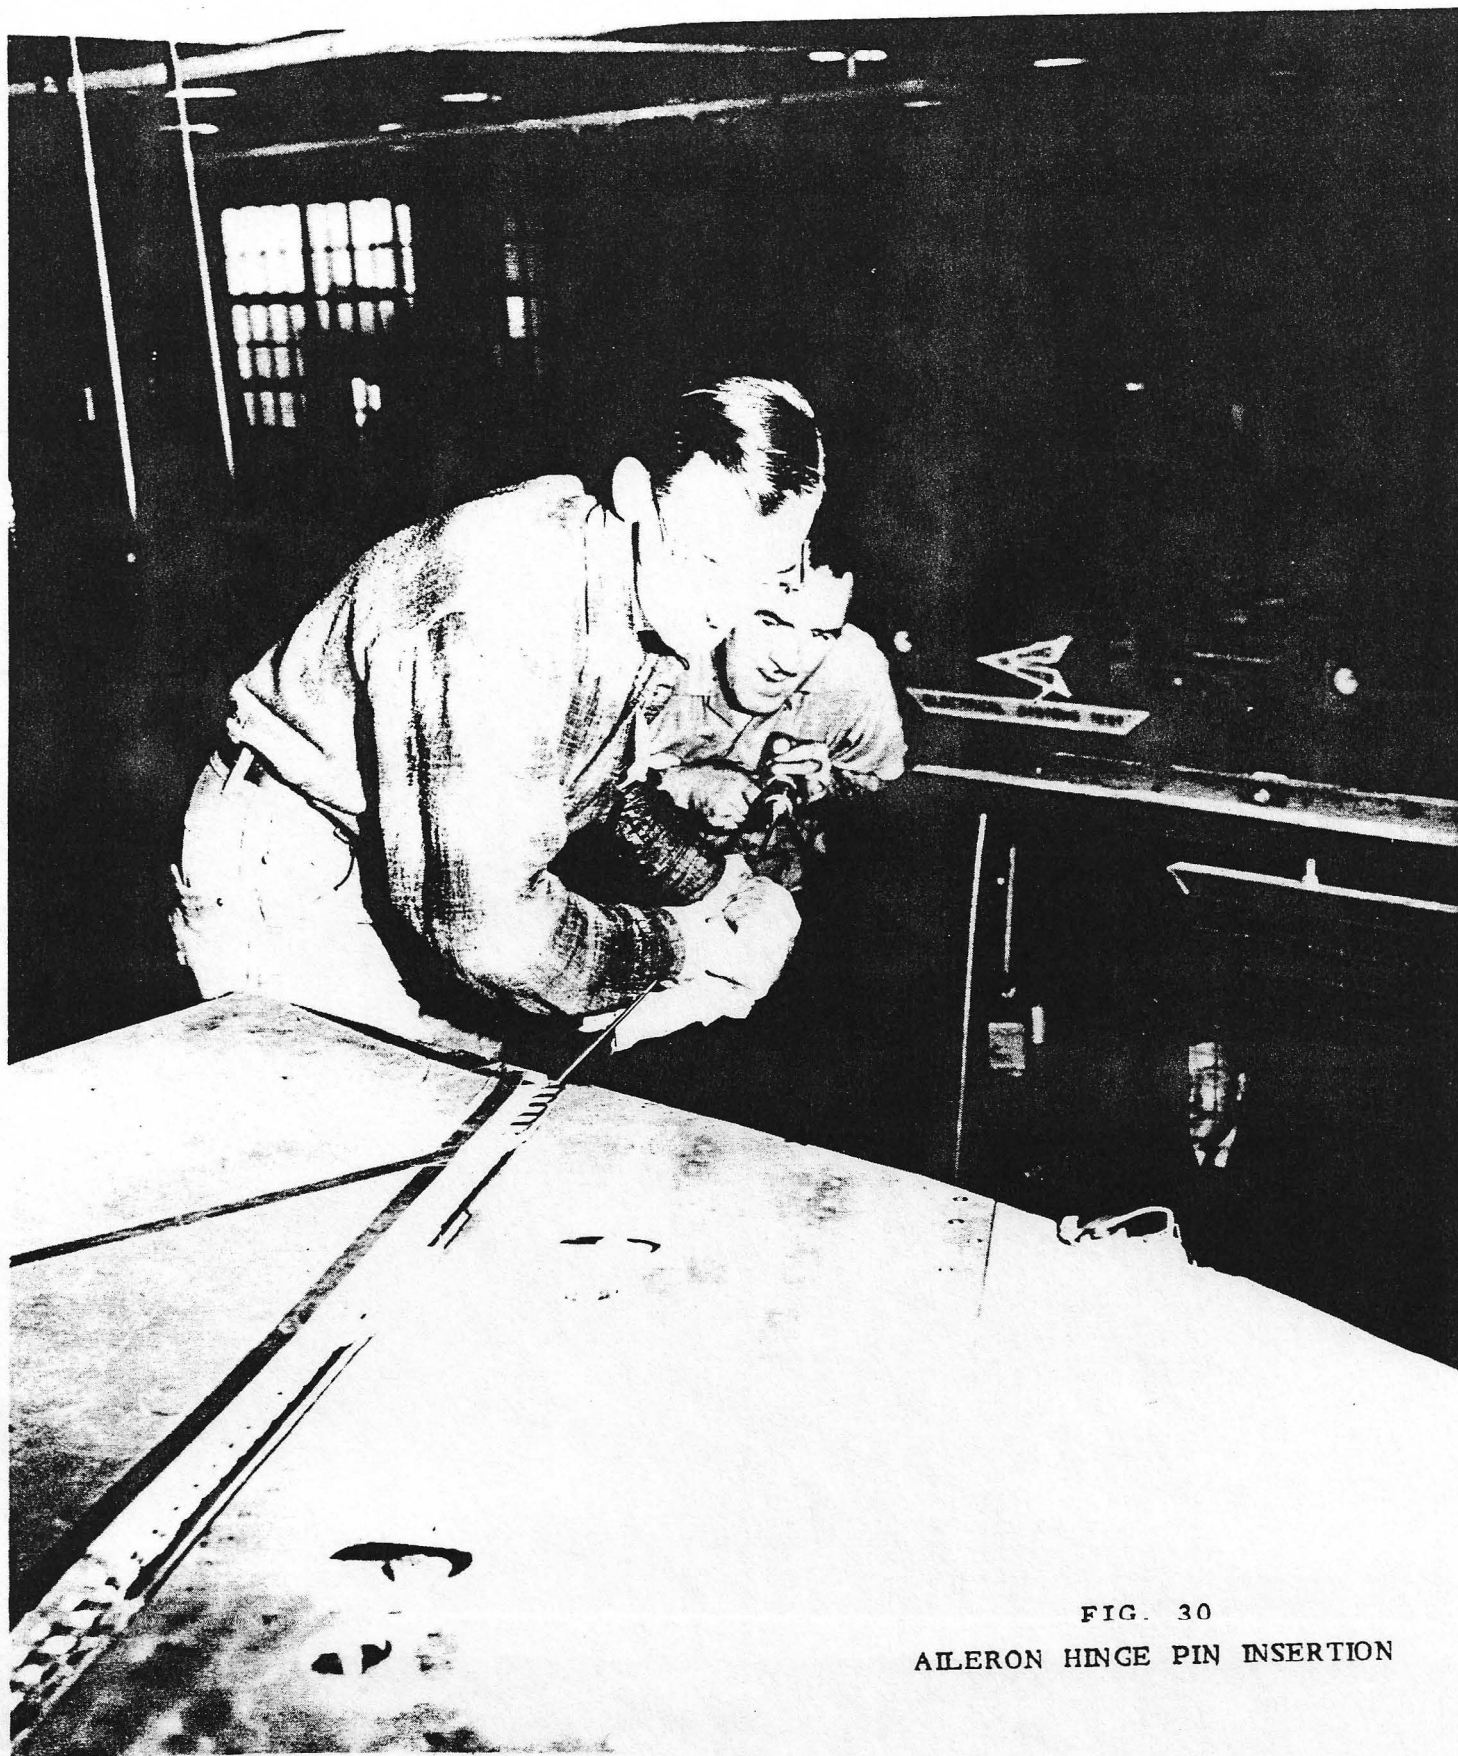
FIG. 30  
AILERON HINGE PIN INSERTION

- (f) Oildag (O.D. 200) the prescribed lubricant, should be used on the hinge pin as recommended. In the case of these demonstrations, the hinge pins had not been lubricated and this accounted for some of the difficulty of removing the aileron hinge pin. In addition, hexagonal ends on the pins, which will be provided on production aircraft, will further assist the removal of the pin. It is interesting to note here that a proper length hinge pin was inserted and removed from the
