**To:** Jason Illari, Historical Society of Carroll County  
**From:** Preston Hull, Building Conservation Associates, Inc.  
Dorothy Krotzer, Building Conservation Associates, Inc.  
**Date:** March 2, 2026  
**Subject:** Kimmey House: Interior Finishes Analysis

### *First-Floor Front Room, ca. 1810 Addition*

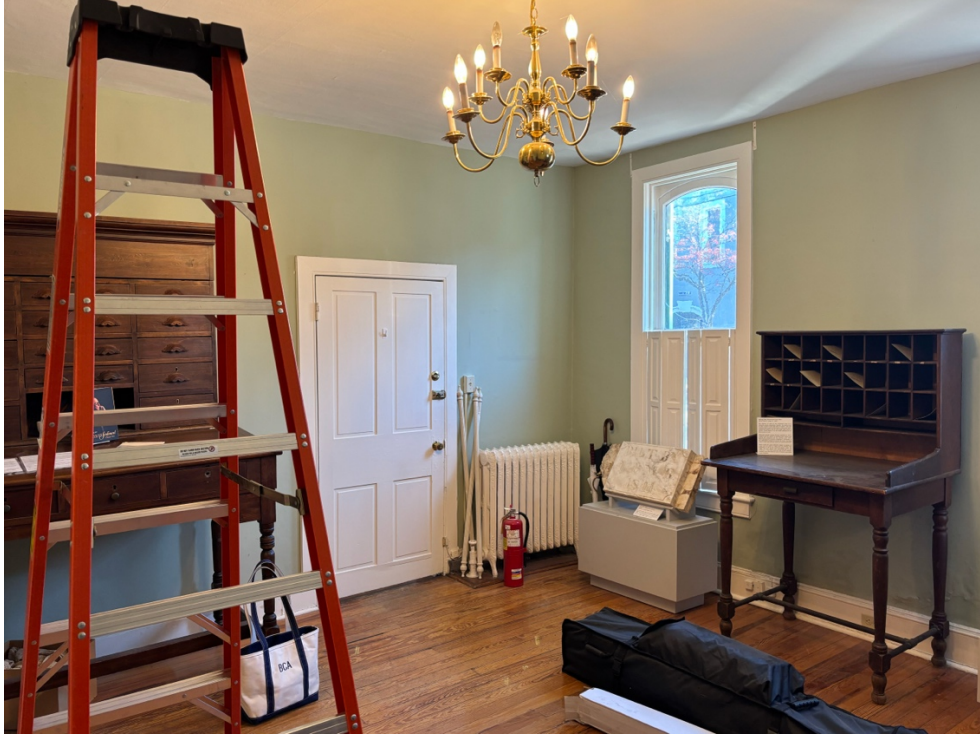
**Figure 1** The front room of the ca. 1810 addition to the Kimmey House, looking northwest toward the door to the center hall.

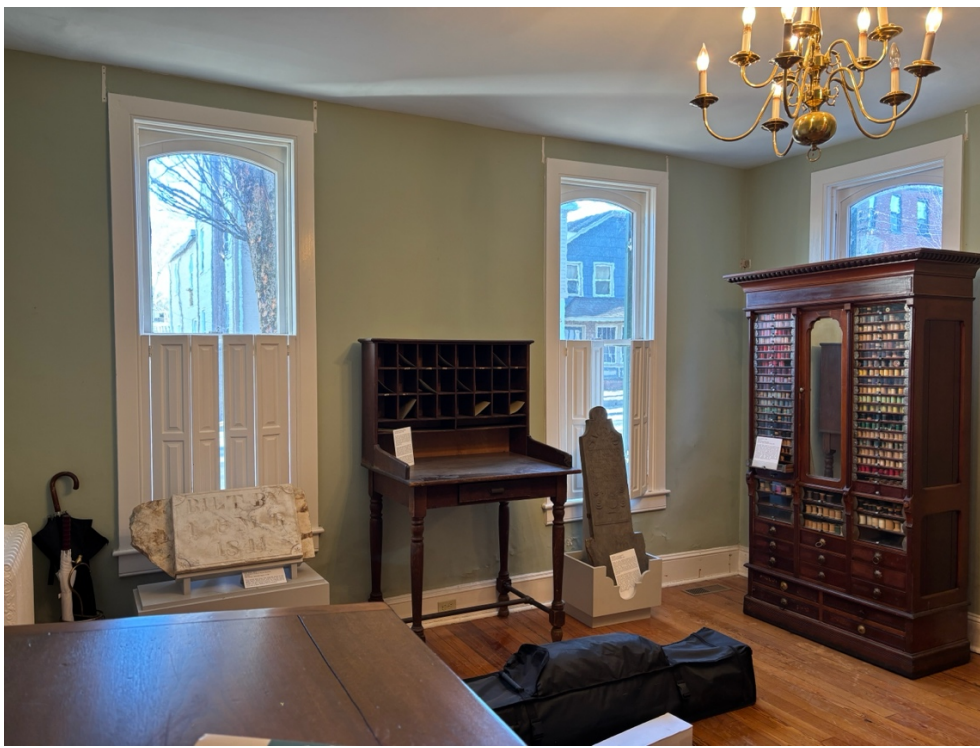
**Figure 2** View looking northeast.

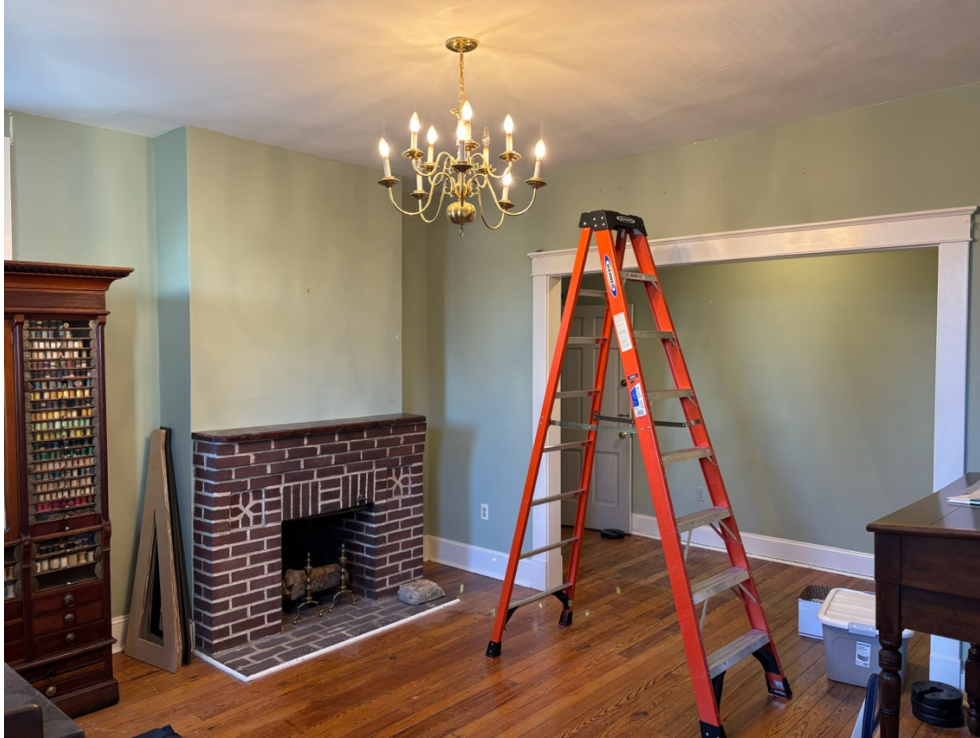
**Figure 3** View looking southeast from the center hall door. The alcove at rear was not in scope.

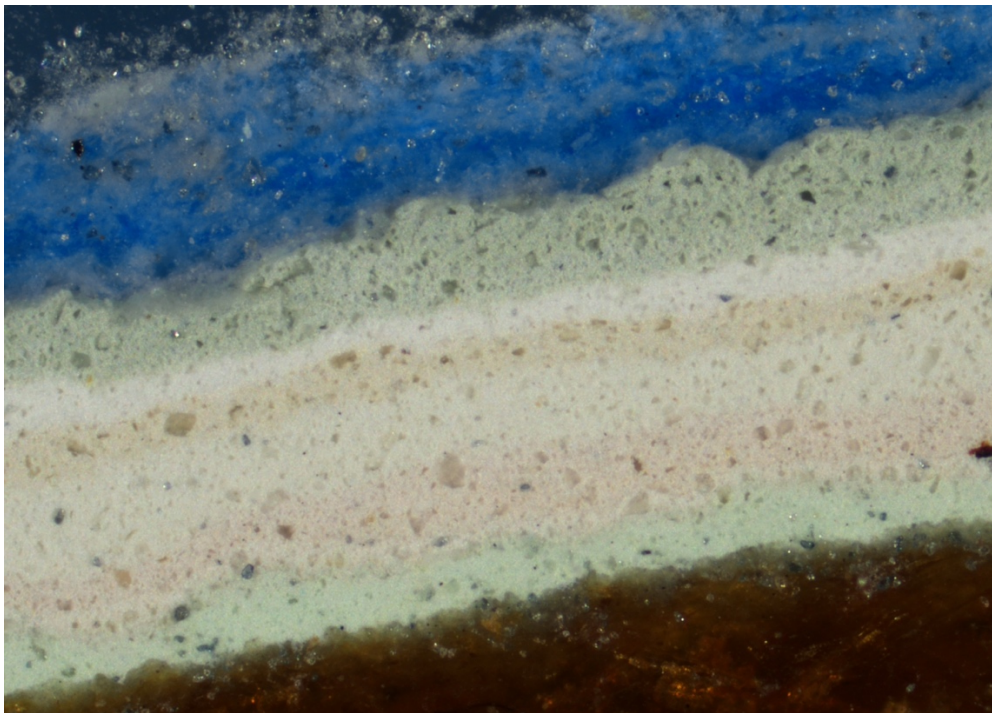
Field microscopy similarly indicated that different areas of the plaster walls exhibited similar or identical paint evidence across all elevations and wall heights. That is, no clear evidence of a two- or three-part wall treatment (i.e., with different schemes at the upper and lower wall) was observed on site. Samples removed from the plaster walls are generally consistent with one another, and similar to the evidence observed at the plaster ceiling: six to seven layers of modern latex paint on top of two to three layers of wallpaper (Figure 6). One of these layers of wallpaper is partially exposed at one location on the east wall of the room, revealing a striped pattern that is also visible in many of the wall samples (Figure 7). The stripes may represent a pattern in and of themselves or may represent a shading technique within a larger graphic.

**Figure 6** Photomicrograph of sample *KH.W8*, removed from high on the west wall over the door. Note the roughly six layers of modern paint above previous wallpaper; the other seven wall samples were virtually identical. Bottom of sample and earliest wallpaper layers not shown. *Visible light, 40x.*

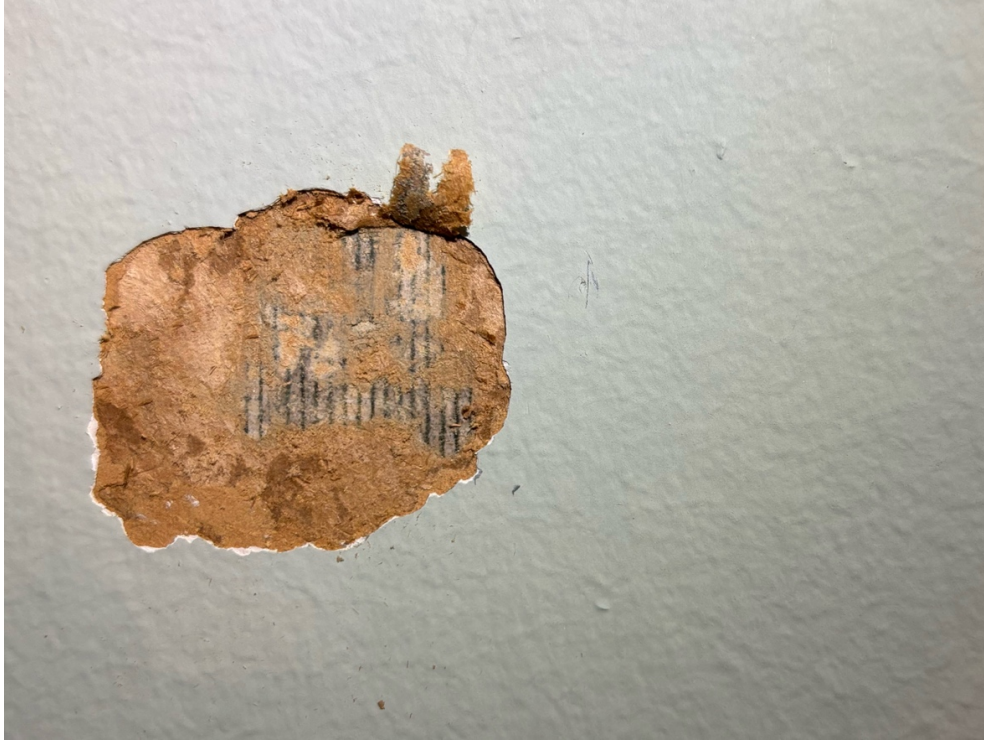
**Figure 7** Small area of wallpaper exposed on the east wall of the room. This striped pattern was visible in several of the samples removed for analysis and appears to be the middle of three layers of wallpaper.

Similarly, in-situ exposures of the wallpaper on the walls and ceiling would be required to provide information about the patterns, which may also provide date information.

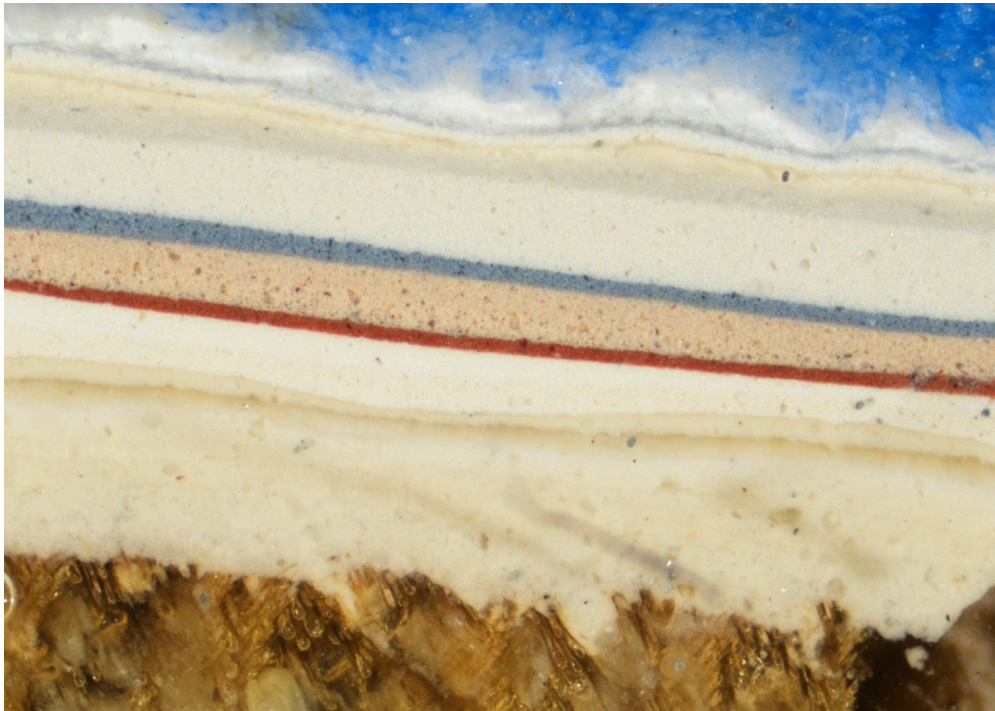
The door trim sample exhibits a very similar stratigraphy to the door itself, but is missing three to four of the earliest layers present on the door sample (Figure 10). The earliest extant finishes are white or off-white. The window trim sample is identical. This evidence may suggest that the trim dates to a renovation, perhaps used to unify the room's window and door openings after later 19<sup>th</sup>-century modifications. Alternatively, it is possible that the trim was stripped of its earliest finishes at some point; the substrates of both samples are slightly irregular. The trim samples generally appear to have been painted to match the doors and window sash: primarily in white and cream colors, but including the red and blue campaigns.

**Figure 10** Photomicrograph of sample KH.DT, removed from the door trim. Note the similarities to the door sample, but the absence of the earliest three to four layers, suggesting that the door trim is from a later date. (The blue layer at the top of the sample is painter's tape from sampling.) *Visible light, 40x.*

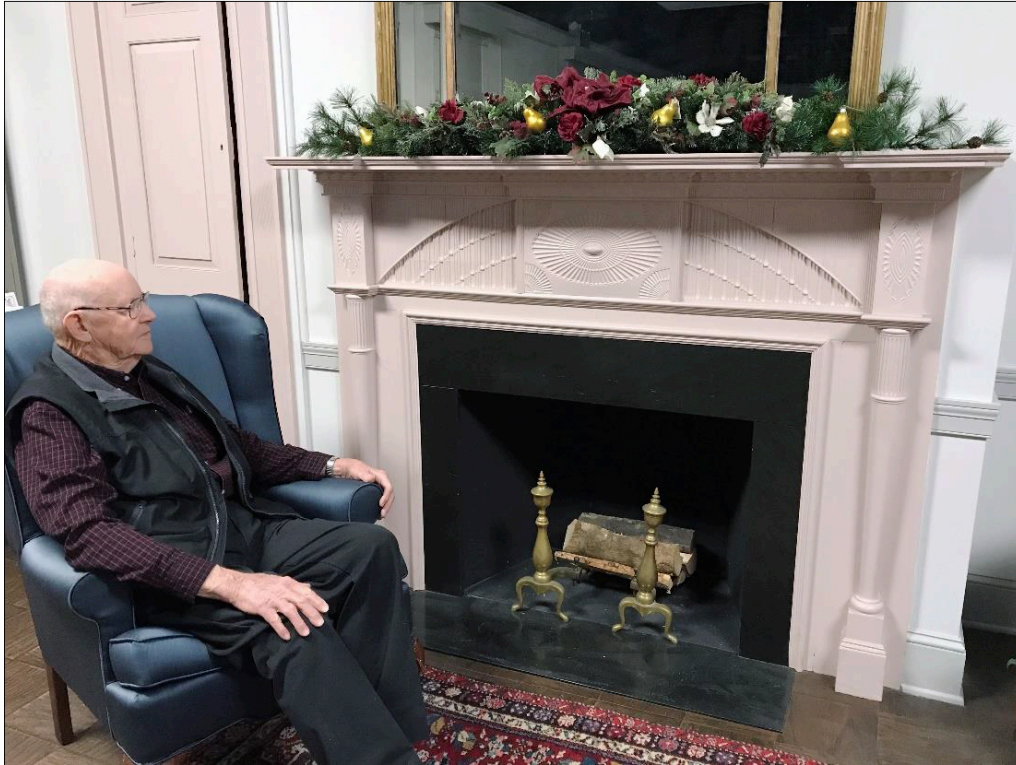
BCA observed that the profiled, ornamental features of the cupboard and mantel were quite well-defined and appeared to lack heavy paint build-up. Field microscopy confirmed that both elements typically feature only two layers of paint: a white initial layer or primer, and the current pinkish white. This evidence suggests that the cupboard and mantel were stripped of their earliest finishes. This may have occurred at the time of relocation, when the disassembled elements could be dipped in a chemical treatment for thorough removal. BCA removed small scrapings from isolated areas of apparent paint build-up in corners and crevices between wood members to determine whether evidence of earlier paint finishes was visible in cross section.

**Figure 14** Photograph of the mantel and cupboard provided by the HSCC and showing the current paint finishes. The level of detail evident in the profiled ornament is evidence of the few extant paint layers.

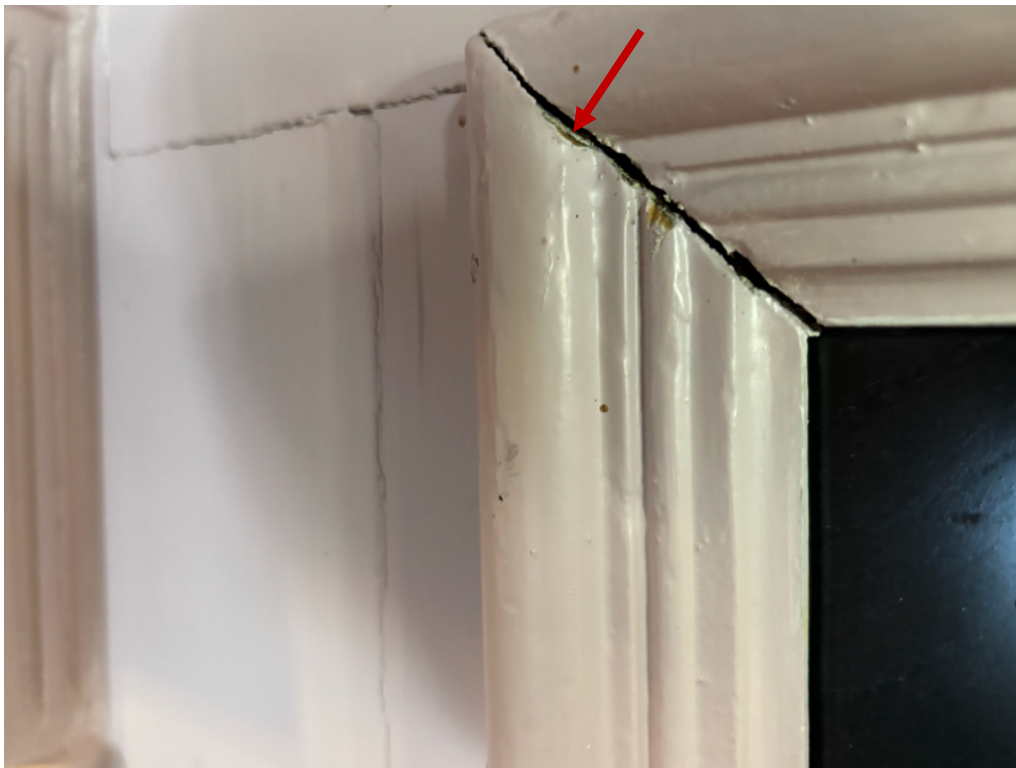
**Figure 15** Trace evidence of paint buildup and surface staining (arrow) is visible at some joints in the cupboard and mantel woodwork. However, only one scraping removed from either feature retained part of a stratigraphic sequence. See following figure.
