**1968 Chris Craft Grand Prix**  
**"RAE"**

# **Report of Marine Survey**

**1968 Chris Craft Grand Prix**

June 3, 2023

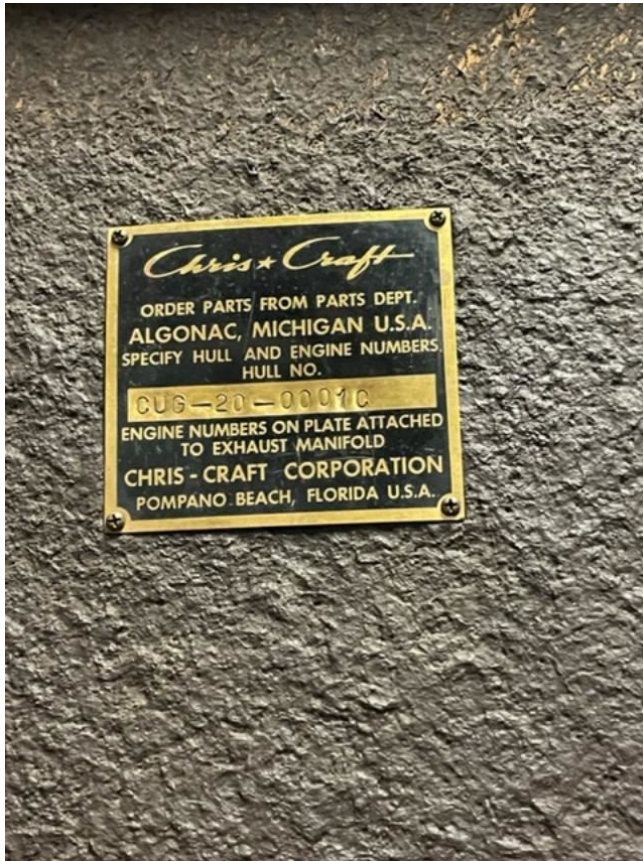
The vessel's HIN (Hull Identification Number) was not displayed on the starboard upper transom corner, nor was it found at a hidden area of the vessel. All boats manufactured or imported on or after November 1, 1972 must bear a HIN. As this vessel was constructed prior to the date of HIN requirement, the HIN for this vessel is located on a metal plate found on the under side of the engine compartment cover.

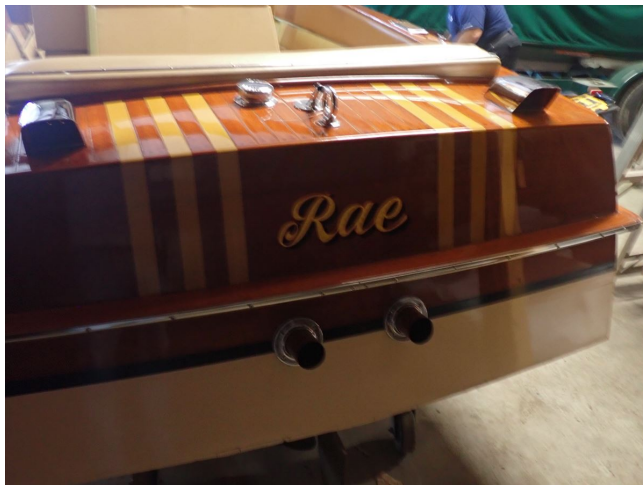
Transom is stake constructed.  
Transom stakes are made of various dimensions of Philippine mahogany and what appears to be holly.

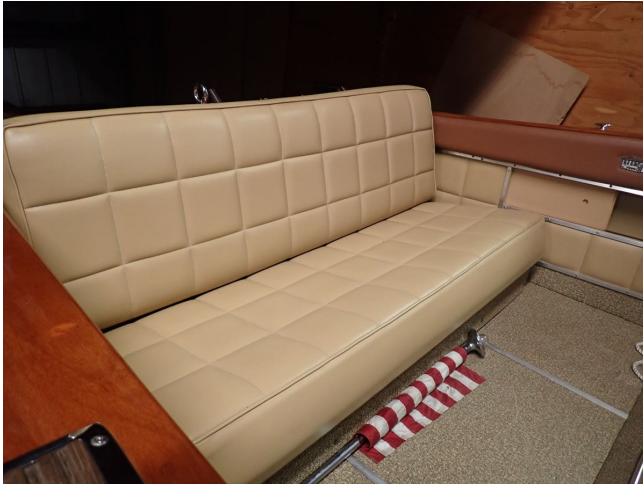
### GENERAL EXTERIOR SOFT-GOODS CONDITION

All of the vessel's exterior vinyl cushions were in excellent condition.

The exterior bright work was noted to be in excellent condition.

### GENERAL HARDWARE CONDITION

No corrosion was observed on the vessel's interior and exterior hardware.

### GENERAL CAULKING/SEALANT CONDITION

No significant weathering was observed on the vessel's exterior sealants.

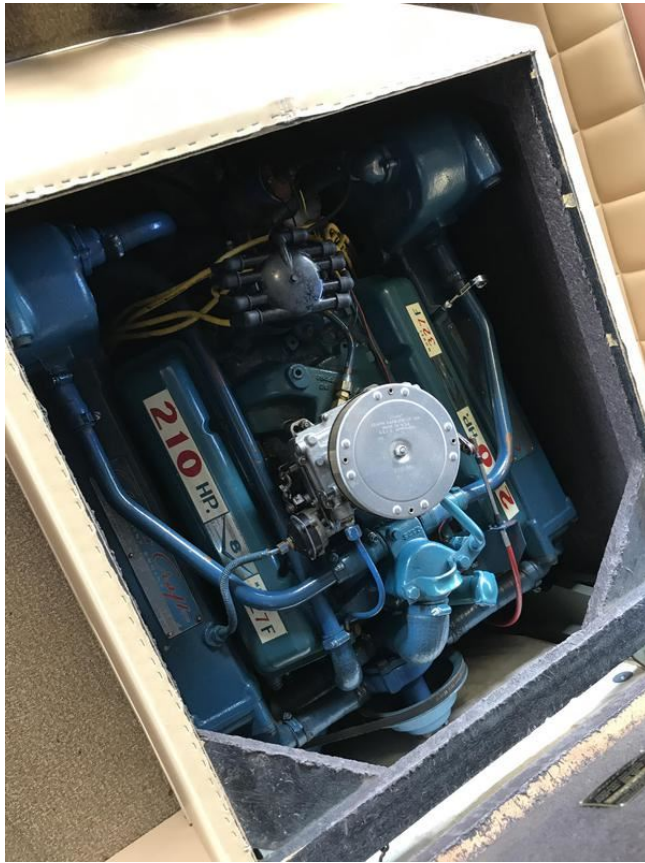
Chris Craft (Chevrolet) 327 V8 gasoline engine.

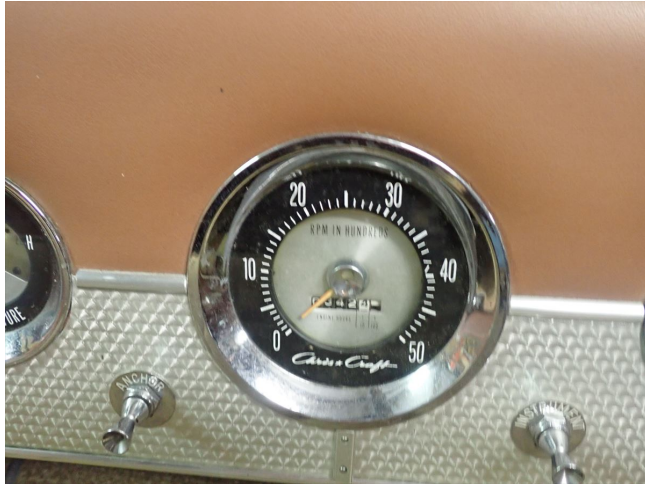
### ENGINE SERIAL NUMBERS

S/N: 709897

Serpentine belt condition appeared serviceable.
