**WORKSHEET**  
**Restoration of Koehl Lot**  
**Section D, Lot 162 W 1/2**

**To:** Dick Ambrus  
**From:** Martha Peterson  
**Subject:** Monument Restoration – Koehl (D-162 W½)  
**Date:** June 2, 2005

## MONUMENT RESTORATION PROJECT

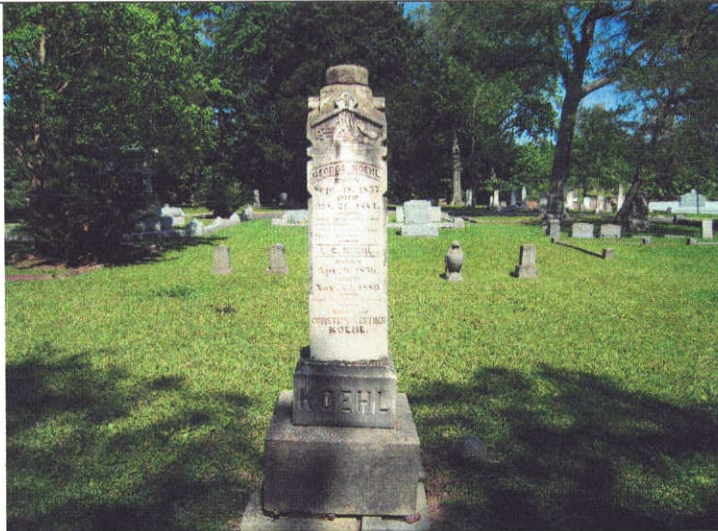
| <b>Work Performed</b> | A 67" tall marble monument was almost plumb, but had no foundation. It was sitting atop concrete pavers, leveled by small stones used as shims (see photograph below). The finial had broken off and was lying on the ground. The monument is inscribed with the manufacturer's name, Seager & Co., of Houston. | | | |

**Before:** The monument is almost plumb, but is not on a proper foundation. It is sitting on concrete pavers, leveled by small stones used as shims.

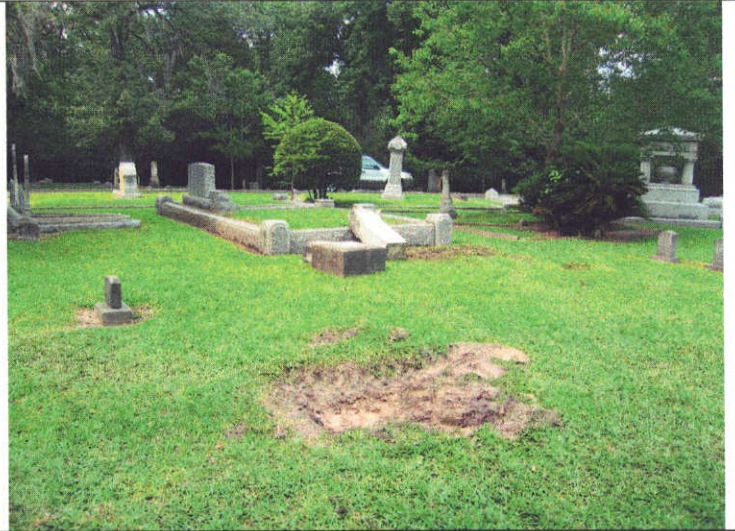
**Before:** Excavation reveals no foundation under the monument.

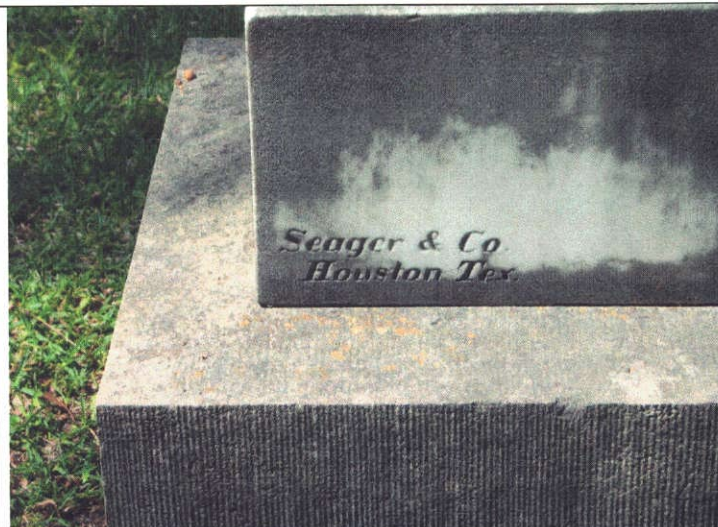
The Koehl monument is one of relatively few in Glenwood that identify the manufacturer.

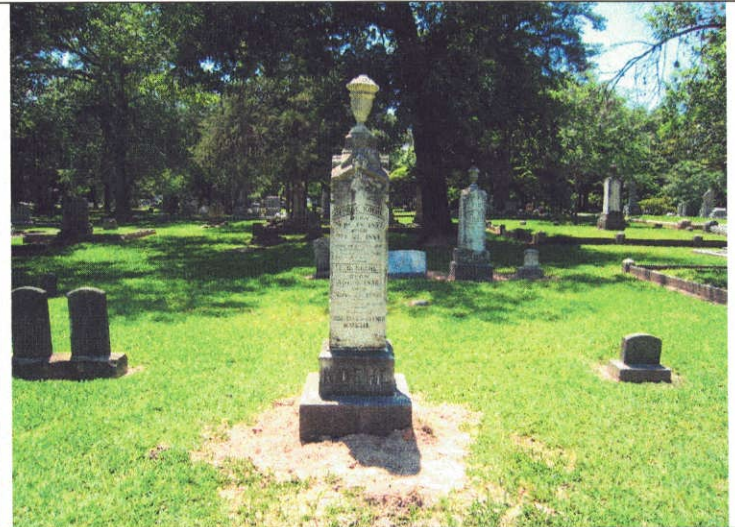
**After:** The monument has been leveled and reset on a proper foundation. The sod around the base of the monument will be replaced.

Attached is a “before and after” of a monument in the north part of Section D. I plan to retake the “after” photo because it doesn’t look plumb.

Before work began on this monument, the epitaph faced west. It was put back together with the epitaph facing east. Mario says he can turn it. Is it worth the expense? Note that the last burial was in 1894.
