GLENWOOD CEMETERY

**To:** Dick Ambrus  
**From:** Martha Peterson  
**Subject:** Monument Resetting, Section E, Lot 133  
**Date:** October 22, 2004

**WORKSHEET**  
**Restoration of E. F. Gray Lot**  
**Section E, Lot 133 NW 1/2**

**To:** Dick Ambrus  
**From:** Martha Peterson  
**Subject:** Monument Restoration  
Rosalie Gray, E-133 NW 1/2  
**Date:** April 28, 2005

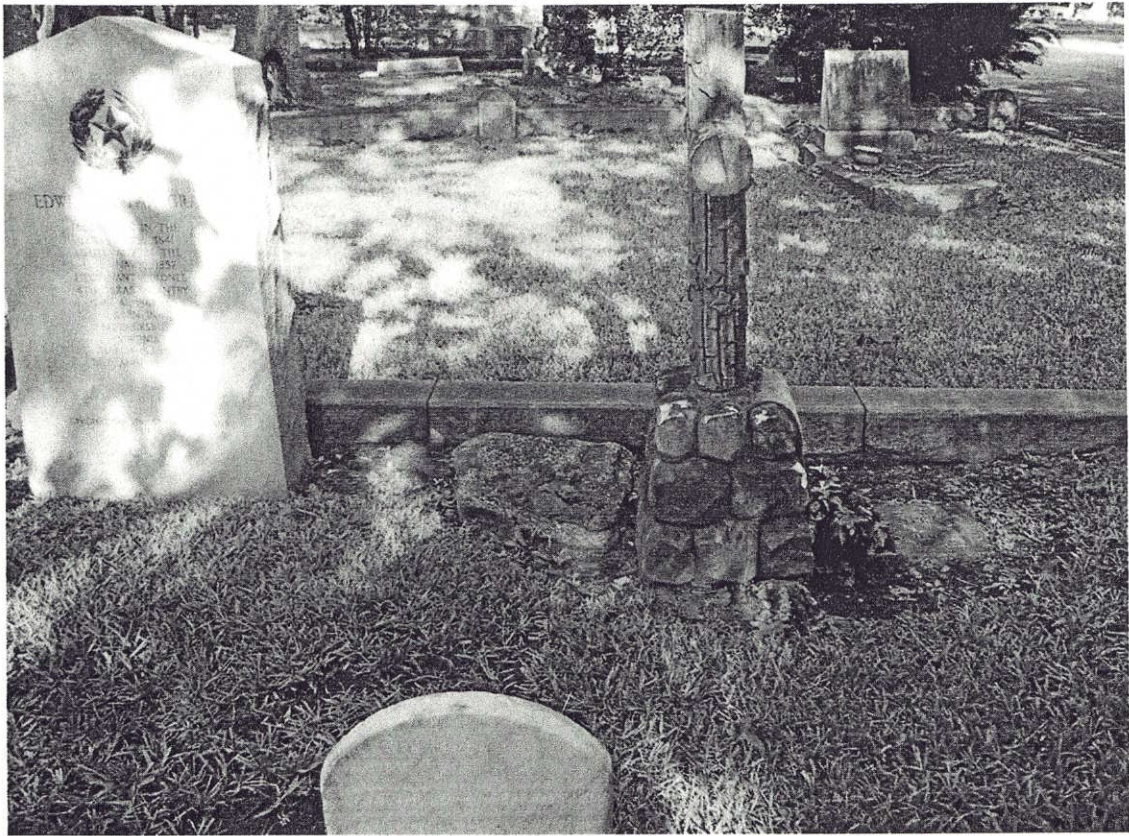
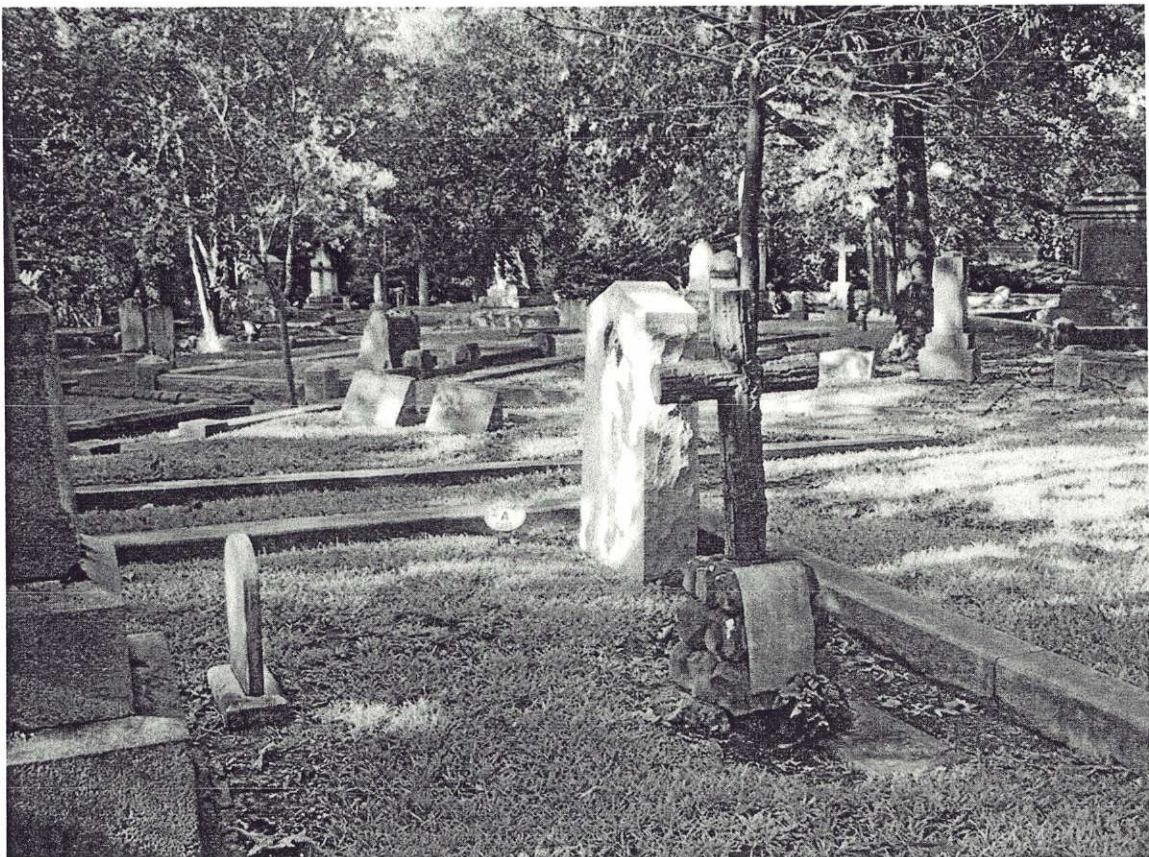
Attachments

One of the sites that will be featured in both the main brochure and the monuments brochure is in need of work. I've attached photographs of the grave of Mrs. Rosalie Woodburn Gray in Section E, Lot 133. Her headstone has slipped off its foundation and turned 90° to the north. It appears to me a new foundation must be poured and the monument placed on it. Is that something we can do in-house? Are funds available to do it before we begin distribution of the brochures?

I propose to include the grave of Mrs. Gray in the monuments brochure. What we presume to be her footstone contains a poem specific to Glenwood (see below), and her headstone is an excellent example of the use of the cairn as a symbol. One photograph could show both.

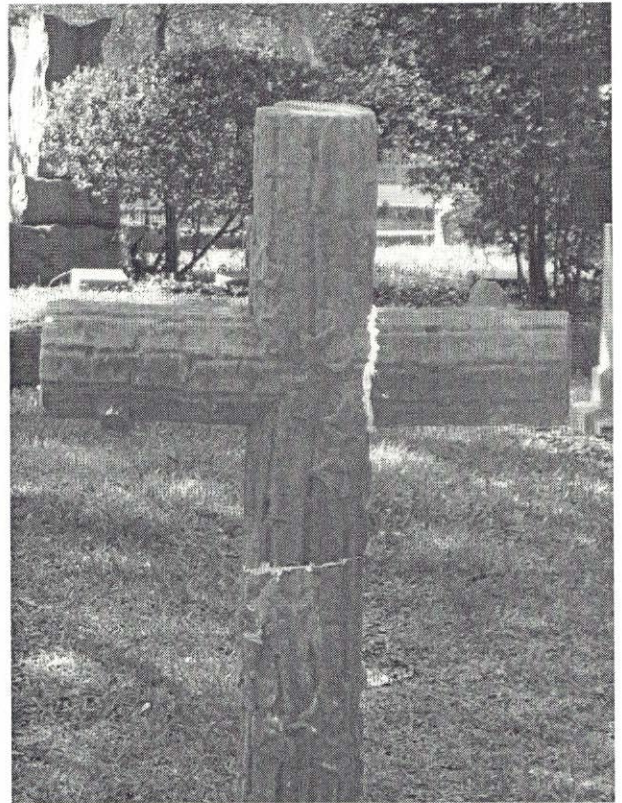
**April 15, 2005 (After resetting)**

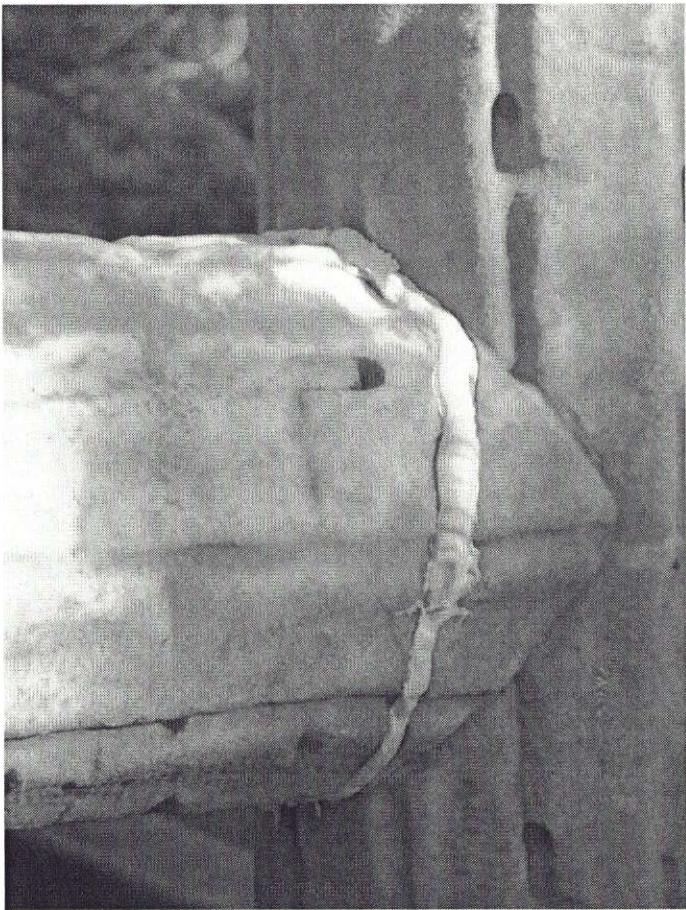
This is the work that prompted my question to Bonnie about the epoxy. It is not appropriate for material that looks like silicone to be visible on the surface of an 1874 stone, even if it were neatly applied.

**Close-up of repair, taken from back of monument**
