**GLENWOOD CEMETERY HISTORIC PRESERVATION FOUNDATION**  
**MONUMENT RESTORATION**

## MONUMENT RESTORATION PROJECT

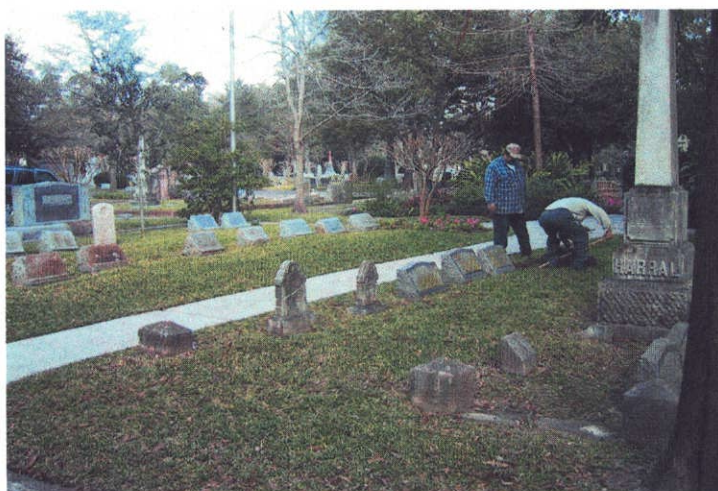
**BEFORE:** The corner posts of the lot and entrance are sunken, and it was thought perhaps a coping had sunk out of sight.

| <b>Work Performed</b> | The corner posts of the lot and entrance were tilted and sunken, and it was thought perhaps a coping was buried between them. Excavation proved the lot was marked only by the posts, and there was no coping. The posts and entrance were leveled and reset on new foundations. All markers on the lot were leveled on new foundations. All lot improvements were cleaned, and the sod was replaced. | | |

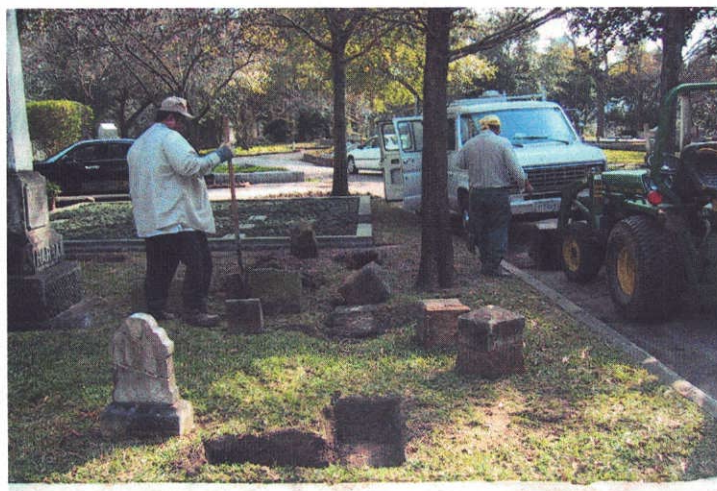
**DURING:** Excavation proved the lot was marked only by the posts, and there was no coping.

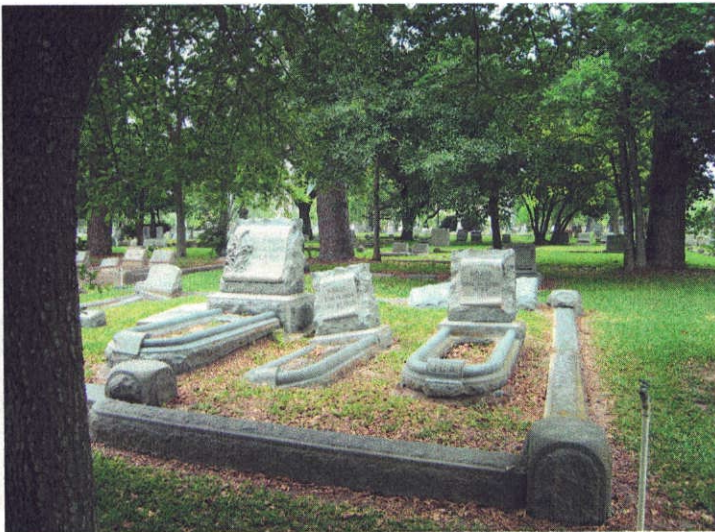
**BEFORE:** Center cradle is tilting 15° south

| <b>Work Performed</b> | An ambitious project. Two heavy granite cradles with attached headstones were severely tilted and partially buried. One was cracked into pieces. Both cradles were leveled and reset on new foundations. A large, upright headstone was laying on the ground, and it was reset in its proper location. A granite headstone at the rear of the lot that was tilting 11° south was leveled and reset on a new foundation. The granite coping on the north and south boundaries of the lot was leveled on new foundations. | | |

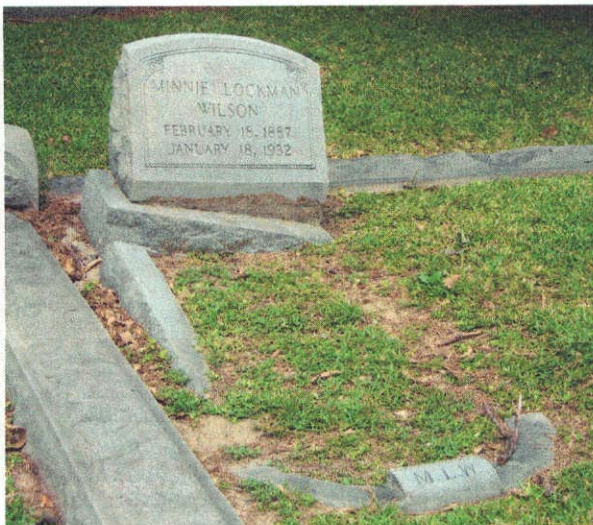
**BEFORE:** Cradle on left rear corner of lot is broken and partially buried. It shows a previous attempt to level the headstone without leveling the cradle.

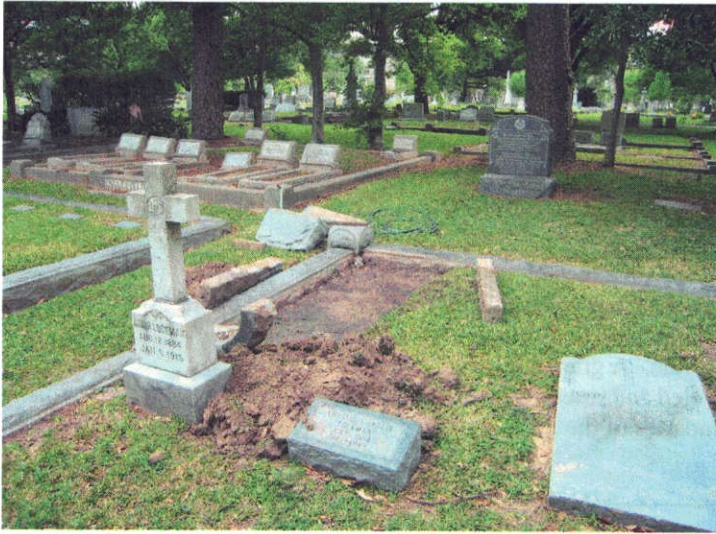
**BEFORE:** Large, upright marker is lying on the ground (right foreground).

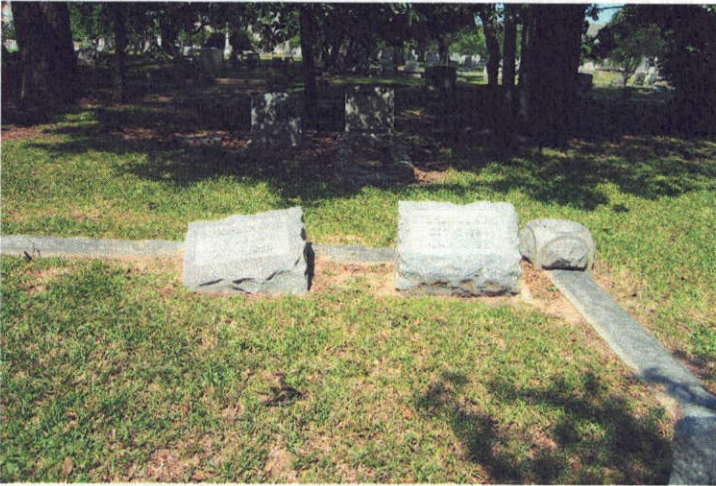
**BEFORE:** Granite headstone is tilting 11° south

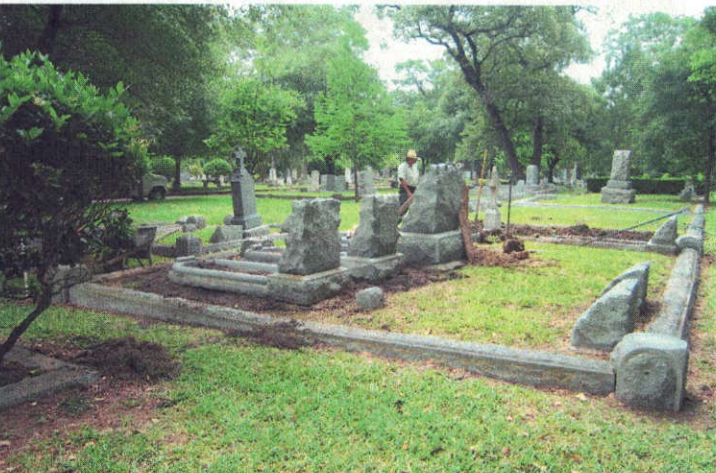
**BEFORE:** Coping on north and south boundaries is sunken toward the center. The photo above shows the north boundary.

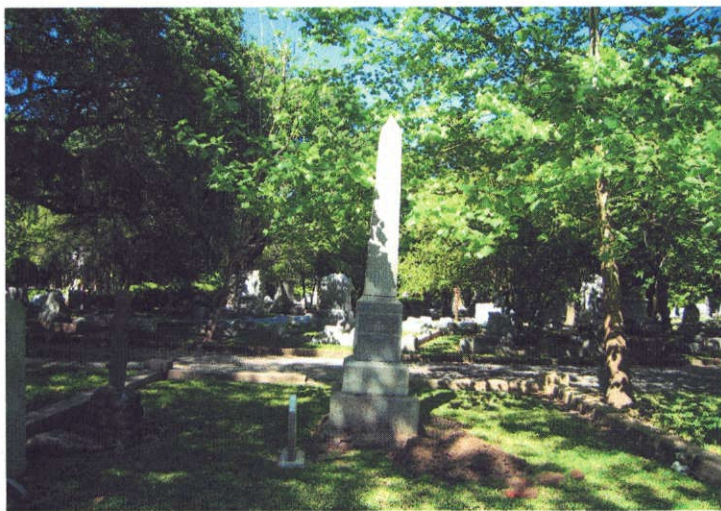
**BEFORE:** 10'-tall granite central monument is tilting 4° east.

| <b>Work Performed</b> | The 10'-tall granite central monument was tilting 4° east. It was leveled, reset on a new foundation, and cleaned. The marble cairn and cross marker for Rosalie Woodburn Gray, wife of Edwin Fairfax Gray (marked with Texas Centennial project marker), had slid off its foundation, rotated 90° to the left and come to rest atop the marker for Bess Hammond Myers. Mrs. Gray's marker was reset on a new foundation in its correct location and cleaned. This grave is of special historic significance, not only because the Grays are one of Houston's prominent pioneer families, but because a poem on Mrs. Gray's footstone specifically mentions Glenwood. | | |

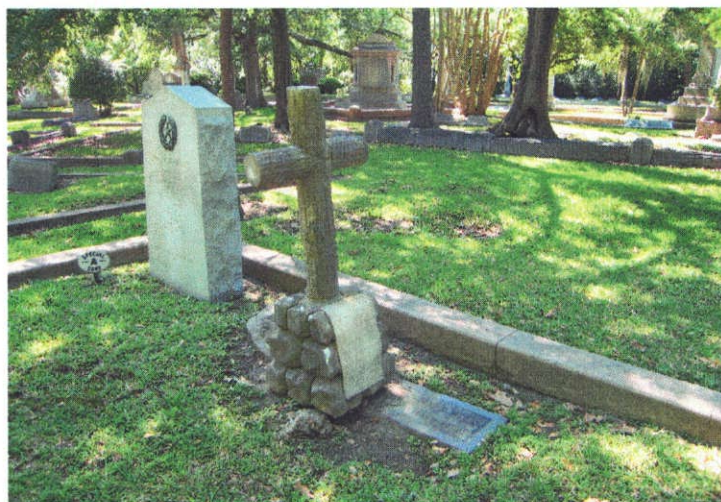
**BEFORE:** Rosalie Gray's marker has slid off its foundation, rotated 90° to the left and come to rest atop the adjacent marker.

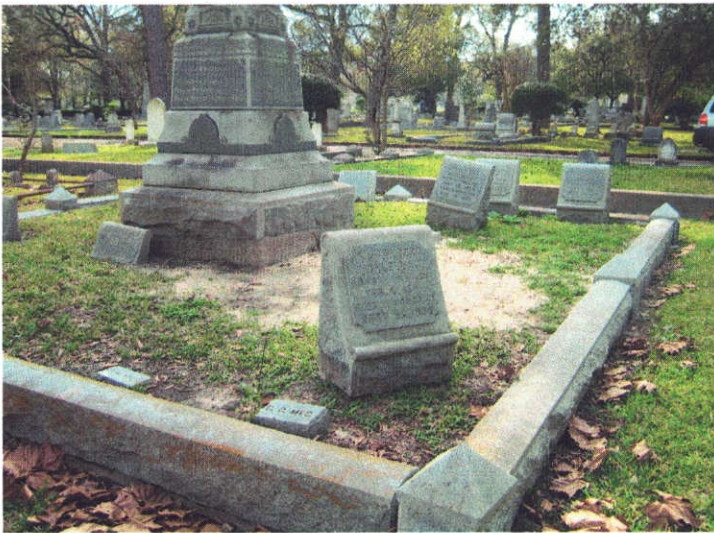
**BEFORE:** Two markers have been moved. Others are tilting.

| <b>Lot No.</b> | 064 | <b>Work Performed</b> | Two markers had been moved from their correct locations. All markers on the lot, except the central monument, needed leveling. The two misplaced markers were returned to their correct locations and reset on new foundations. All remaining markers were leveled and reset on new foundations, and the sod was replaced. | | |

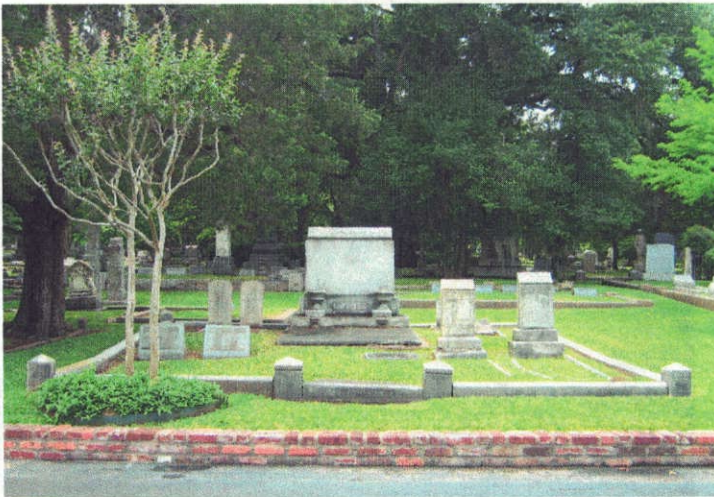
**BEFORE:** The coping and entrance are tilted and partially buried. Six marble cradles are partially buried, and some markers have been improperly leveled.

| <b>Work Performed</b> | Six marble cradles were broken and partially buried. All pieces were located and the cradles were reassembled and set on new foundations. Four marble markers were leveled and reset on new foundations. On the right rear corner of the lot, an 1892 marker was broken into several pieces, some of which were buried. It was reassembled and set on a new foundation. The marble coping and entrance were leveled and set on new foundations. The large monument and two of the markers are carved with an unusual "Heaven's gate" motif. | | |

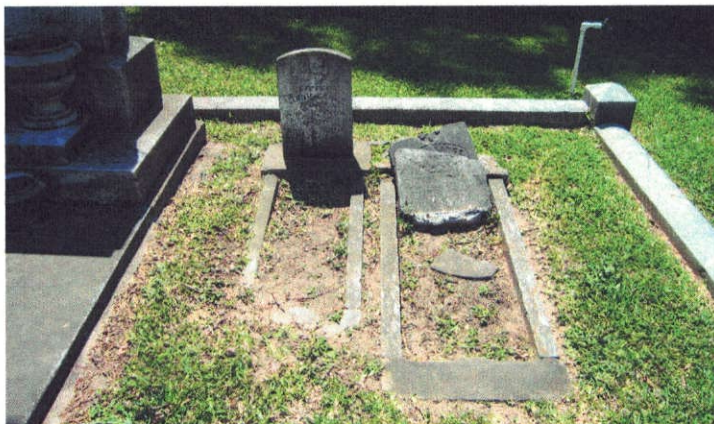
**BEFORE:** An 1892 marker is broken into pieces and some pieces are buried. The adjoining cradle is partially buried.

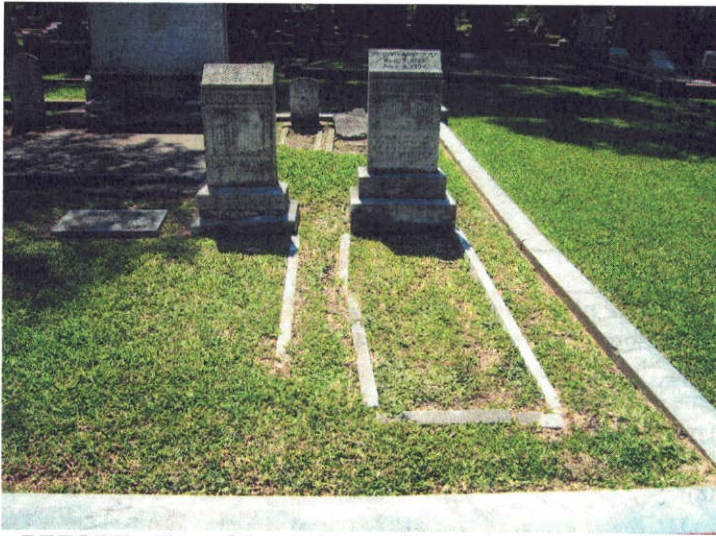
**BEFORE:** Two of the marble cradles are broken and partially buried. The marker on the left has been improperly leveled in the past.

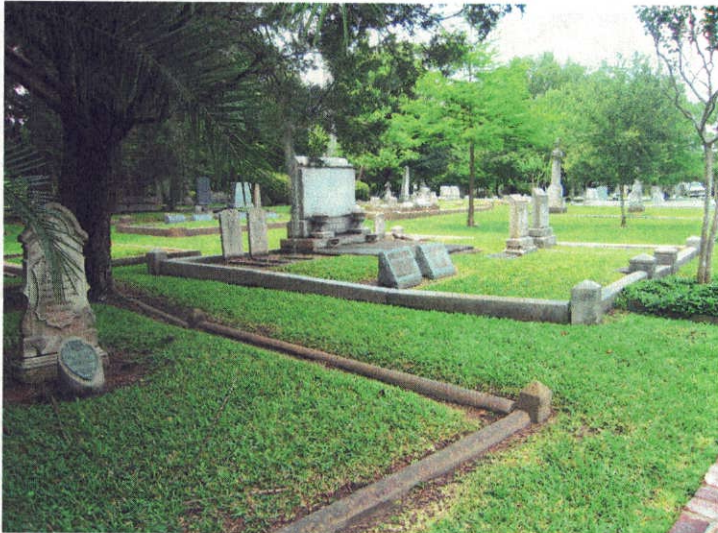
**BEFORE:** Partially buried cradles are visible in the left rear corner of the lot. The coping is not level and the posts are not plumb.

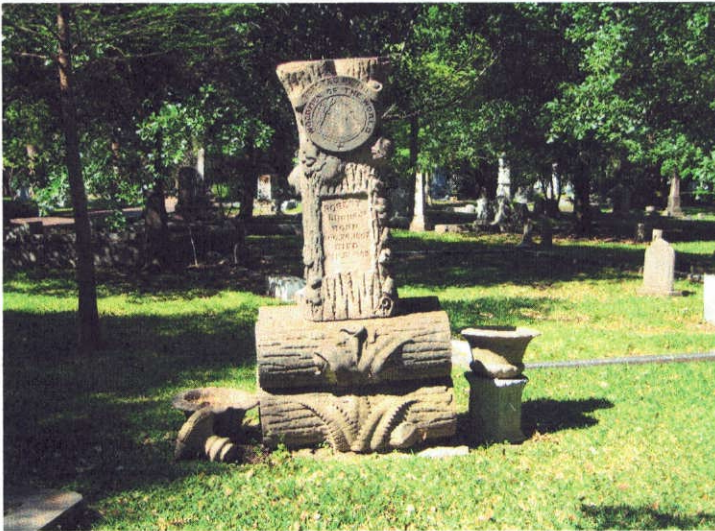
**BEFORE:** The monument is tilting 3° west.

| <b>Work Performed</b> | An excellent example of a Woodmen of the World monument was tilting 6° south and 3° west. The 6'4"-tall sandstone monument incorporates an unusual number of the WOW symbols: the log and tree motifs, the lilly, the fern, and the WOW seal and motto, "Dum Tacet Clamat" ("though silent, he speaks"). The 37"-wide base and monument were leveled and reset on a new foundation. One broken concrete urn was reattached to its base. | | | |

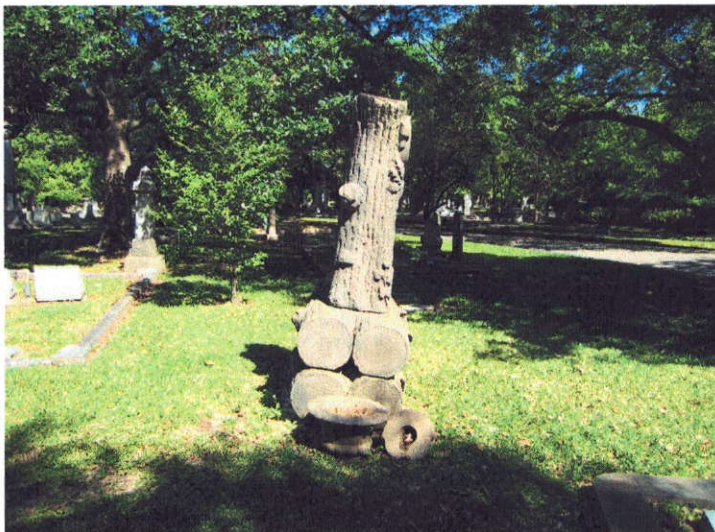
**BEFORE:** The monument is tilting 6° south.

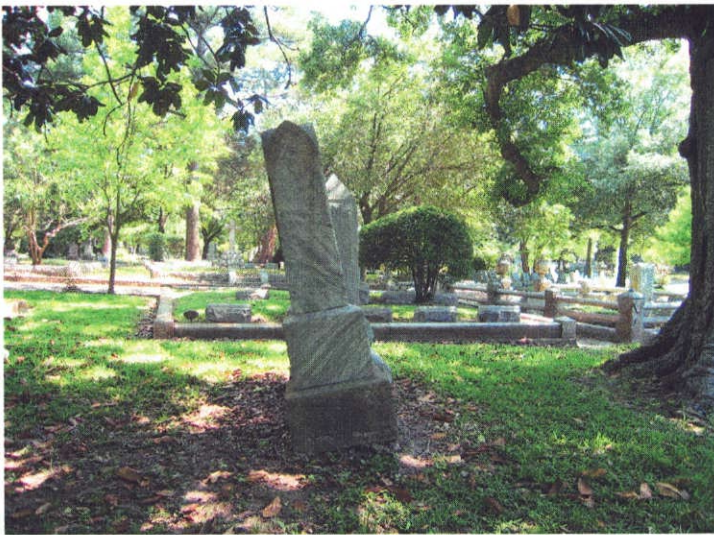
**BEFORE:** Monument is tilting dangerously 12° east.

| <b>Work Performed</b> | A 6'8" tall marble monument was tilting dangerously 12° east and in danger of falling. The monument was reset on a new foundation. During excavation, it was discovered that the monument was set on an unstable foundation of rubble. After that discovery, the adjoining 6'-tall granite monument was also reset on a new foundation. | | |

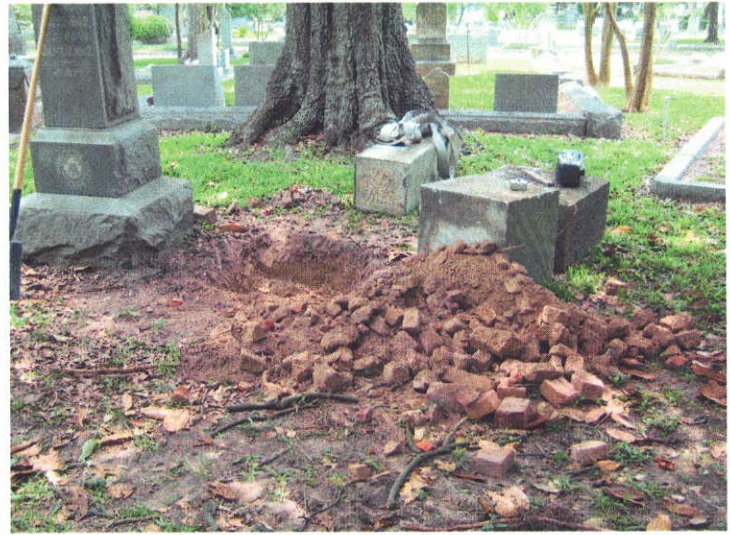
**DURING:** Excavation reveals only rubble for a foundation.

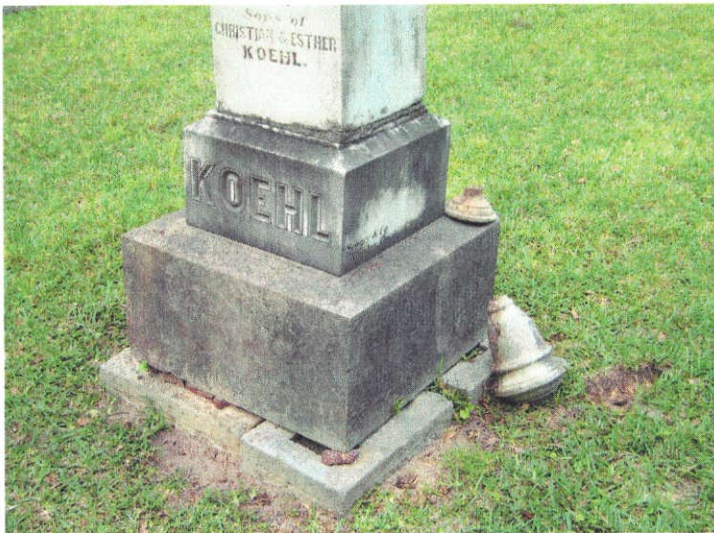
| <b>Work Performed</b> | A 67" tall marble monument was almost plumb, but had no foundation. It was sitting atop concrete pavers, leveled by small stones used as shims (see photograph below). The finial had broken off and was lying on the ground. The monument is inscribed with the manufacturer's name, Seager & Co., of Houston. | | | | |

**BEFORE:** The monument is almost plumb, but has no foundation. It is sitting on concrete pavers, leveled by small stones used as shims. The broken finial is lying on the ground

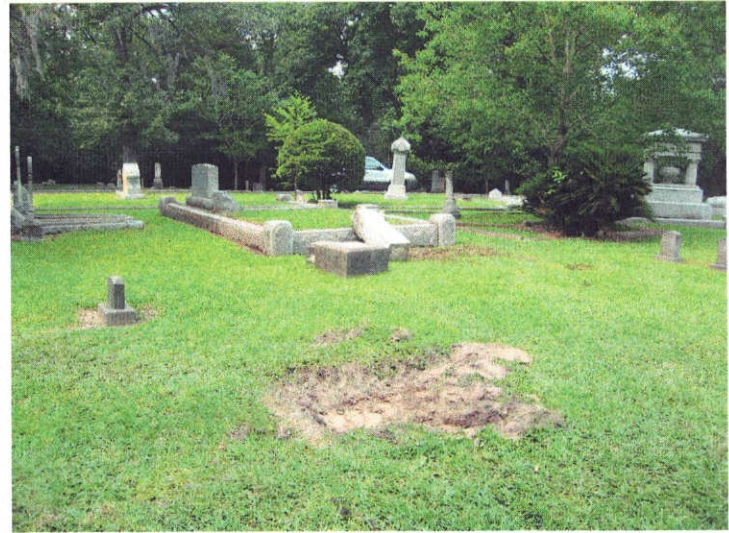
**DURING:** Excavation reveals no foundation under the 67"-tall monument.

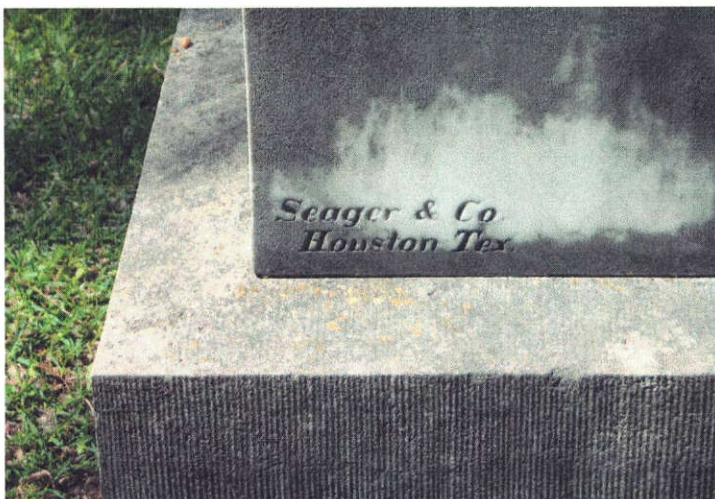
The Koehl monument is one of relatively few in Glenwood that identify the manufacturer.

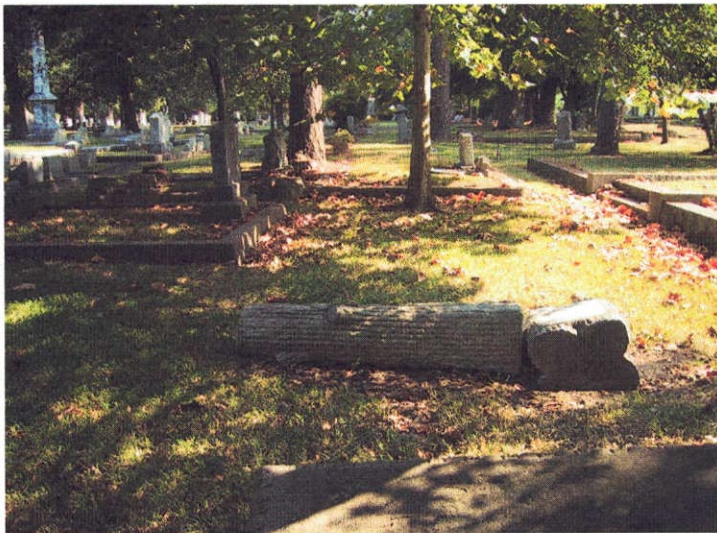
**BEFORE:** The base of the 6'-tall sandstone Woodmen of the World monument had tilted. The shaft had slid off the base.

| <b>Work Performed</b> | The base of the 6'-tall sandstone Woodmen of the World monument had tilted east. The shaft had slid off the base and was lying face down on the ground. The base was leveled and reset on a new foundation and the shaft was reattached. | | | |

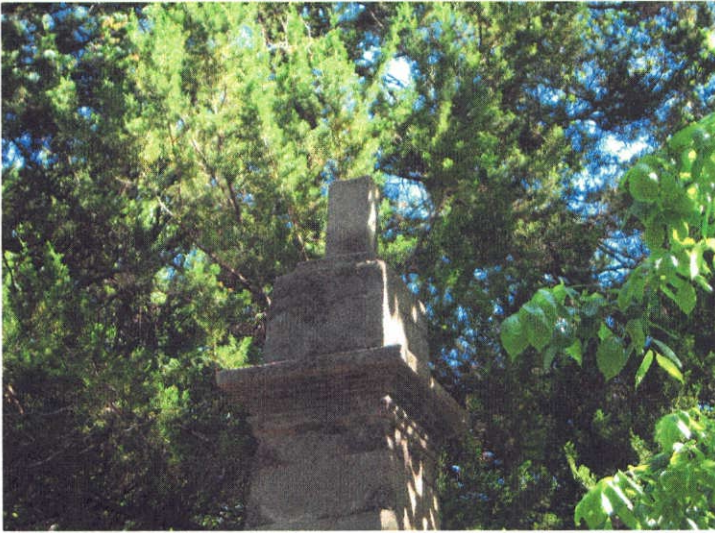
**BEFORE:** The top half of a cross approximately 20" tall had broken off and was lying loose at the base of the monument.

| <b>Work Performed</b> | The top half of a cross approximately 20" tall had broken off and was lying loose on the lot. The cross was repaired to prevent the piece from being lost. | | |

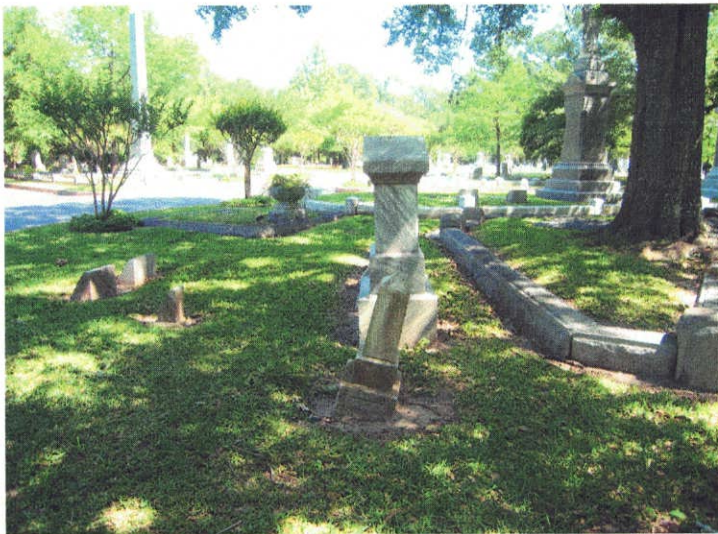
**BEFORE:** A 24"-tall marker for two infants is tilting 10° west and 5° north. The base is cracked through. The upper portion is not attached to the base, and can be lifted off.

| <b>Work Performed</b> | A 24"-tall marker for two infants was tilting 10° west and 5° north. The base was cracked through. The upper portion was not attached to the base, and could be lifted off. The marker was leveled and reset on a new foundation, and the upper portion was secured to the base to prevent loss. | | |
