House and Garden Walk

Saturday, September 14, 2002

Presented By
Logan Square Preservation

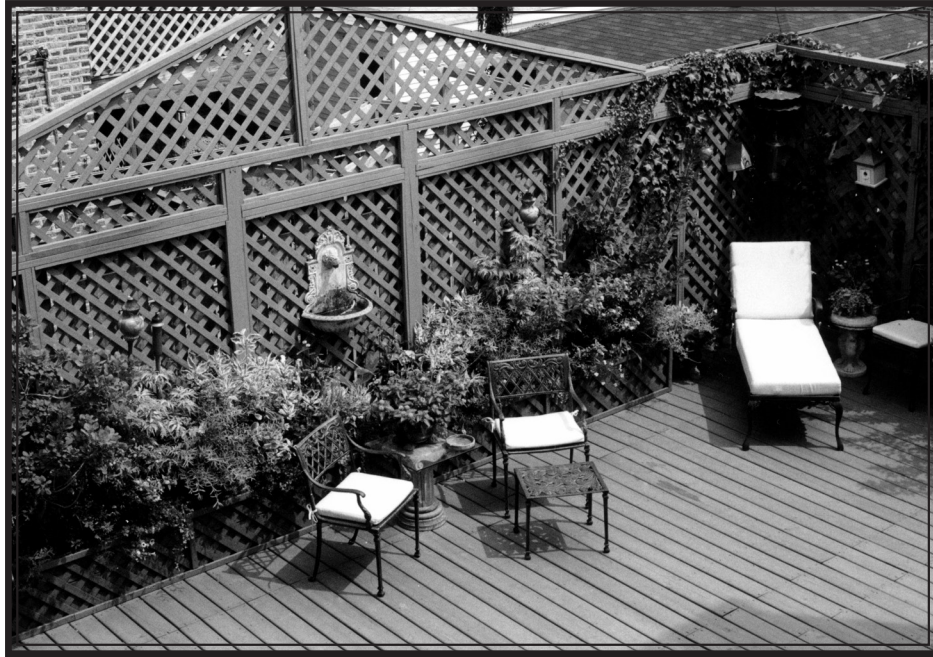
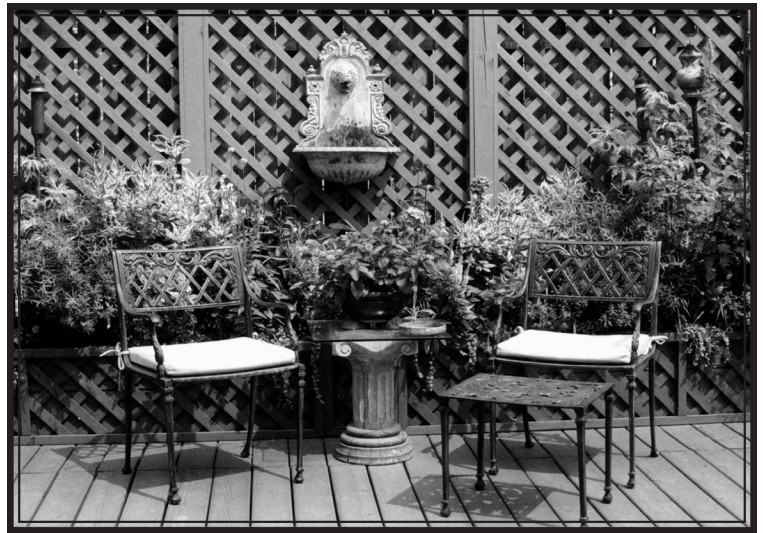
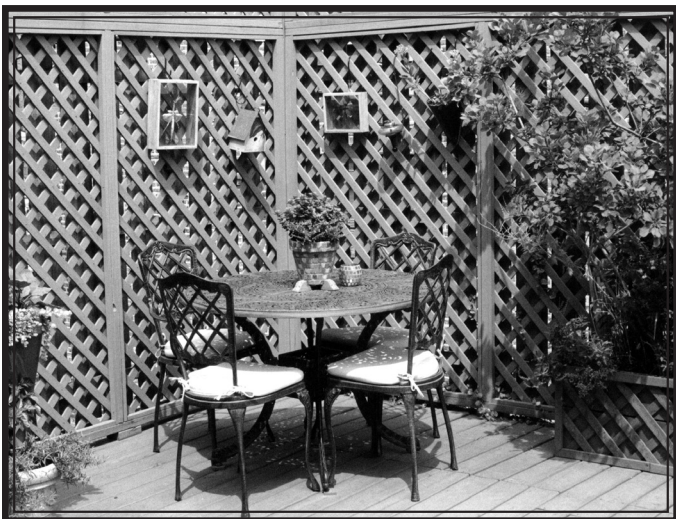
③ 2954 W. Logan Boulevard (garden deck on roof of the garage)

This garden deck built on a garage demonstrates how an additional living area can be added to a previously unusable outdoor space. In order to support the tremendous weight of a landscaped garden, the structure had to be strong, constructed of steel I-beams and heavy timbers to support the roof.

Proper drainage is required for summer gardening and weather protection and moisture conservation is essential for over-wintering garden plants.

B - 2954 W. Logan Boulevard: (Also listed as #3 building) Clever garden deck built over a garage. Secrets of how to reinforce the structure will be revealed.

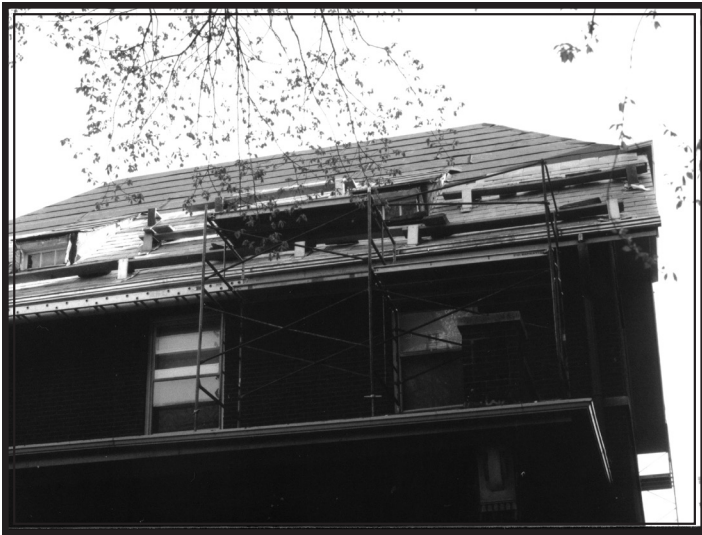
Tar paper and ice shield are installed on the wooden roof.

Removing the old roof, making necessary wood repairs and preparing the surface with waterproof felt and ice shield (see figure at top left and bottom left on page 7) costs the same regardless of the final covering material. The installation cost of slate is similar to heavy duty, 30 year simulated slate shingles, but it is guaranteed for 60 years and can last much longer.

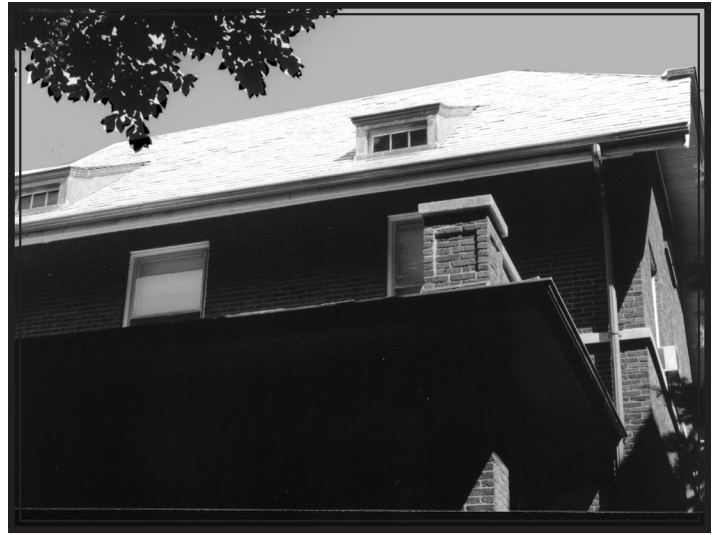
Slate and copper are applied over the tar paper.

house in May of this year. It is quarried in Vermont and it is called semi-weathering green slate, because it contains traces of iron and over the years some of the pieces will weather to a brownish-green color, creating the typical alternating color we recognize in historic buildings. Slate is quarried in large blocks using carbide saws, but the final pieces are split apart by hand using a cold chisel and hammer. This is one of the old professions that still exists. Two holes are drilled in the top of each piece and two copper nails hold it in place. Each tile is overlapped to make it watertight. Although rain will run between two tiles, it hits the face of the tile below and therefore rolls on down the roof. Copper flashing is placed around the chimney and along walls to insure watertight fittings. Of course, slate cannot be placed on every roof, since

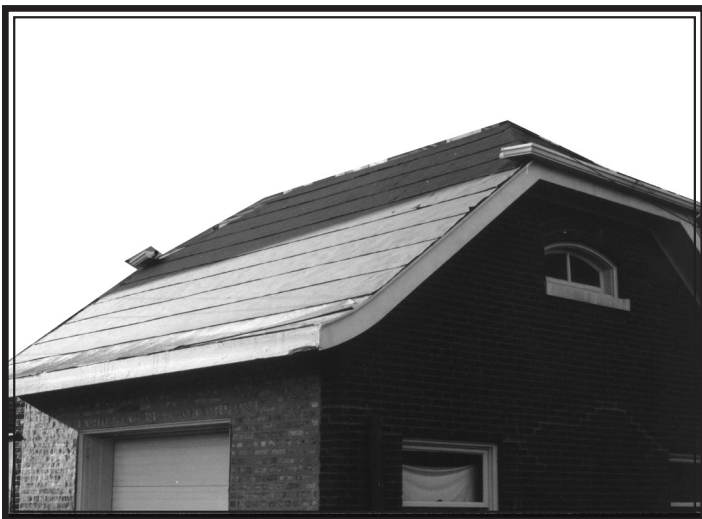
Tar paper and ice shield are installed on the coach house.
