# THE COMMUNICATIONS RECEIVER

## The RCA Radiomarine Corporation Model AR 8506B Liberty Ship and Victory Ship Receiver

By Gene Garrison

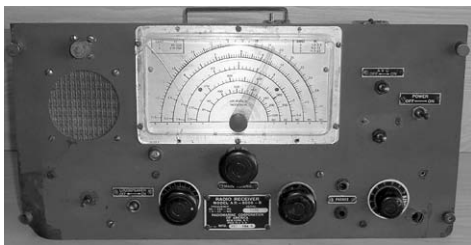
*Front panel of the AR-8506-B prior to restoration.*

After the technical issues were successfully resolved, the front panel paint was stripped, and the panel and the cabinet were repainted. I matched the original color, which I term "Radiomarine Blue." In some RMCA gear a gray color was used. (*I have seen other RMCA receivers with the blue color used by the author. W.F.*)

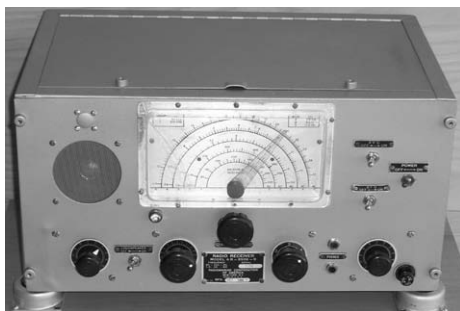
*Here the radio is buttoned up in its cabinet, shock-mounted on a baseboard and ready for display.*
