## AN HRO STORY

Michael D. Tannenbaum, K2BN  
42 Bulaire Rd., E. Rockaway, NY 11518

## THE RDG: AN UNUSUAL HRO-DERIVATIVE

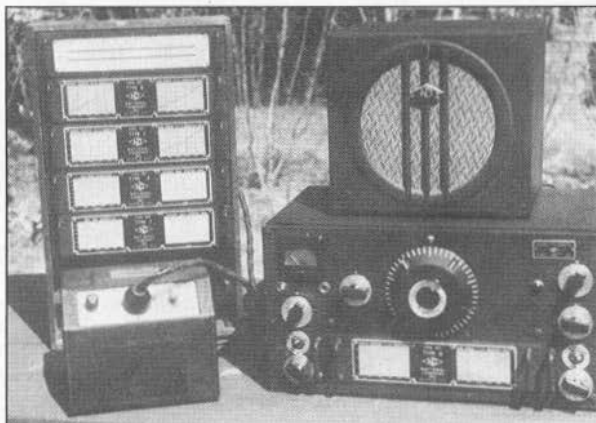
The complete set: coils, power unit, speaker, and receiver itself.
