# THE COMMUNICATIONS RECEIVER

## The Kaar Model 25E Marine Communications Receiver

By William B. Fizette, W2DGB, and Tom Laszynski, K8JRM

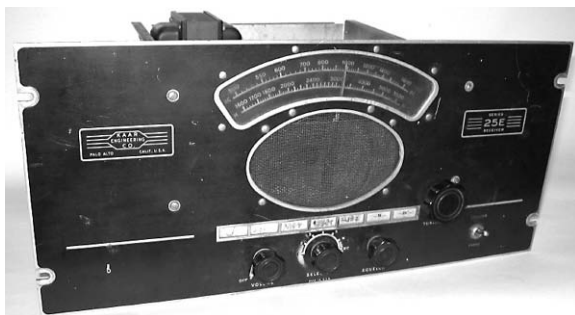
Bill Fizette’s rack-mount Kaar 25E.

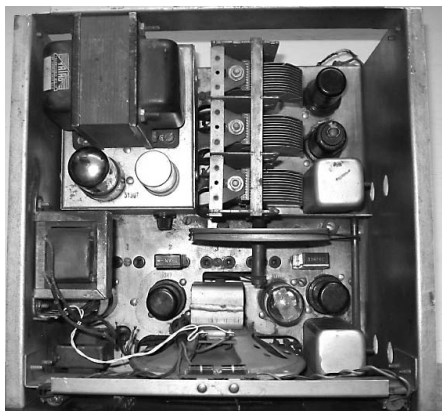
*Top view of Bill's radio.*

This particular 25E was replete with the infamous "black beauty" bypass and coupling capacitors, and after testing a few, their poor reputation was found to be well deserved. Along with the several filter capacitors, all were replaced by new stock, mostly disk ceramics. The cans were left in place for appearance, and the leads removed and tied into new axial electrolytics. The tubes were missing, so replacements were found and tested in a good mutual-conductance tester before installing. The bandswitch was sprayed with contact cleaner and worked back and forth to clean the various contacts.

B+ line resistance test to ground was run. Something in the order of 8000 to 50,000 ohms was expected, but only 600 ohms was measured. Eventually this was traced to the B+ lead to V3, where the bottom of the tube socket was coated with black greasy dirt. Contact cleaner took care of the dirt, but at the same time a non-insulated loose wire lead was discovered. With these problems solved, the resistance was correct, and the smoke test was run.

But the set didn't work! Finally, the output transformer was replaced. Now the BC band came very alive, but with significant noise between the stronger stations. The medium-frequency "B" band (so labeled on the diagram), however, was still dead, and after considerable time the problem was traced to a corroded coil lead hidden under a solder connection on the oscillator coil form.

The "B" or medium-frequency band now worked, and the set was aligned per instructions. However the two tunable bands were still extremely noisy between stations, and the weaker ones were obscured. It was suggested that the AVC circuits be checked, and sure enough, one of the 0.0001 mfd caps was found bad. Replacing this led to a much improved performance.

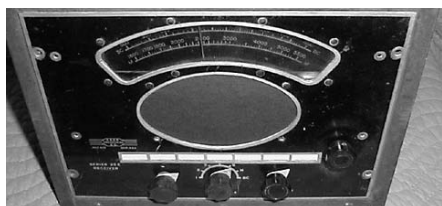
*Tom's 25E came in its own cabinet.*

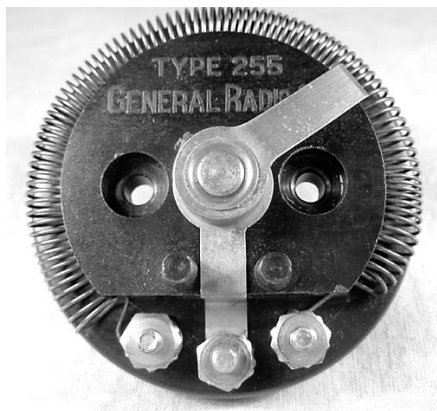
Fig. 2. The cleaned resistance wire back in place on the rheostat body.

wire mounted in a fixture to hold the turns apart. The fixture was made from  $\frac{1}{8}$ " brass brazing rod with a "peewee clip" soldered in place on each end.

The washing soda solution ( $\frac{1}{2}$  cup sodium carbonate per gallon of water) was placed in a shallow glass baking dish and the fixture was held in position by clamping the clip lead wire holding the fixture. A sheet lead anode about  $1\frac{1}{2}$ " wide  $\times$  6" long was placed in the bottom of the dish.

The current was set to 200 mA which required approximately 3V. This condition was run for 20 hours, after which the element was removed and rinsed in hot water. The wire was then dried with compressed air while being held in the fixture.

A wooden dowel was turned to the ID of the coil with a taper for the one end (this taper is a critical part of the rheostat design). The coil was mounted on the dowel and again spread out and held in place with a tack at each end on the coil. It was then brushed with a fine stainless wire wheel. The inside of the coil had to remain "as-

is" because I could not see any way to clean it.

After remounting the coil on the rheostat body, I had a reasonably nice unit for the General Radio amplifier module. Figure 2 shows the re-assembled rheostat.
