# THE COMMUNICATIONS RECEIVER

## A World-War II National HRO

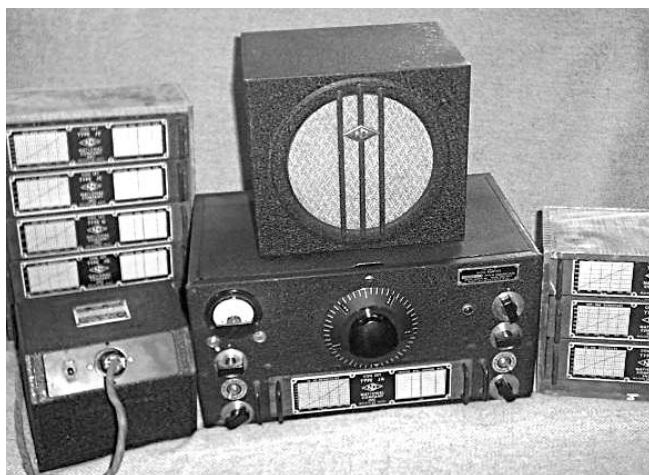
*The complete HRO-W package described in the text.*

The National speaker shown in the photo was somewhat "bassy" for communications work, although the owner reported he was quite pleased with it. A small modern communications speaker was adapted by mounting an output transformer inside, and it seemed to be easier to listen to. (NOTE: In contrast to the Navy RAS version of the HRO, the Signal Corps set followed the original design by incorporating the output transformer inside the speaker cabinet. If an HRO is used without this output transformer, the audio output tube must be removed to prevent burnout.)

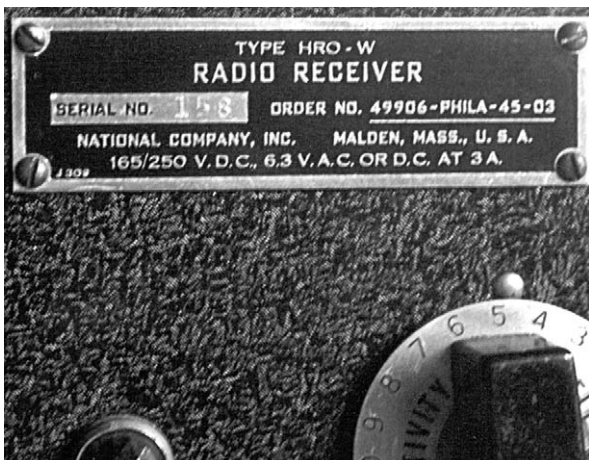
So why the interest in just another HRO? Let's see if I can make the case. The -W model was designed in 1944, along with the HRO-5, to US Army Signal Corps JAN AWS (Joint Army Navy American War Specifications) specs. This particular set, Serial No. K329, has a label with a 1945 contract date and a Signal Corps acceptance stamp (SC7091P) located in three places: the cabinet outside, the chassis, and on one of the IF transformers.

*A close-up of the label on the receiver.*
