# A STRUCTURED APPROACH TO FIXING UP THOSE NICE OLD RADIOS

## Preserving The Clough Brengle Model 87 Transmitter

### *Part 1—Acquiring a Rare CCC Veteran*

### Part 2—The Restoration

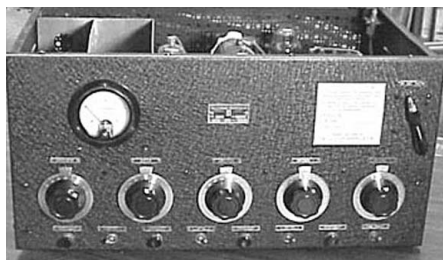
*Model 87 front panel after restoration.*

Some time ago I ran across an item in a 1950s *RCA Ham Tips*, recommending the use of thinned black paint applied with a balled-up cloth, rubbing the paint color into the textured finish. This will leave just the color and not fill in the depressions. I found another way to accomplish the same thing using Testors Paint Pens (available at most hobby shops) instead of the thinned black paint. I tried it on an old voltmeter with the typical gray color. The result was outstanding, with the original texture clear and

sharp under a clean gloss black color.

The paint pen looks like a magic marker, except the tip is spring-loaded. The pen is shaken and pumped to load the paint into the tip, and after a few seconds the paint will begin to flow. The best method I have found is to do a small area, and then use a paper towel to wipe off the excess. As you progress to the next area, wipe the excess off over the previous area to avoid lines.

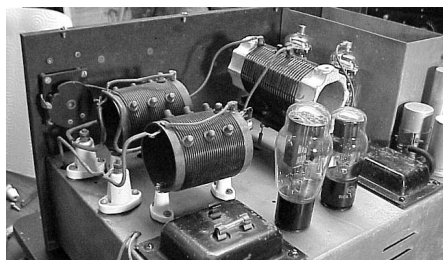
*Interior view showing repaired antenna coils.*

well. I cleaned up the broken forms, making a square hole at each location, sanding and filing until the patches fit. I next bridged each patch on the bottom of the coil with another piece from the donor form, out of sight, to give the patch the needed strength to support the coil. Contact cement worked well.

After the cement had set, I used brown plastic wood filler to blend the patches with the original. Sanding and coloring with a brown Magic Marker completed the patch. Mounting holes were drilled, and the coils remounted on the standoffs. Replacement tubes, a pair of 802s and an 83, were obtained and installed.
