National Register of Historic Places
Registration Form

historic name Martin, Hendrick, House

street & town 65 Willowbrook Lane

city or town Red Hook

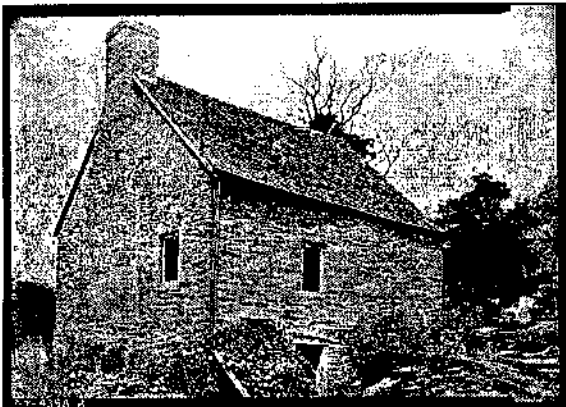
Konradt Lasber House, "Stone Jug," Clermont vicinity, c. 1752; quintessential example of a Palatine stone house in the Hudson Valley.

Prior to its expansion southward at which time the stone envelope assumed its current extent, the Hendrick Martin house shared similarities with other identified examples of stone dwellings constructed for German settlers in the mid-Hudson Valley, notable among them the Stone Jug, and to a lesser extent the Kocherthal house in West Camp. These two examples date to the period from c. 1735-52 and share distinctive similarities in the way in which they are sited and the interior disposition of spaces, with the Stone Jug providing the closest parallels in what amounted to a one-room plan on the first floor and basement level.⁵ All of the cited examples were built into banked sites, a situation directly related to the relegation of the

The Kocherthal dwelling in West Camp, while it features a banked construction site with basement kitchen which did not directly communicate with the room above, nevertheless deviates from the Martin house and Stone Jug in its two-room plan. In any event this house does feature another distinctive feature associated with vernacular German interior design, that being the *stube* arrangement, with a five-plate stove in the parlor fed directly with hot ashes from the hearth located directly behind it in the adjacent "keeping room."
