AIKEN-RHETT INTERIOR PLASTER BLIND STUDY

PREPARED FOR:
HISTORIC CHARLESTON FOUNDATION
40 EAST BAY STREET
CHARLESTON, SC 29401

PREPARED BY:
MEADORS, INC.
PO BOX 21758
CHARLESTON, SC 29413

DATE: 11.13.2014

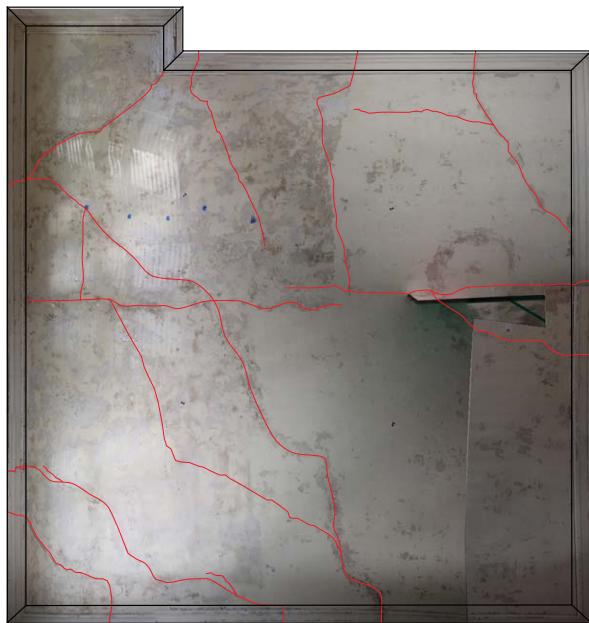
SOUTHWEST CHAMBER

Figure 9: Southwest chamber, facing northwest: Stabilization installed in 2014. The battens in this room only partially span the ceiling.

In order to address potential life safety issues, Historic Charleston Foundation has installed several 1x4 wood battens over the ceiling cracks within both bedrooms (**Figures 7-8**). This has stabilized several areas of detachment and has minimized the life safety risk.

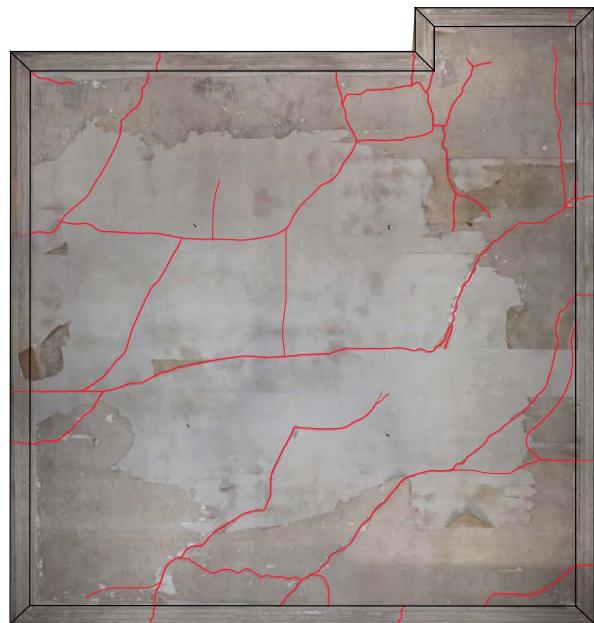
SOUTHEAST CHAMBER

Figure 7: Southeast chamber, facing north: Stabilization installed in 2014 over existing cracks. The battens in this room span the full width of the ceiling.

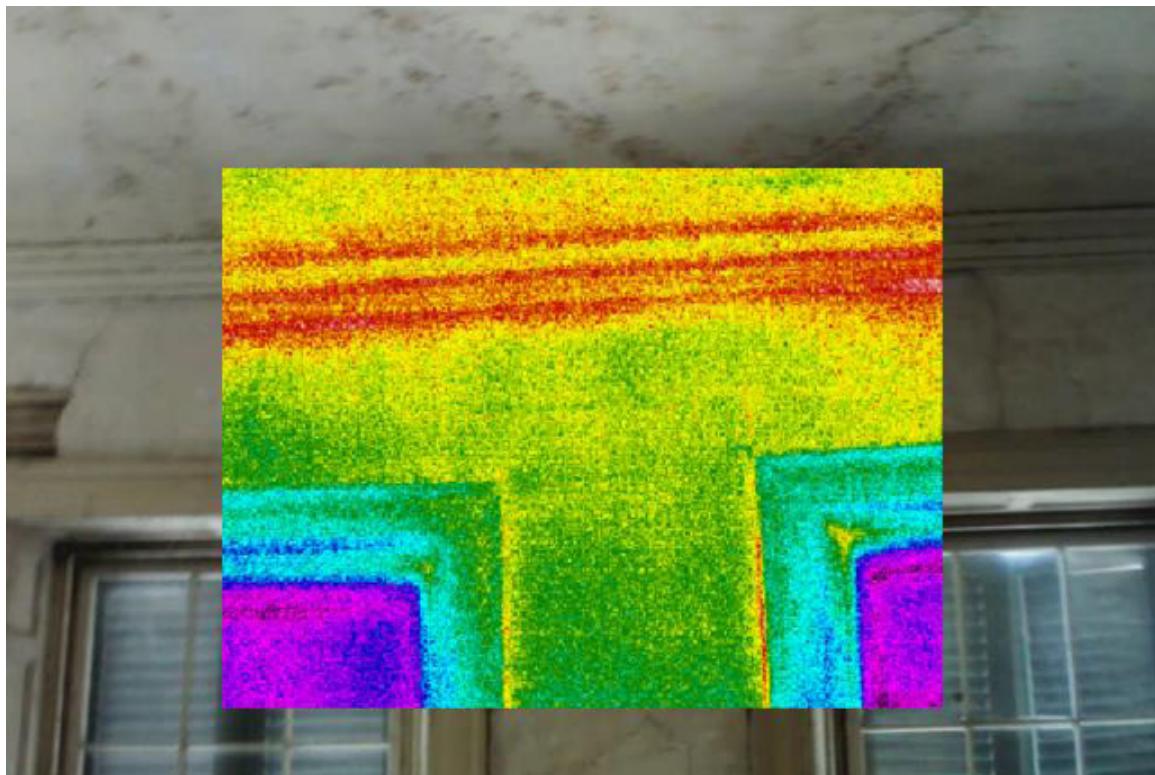
Figure 15: Southwest chamber, west wall: Thermograms taken with passive thermography showing even temperature distribution. Higher (red) temperatures common on corners were there is reduced air flow. Note: Pixelation of image due to narrow temperature range detected on wall.

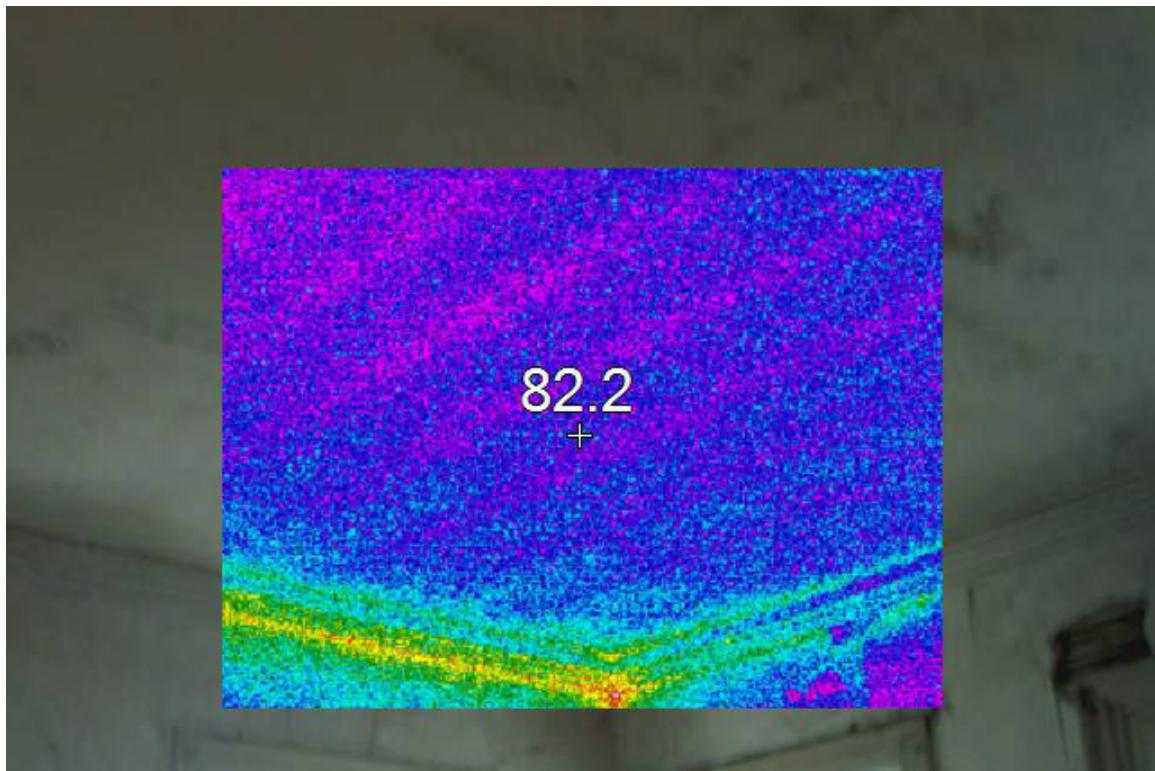
Figure 16: Southwest chamber, ceiling: Passive thermography trials enabled accurate mapping of ceiling framing members (purple).

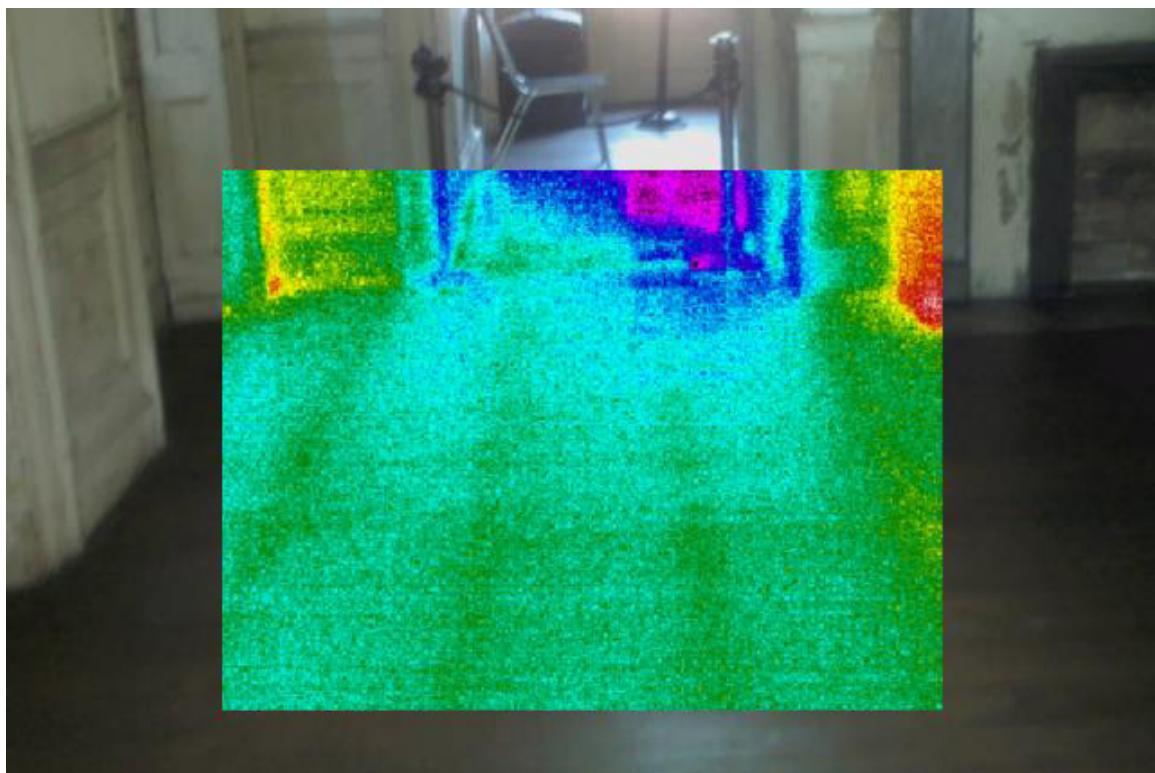
Figure 17: Southwest chamber, ceiling: Passive thermography also allowed for mapping of floor framing members (green). Location of the framing can be further verified by marking the nailing patterns within the flooring.

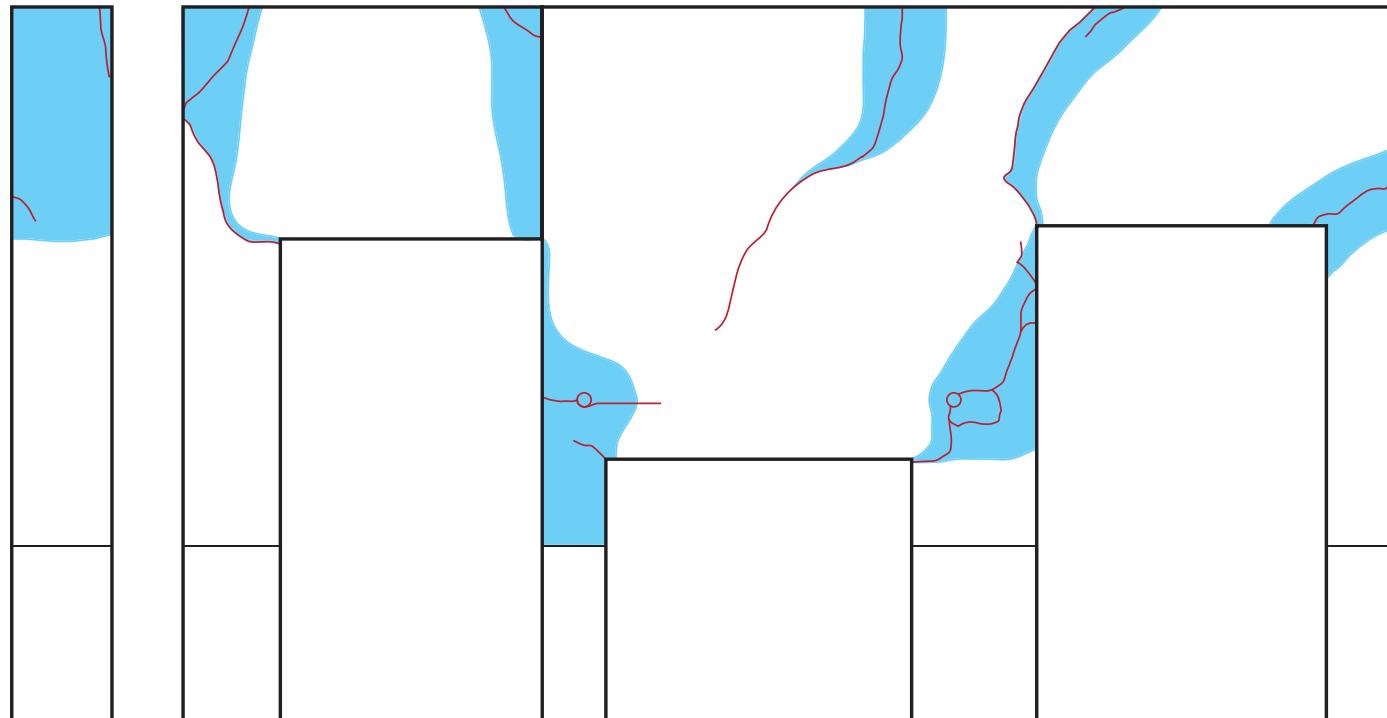
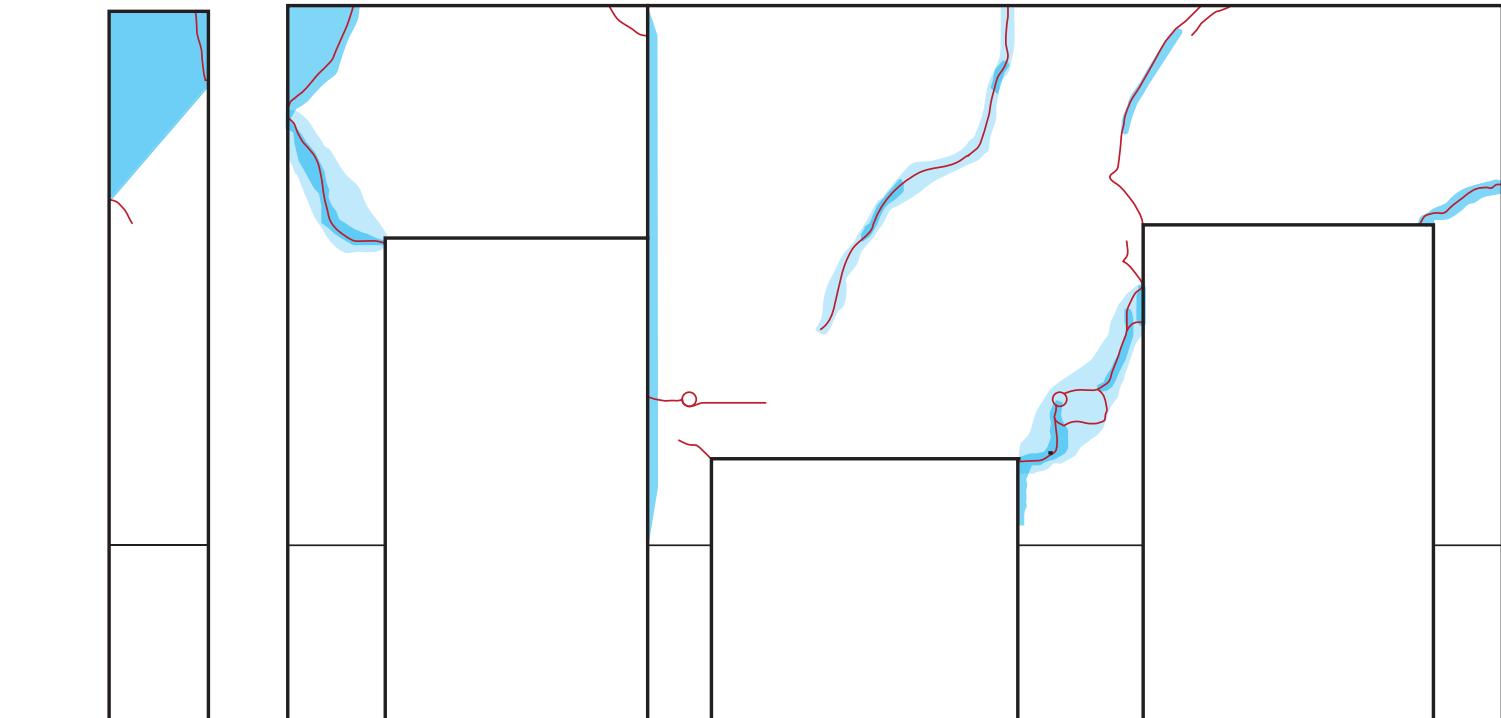
SOUTHWEST CHAMBER- NORTH WALL

Analysis of an image taken of the north wall in the southwest bedchamber (Room 202) shows that extensive cracking of the plaster existed in 1979 (**Figure 1**). Comparison of these cracks with a current image indicates little to no growth of a majority of the visible cracks over the last 35 years (**Figure 2**). There does not appear to be any new crack formation on this wall, but two cracks appear to have worsened over time. One crack, directly over the doorway into the northwest dressing room (Room 201) appears to have increased in severity during this time with noticeable vertical separation. Additionally, there appears to be greater separation in the ceiling crack directly over the closet door. The most dramatic change between these two images is the deterioration of the finishes on the woodwork and the removal of the plaster and wallpaper along the casing bead at the fireplace.

The HCF crack study conducted within this room is reflective of current conditions, with a majority of cracks increasing in width over the last 5 years.

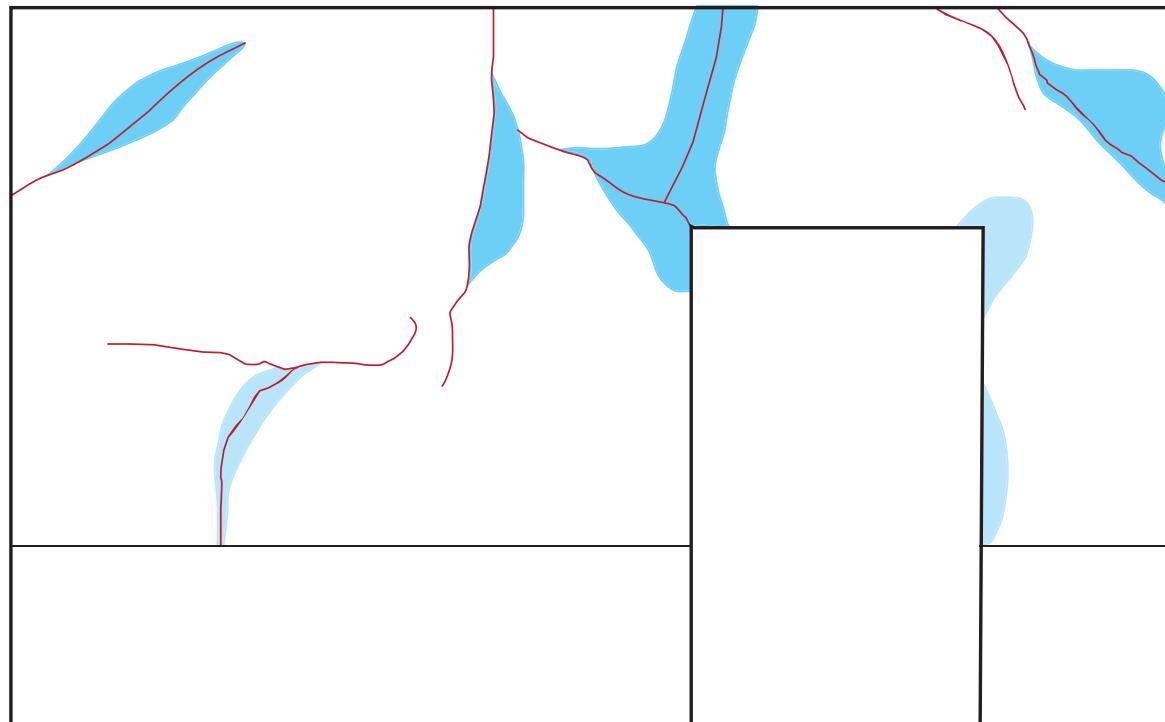
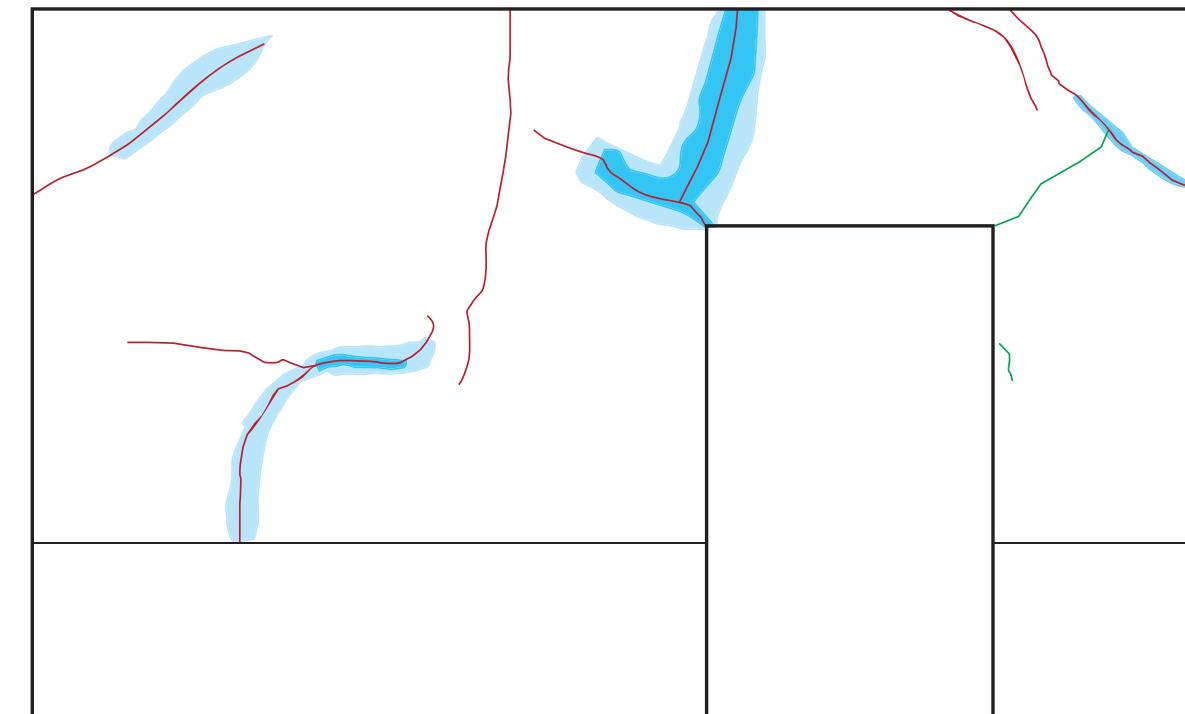
SOUTHWEST CHAMBER- EAST WALL

An alternative view taken in 1979 of the east wall within this bed chamber reveals a similar situation (**Figure 3**). Over the last 35 years, there has been further deterioration of the historic wallpaper, but little to no change in the plaster in this location (**Figure 4**). On the southeast corner, on both sides of the doorway, the wallpaper obscured the presence of cracks in 1979. Areas visible in the original photograph do not appear to have worsened over time.

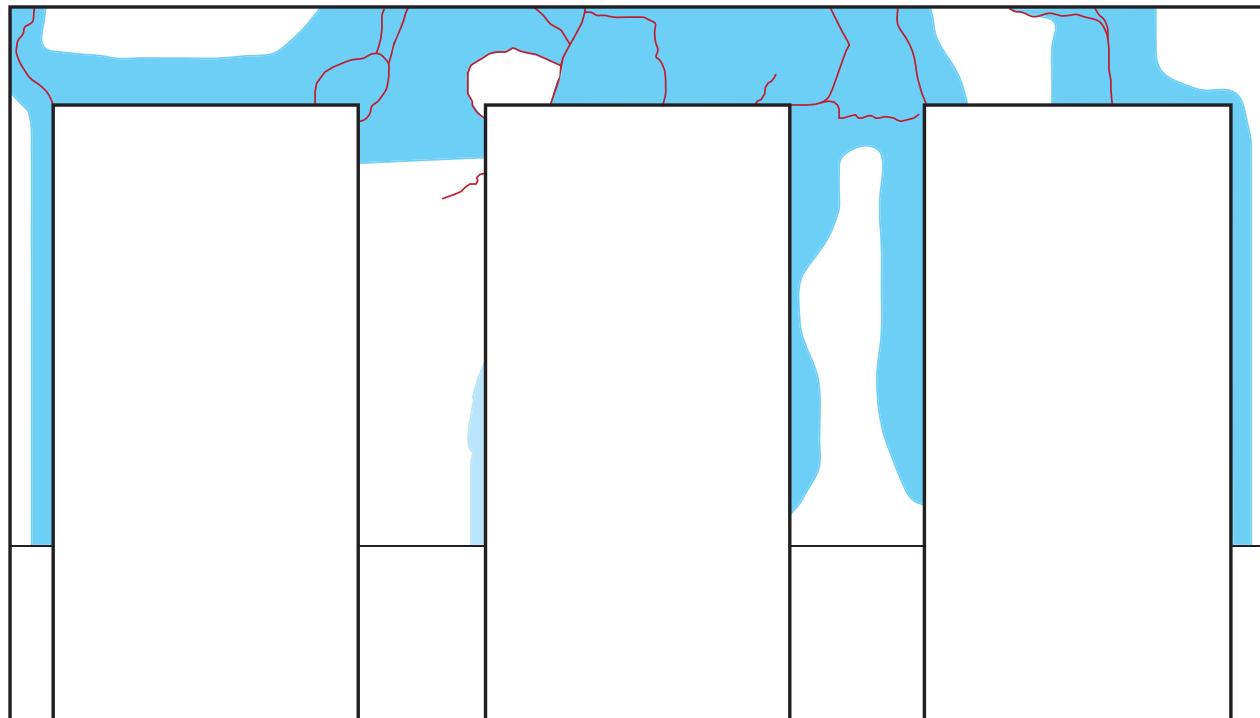
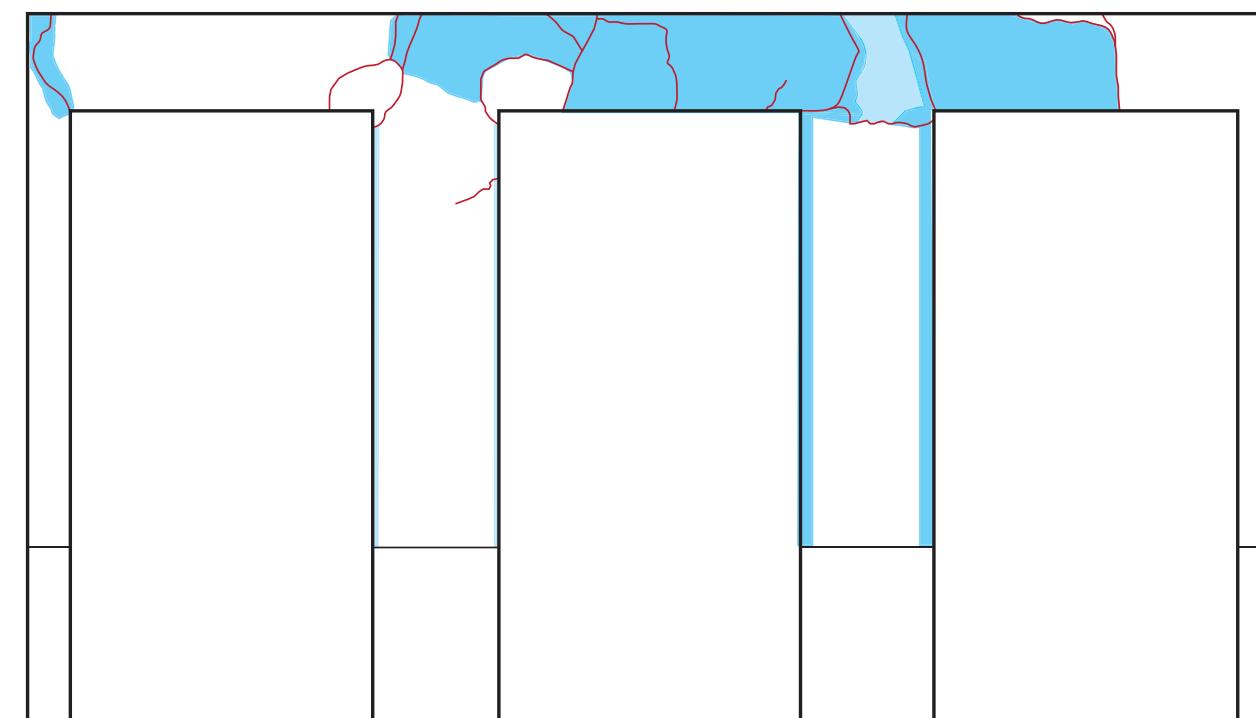
SOUTHWEST CHAMBER- WEST WALL

Figure 19: Southwest chamber, west wall: Note: Areas of higher temperatures and presumably detachment along open cracks. Void spaces within cracks correspond with highest temperatures.

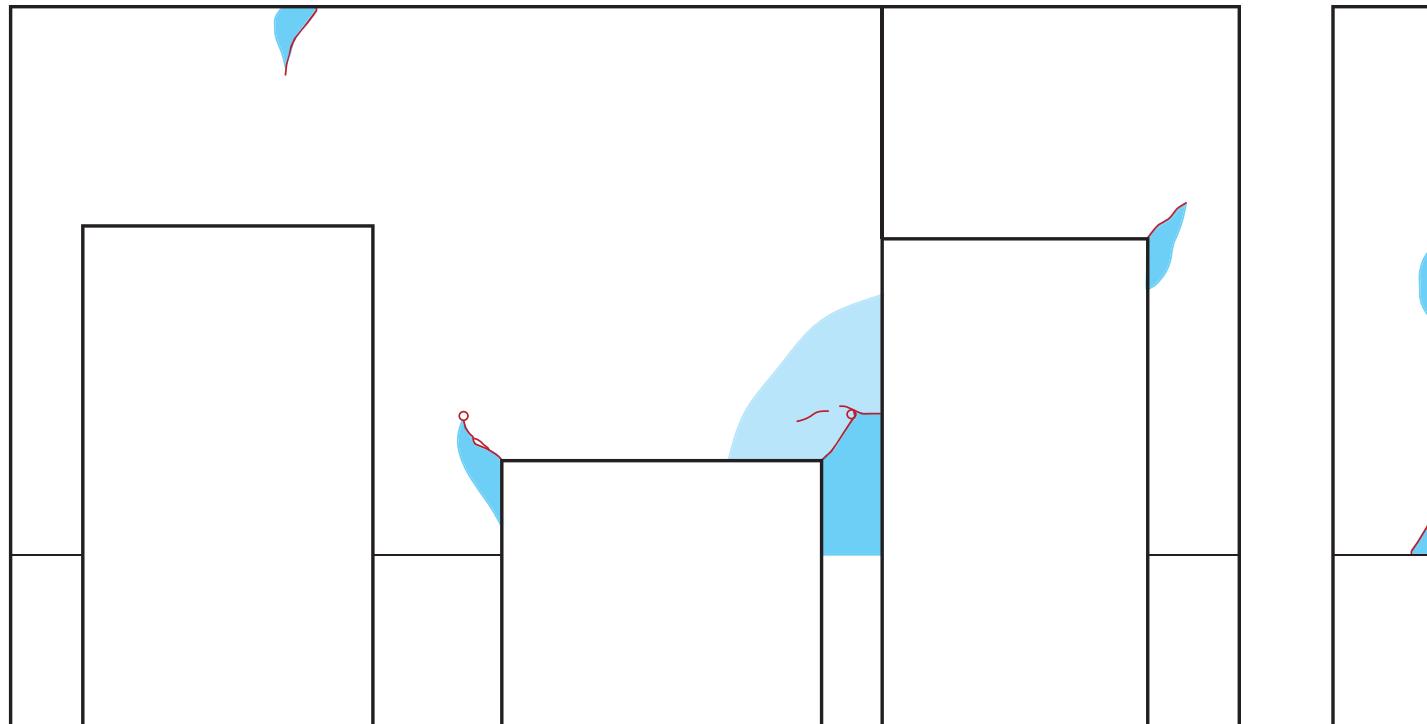
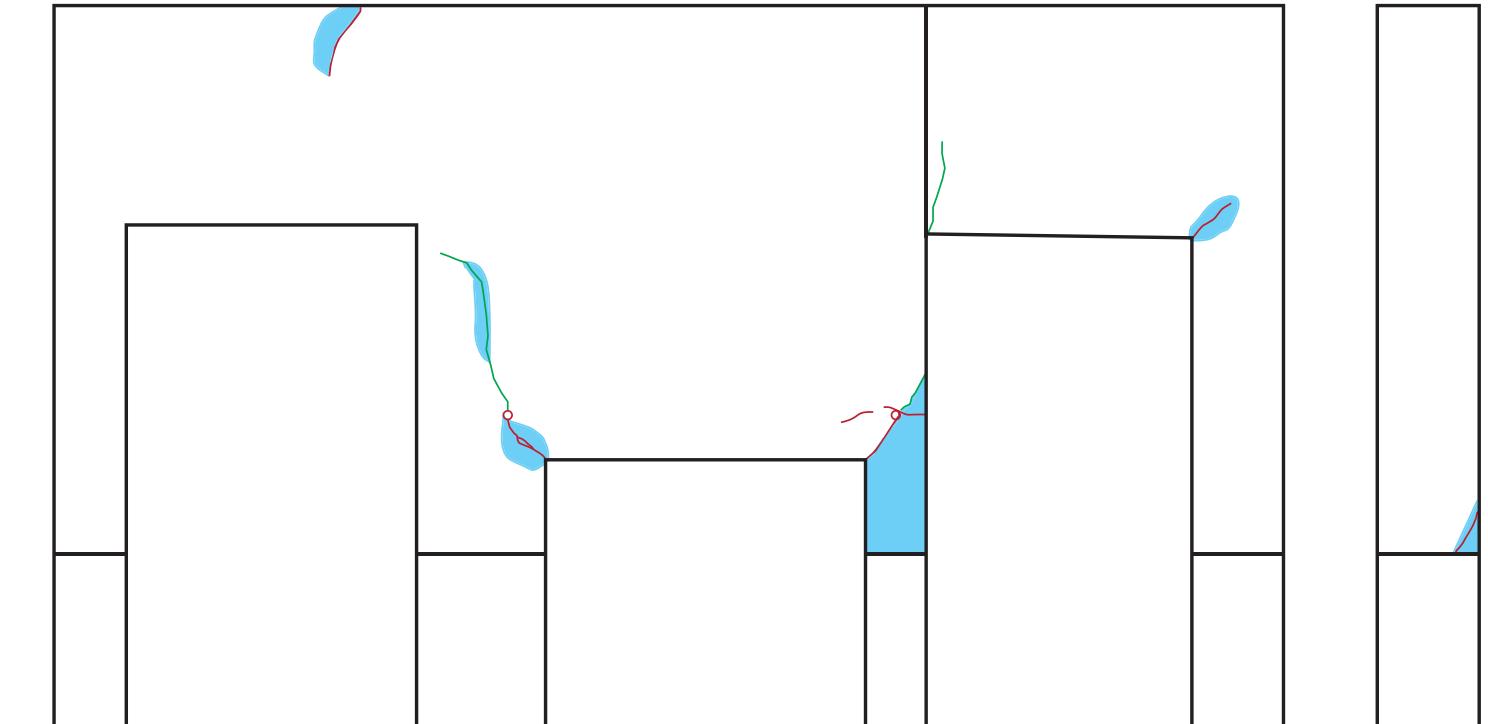
SOUTHEAST CHAMBER- NORTH WALL

One image of the north wall in the southeast chamber was taken during the documentation in 1979 allowing for only one comparison with current conditions. The plaster at this location in 1979 has little visible cracking as it is obscured by wallpaper (**Figure 5**). At this time, the wallpaper along the ceiling was beginning to deteriorate while the remaining paper on the walls appears to be in good condition. Comparison with the 2014 image shows there has been increased deterioration of the wall paper as several sheets have begun to detach at the ends and corners (**Figure 6**). One crack visible on the ceiling above the casing bead on the fireplace appears to have increased in separation over the last 35 years. Cracking present within the cornice does not appear to have increased during this time.

The HCF crack study conducted within this room is reflective of current conditions. However, as noted in the document, much of the current cracking is obscured by the wallpaper and there is little data on the growth of these cracks over time.
