HISTORIC PRESERVATION CERTIFICATION APPLICATION  
PART 2 - DESCRIPTION OF REHABILITATION

Address of property: Street 231 King Street

City Charleston County Charleston State SC Zip Code 29401

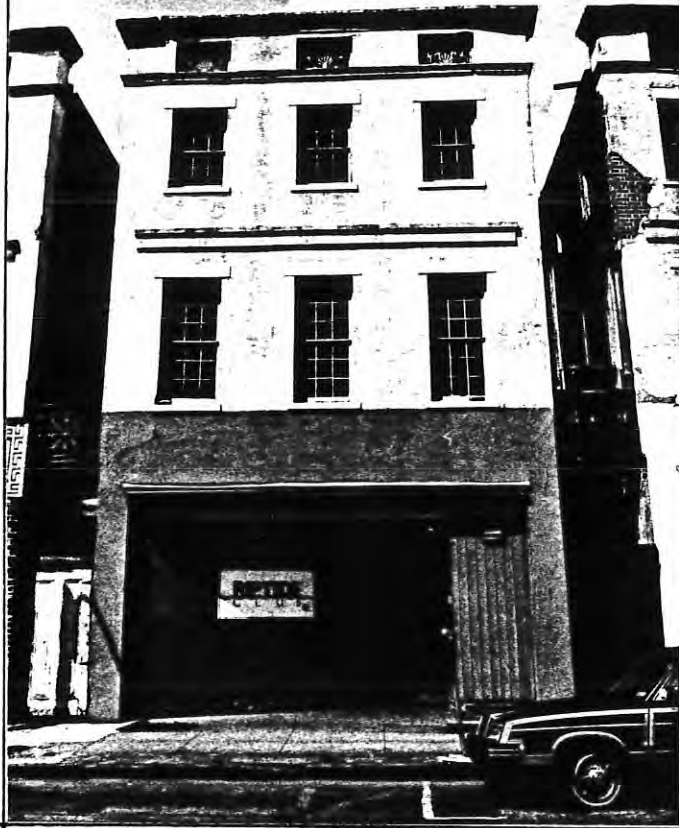
#1

**East Elevation, Facing West**

**After Rehabilitation, 2/85**

Note: Parapet/entablature decorative grills at frieze, original 6/6 and 9/9 sash windows, and molded brick courses were retained and repaired as needed; storefront was rehabilitated as per historical documentation and plans submitted

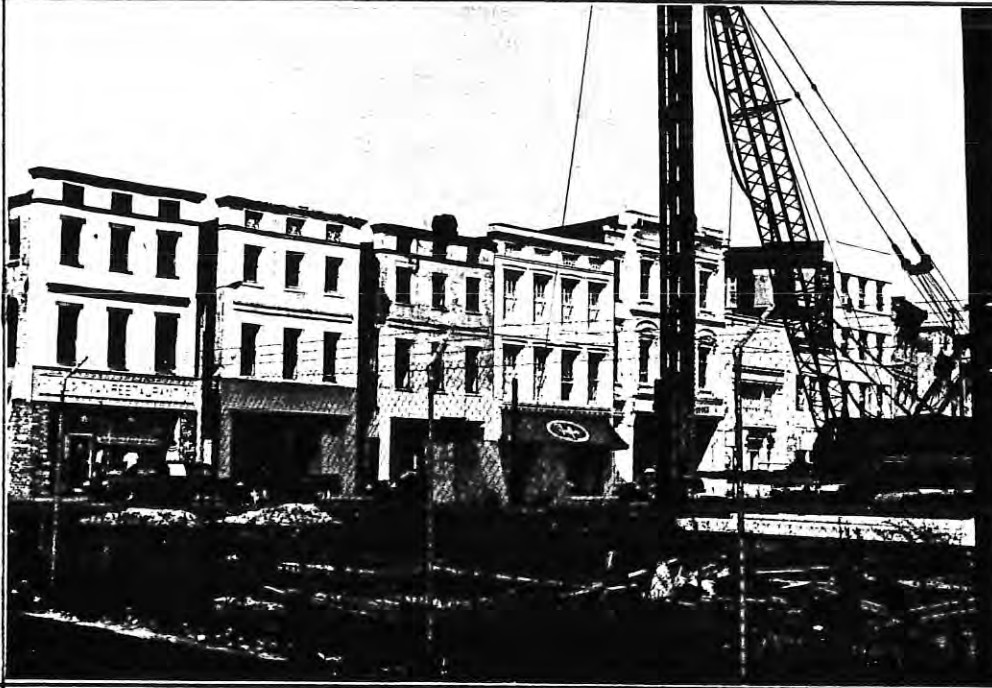
#3

## Streetscape

Prior to Rehabilitation, 8/84

Note: Row of three identical  
Greek revival structures at  
229-233 King Street, 231  
King Street at Center

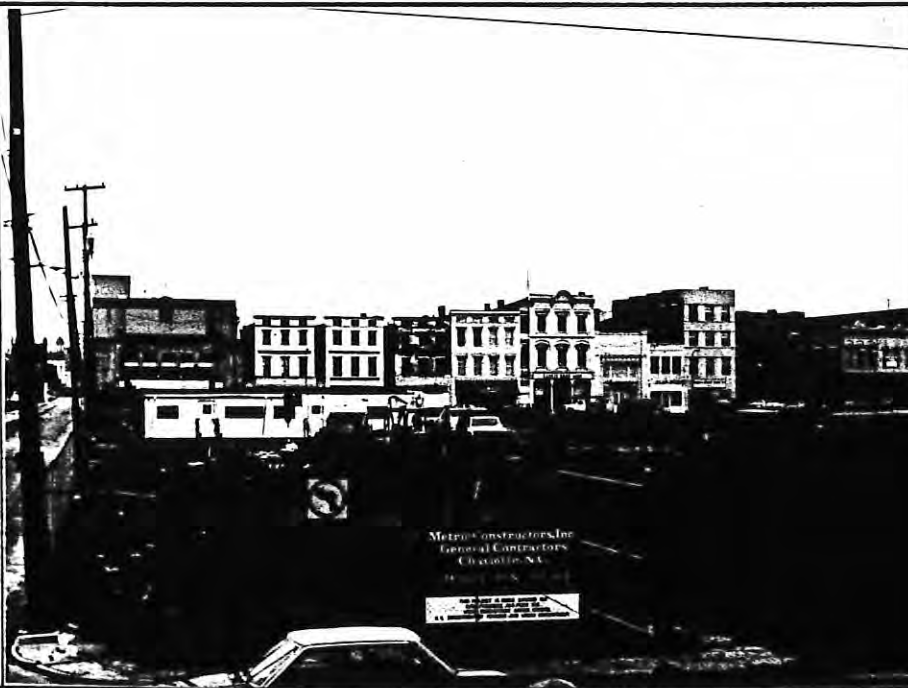
#4

## Streetscape After Rehabilitation

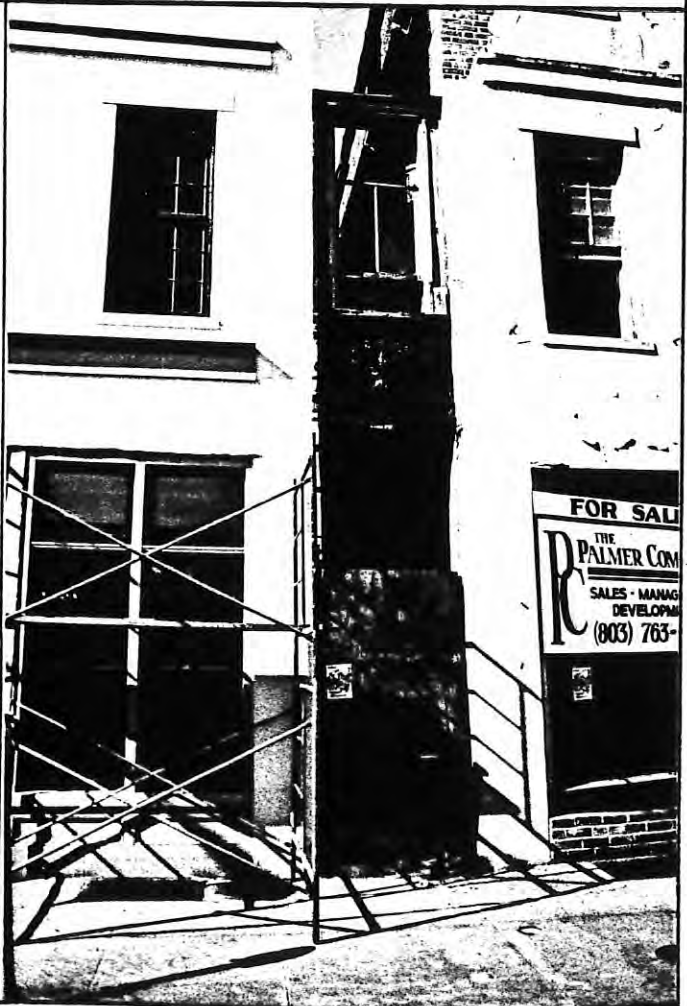
#10

**East Facade, Northern  
Entry Screen**

**After Rehabilitation, 2/85**

Note: Northern entry screen is part of the property at 233 King Street and was not included in rehabilitation

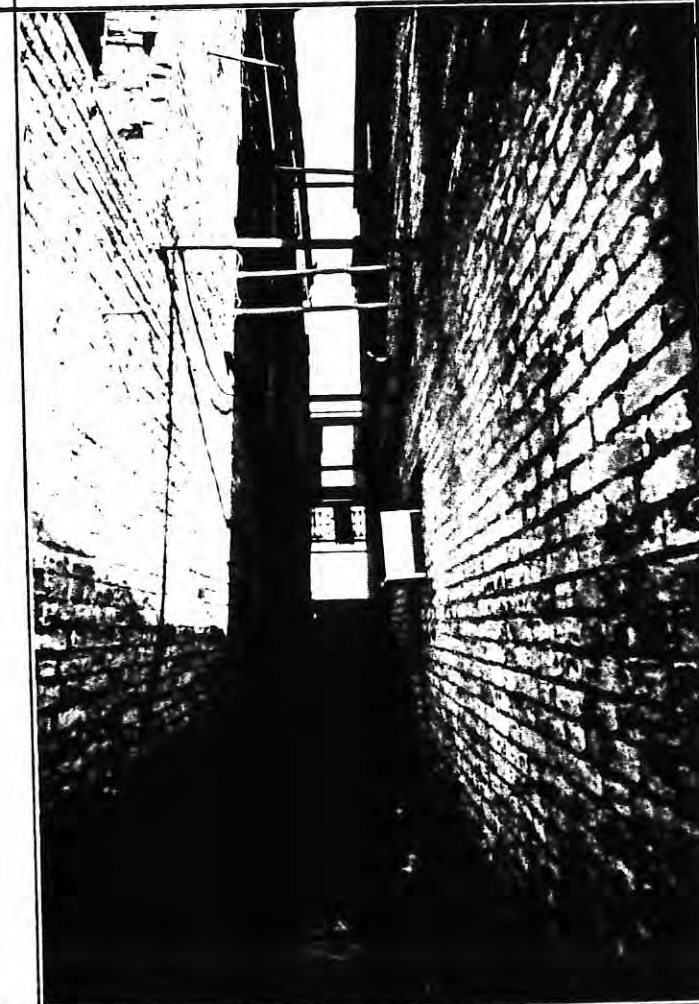
#12

North Elevation

Prior to Rehabilitation, 8/84

Note: Space between 233 (left)  
and 231 (right) King Street;  
not included in rehabilitation

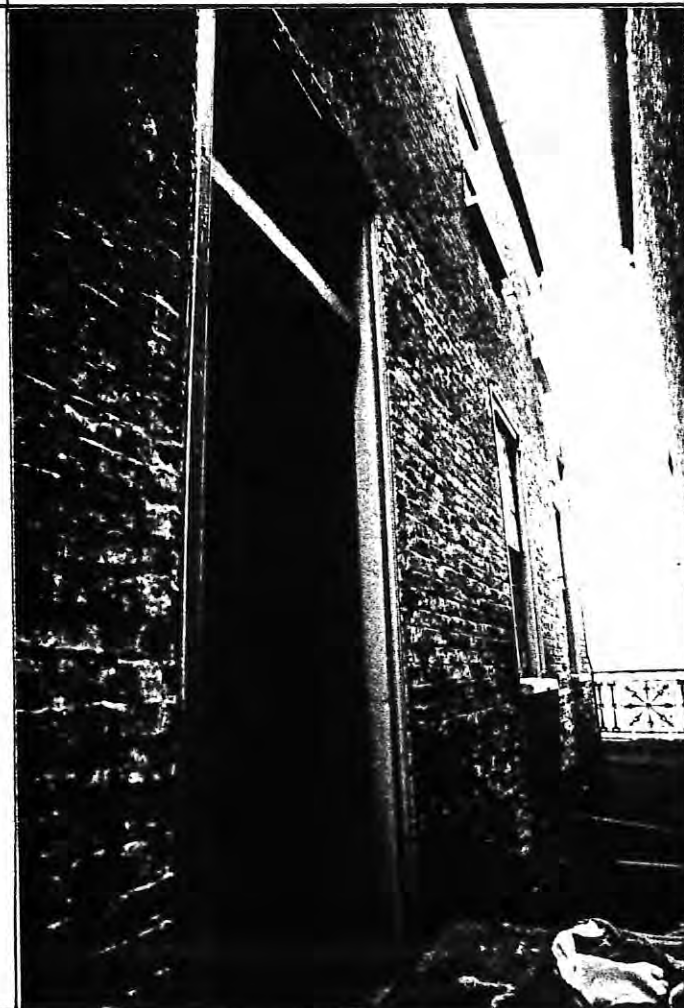
#14

**South Elevation,  
Facing Northeast**

**After Rehabilitation, 2/85**

Note: Space between 231 (left) and 229 (right) King Street; original secondary entrance to upper levels of 231 King, original sash windows, entry screen at lower right

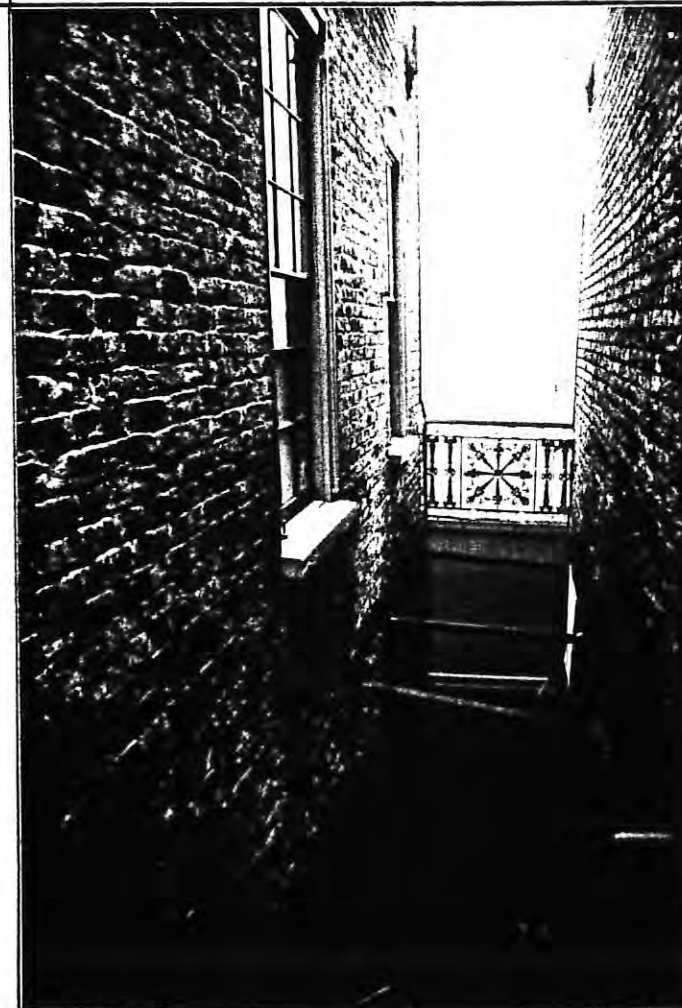
#16

South Elevation,  
Facing East

After Rehabilitation, 2/85

Note: Original 9/9 sash  
windows, exposed brick wall,  
restored entry screen

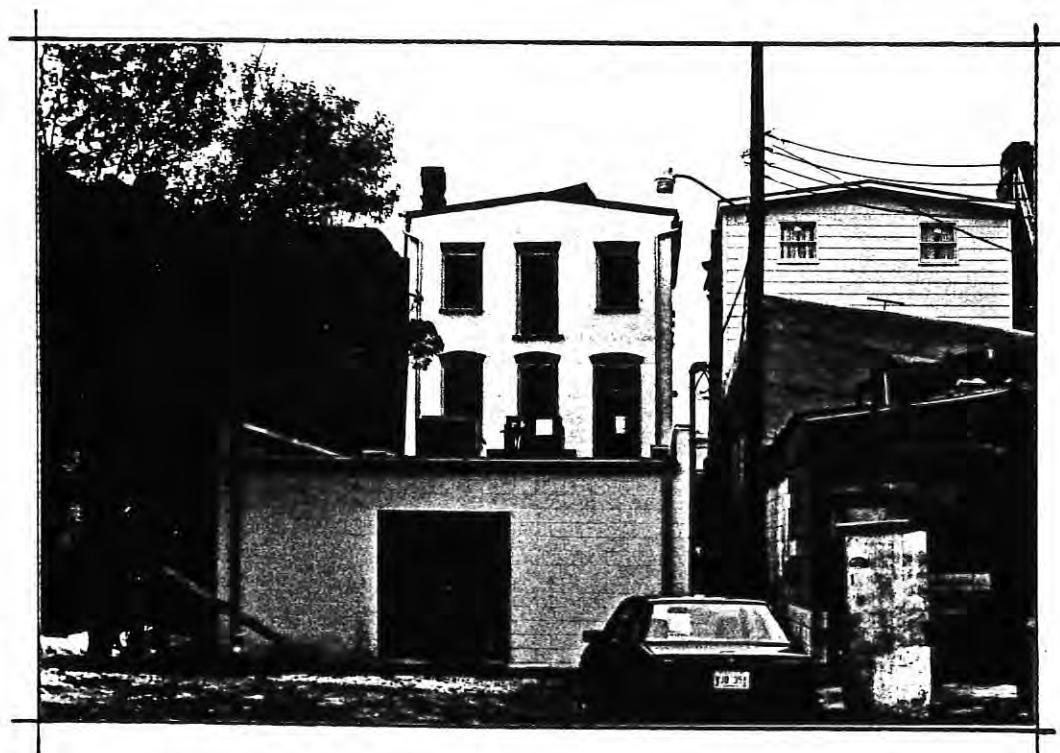
#18

West Elevation,  
Facing East

Note: Original three story structure with chimney at left, one story addition in foreground; rear wall reconstructed as per Item #9 (see Photos #70-71)

The rear wall was removed and reconstructed as per plans submitted. Original materials, including window sash and interior trim, were re-used wherever possible. Replacement components were constructed to match the original conditions in design, material, and workmanship.

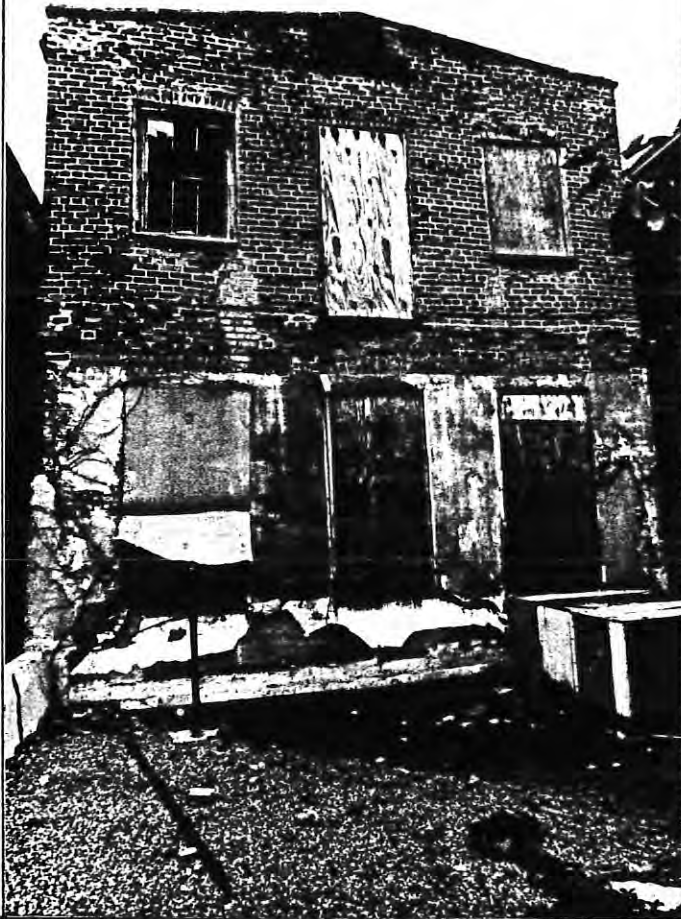
**#19**

**West Elevation,  
Facing East**

Note: Deteriorated window sash,  
infilled window and door  
openings

Existing windows were retained and repaired as needed. Repairs were accomplished to match existing adjacent conditions in design, materials, and workmanship in accordance with Preservation Briefs #9. All windows were carefully hand-prepared for new finishes, primed, re-glazed and painted.

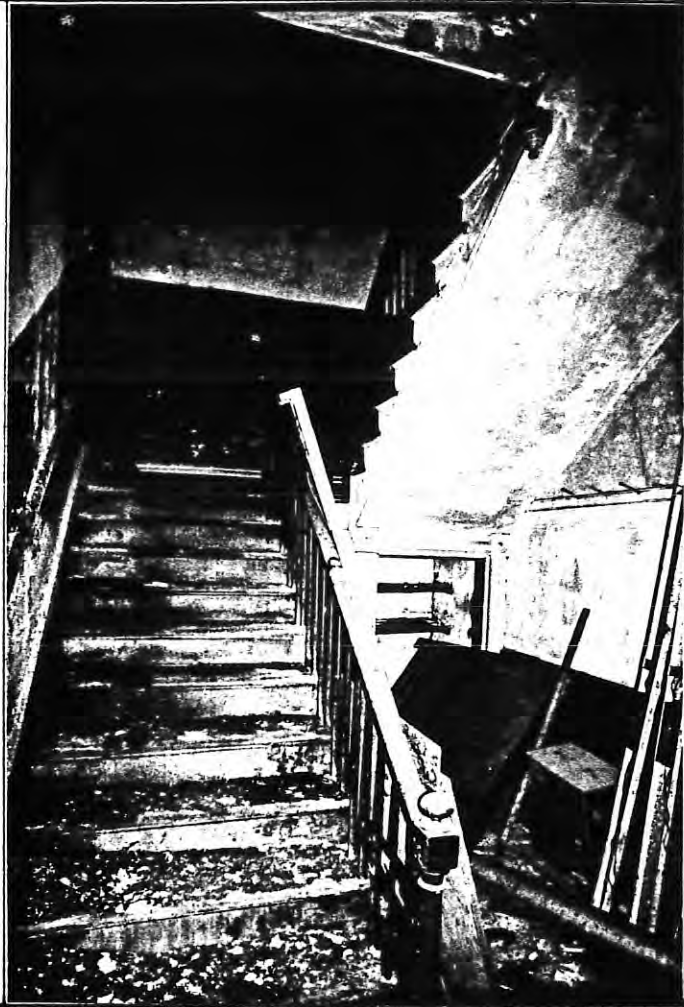
**#27**

**Second Floor  
Stairhall, Facing  
North**

**Prior to Rehabilitation, 8/84**

Note: Original staircase with  
ballustrade and chair rail,  
entrance to storage area beneath  
staircase

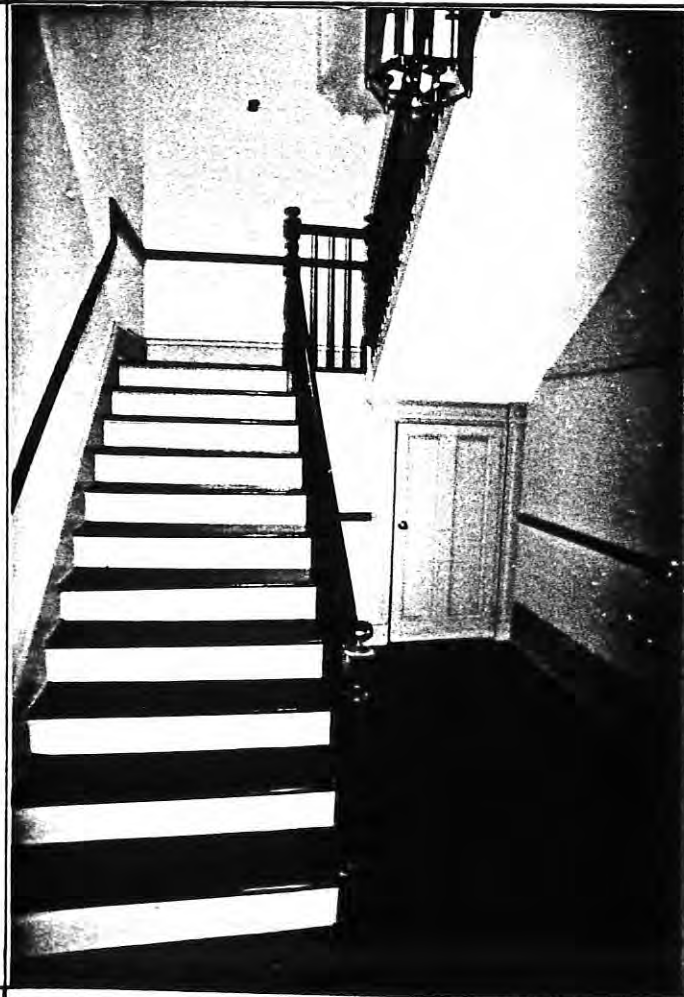
**#28**

**Second Floor  
Stairhall, Facing  
North**

Note: Original staircase with  
ballustrade and chair rail was  
retained and repaired as needed,  
storage area beneath staircase  
was converted for use as a  
half-bath

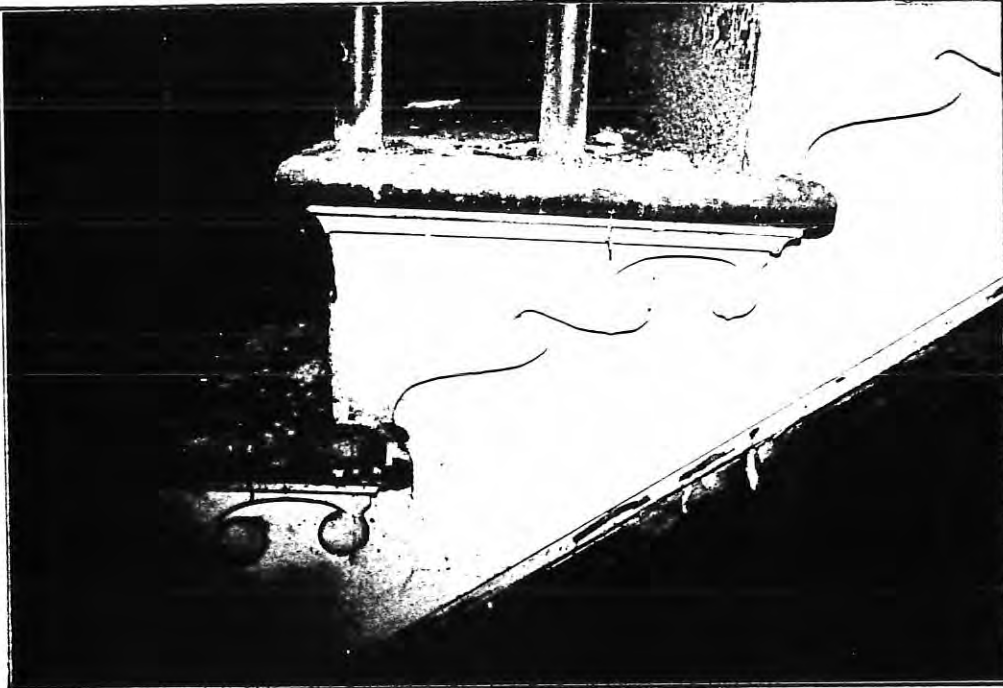
**#29**

**Second Floor Stair,  
Stringer Detail**

**Prior to Rehabilitation, 8/84**

Note: Original stringer detail

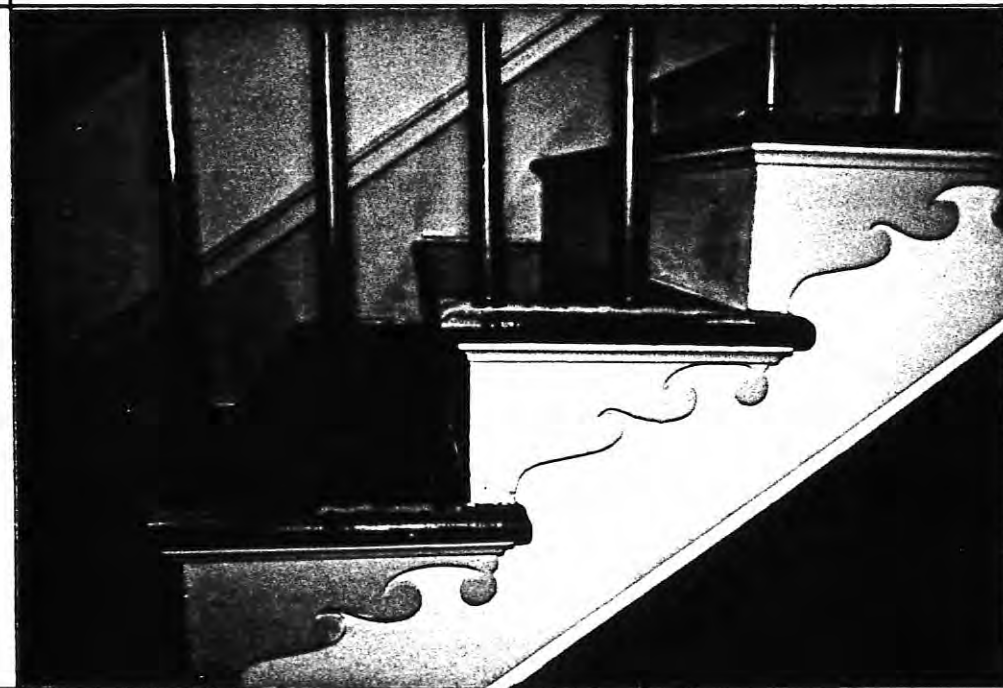
**#30**

**Second Floor Stair,  
Stringer Detail**

Note: Original stringer detail  
retained and repaired as needed

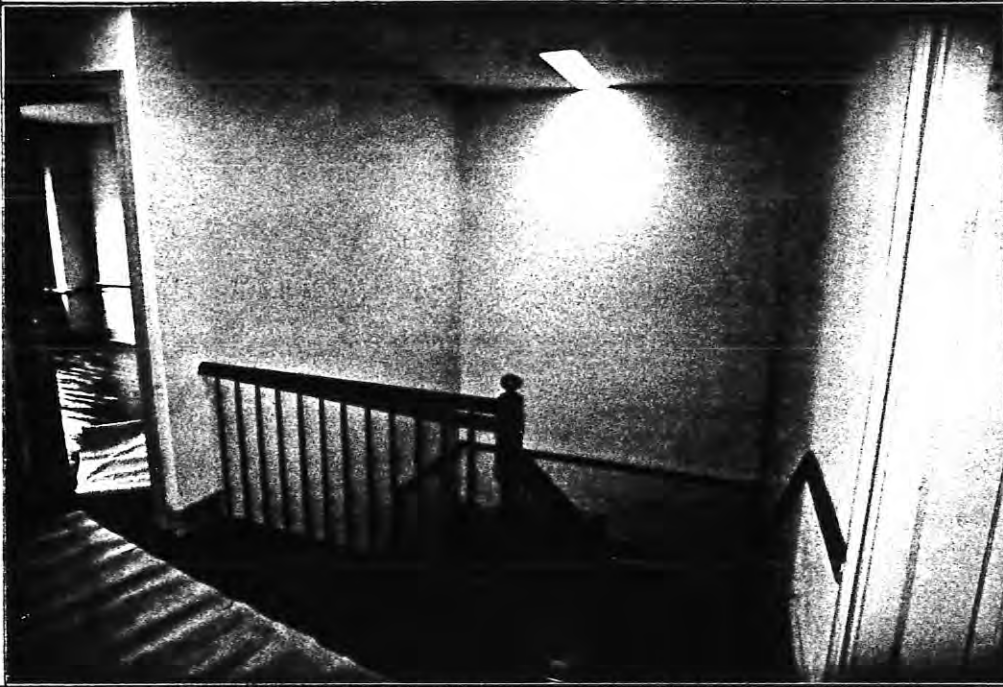
**#35**

**Third Floor Stairhall**

Note: Original stairhall space  
remains intact

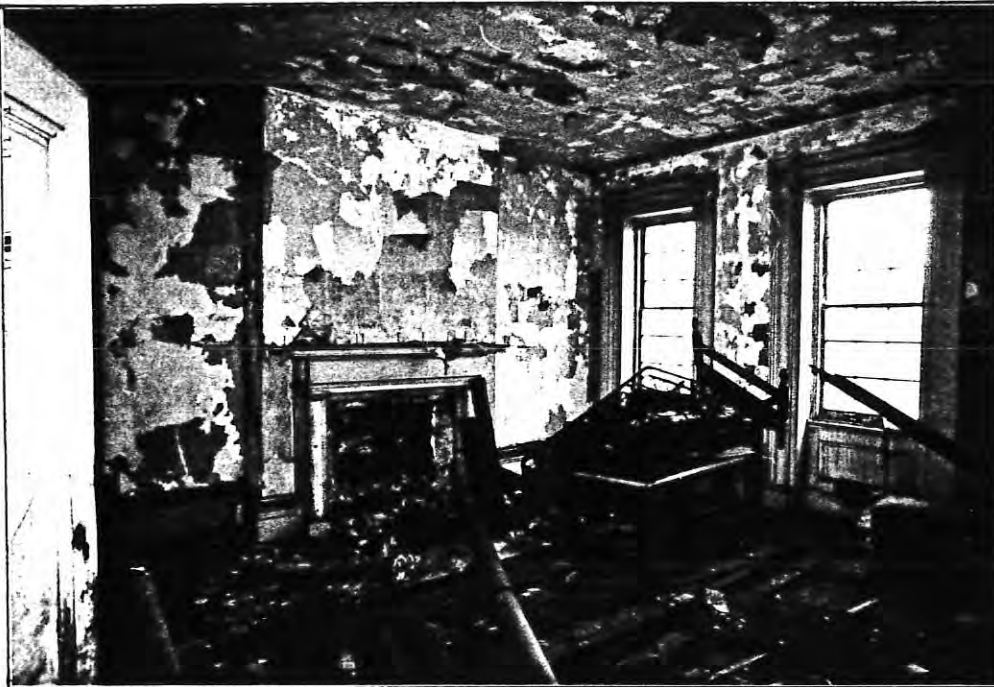
**#36**

**Second Floor East  
Parlor, Facing  
Northeast**

**Prior to Rehabilitation, 8/84**

Note: Original 9/9 sash,  
molded window surrounds with  
cornerblocks, mantelpiece,  
baseboards, and hardwood floors

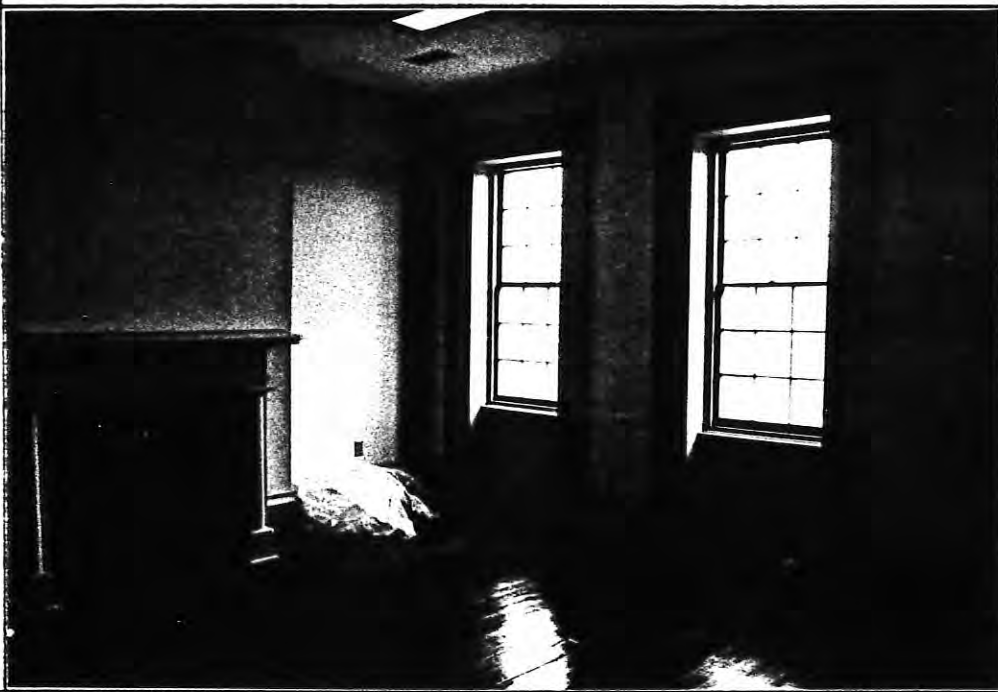
**#37**

**Second Floor East  
Parlor, Facing  
Northeast**

Note: Original 9/9 sash,  
molded window surrounds with  
cornerblocks, mantelpiece,  
baseboards, and hardwood floors  
retained and repaired as needed

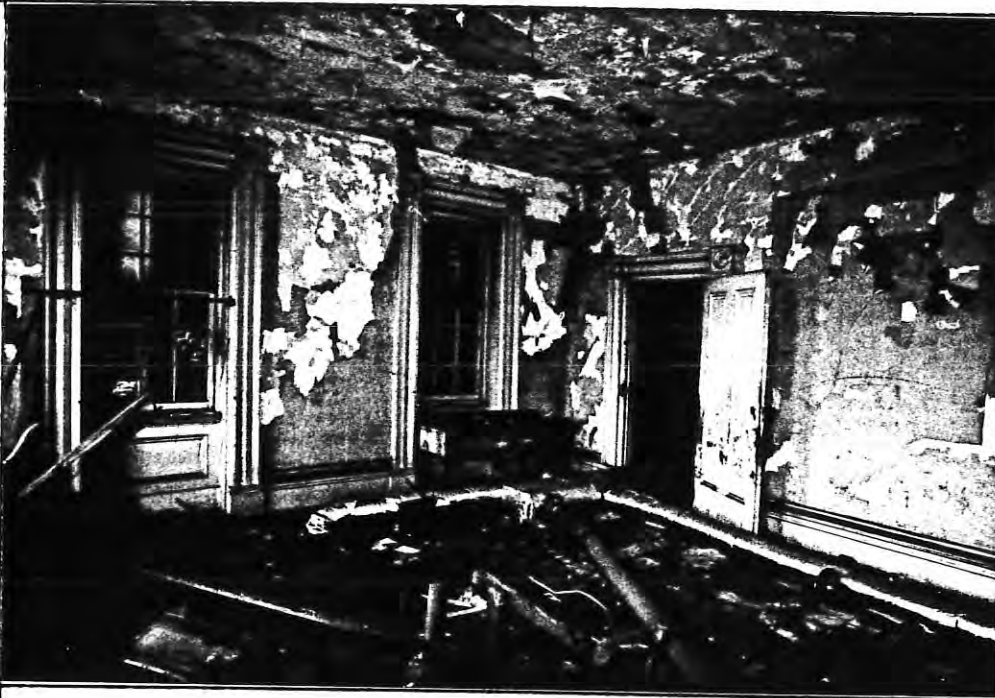
**#38**

**Second Floor East  
Parlor, Facing  
Southwest**

**Prior to Rehabilitation, 8/84**

Note: Original 9/9 sash, molded window and door surrounds with cornerblocks, 2-panel door, and hardwood floors

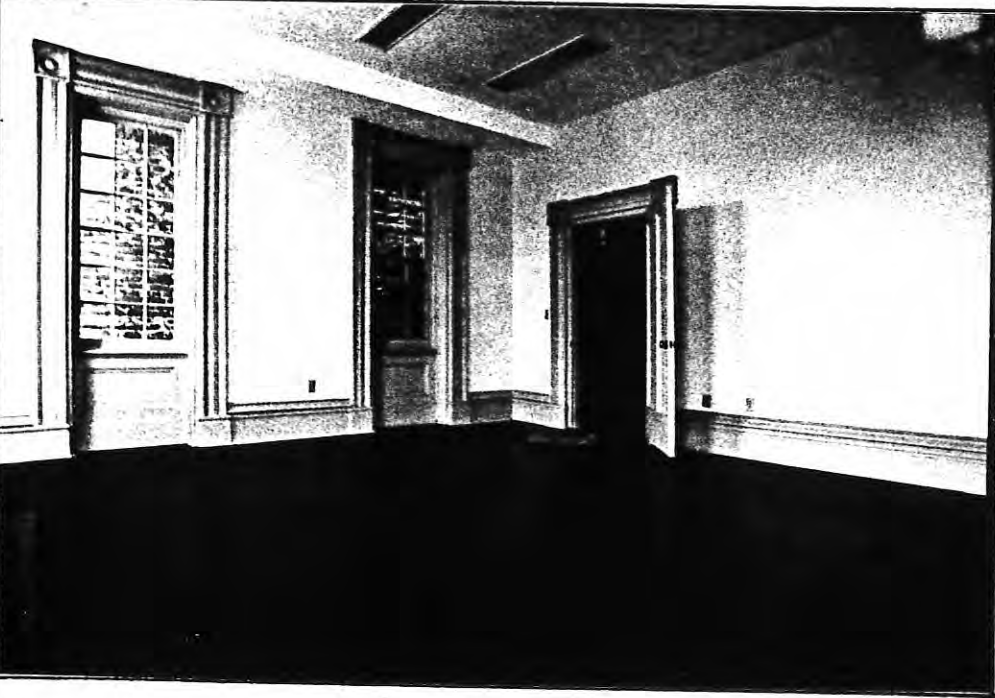
**#39**

**Second Floor East  
Parlor, Facing  
Southwest**

Note: Original 9/9 sash, molded window and door surrounds with cornerblocks, 2-panel door, and hardwood floors retained and repaired as needed

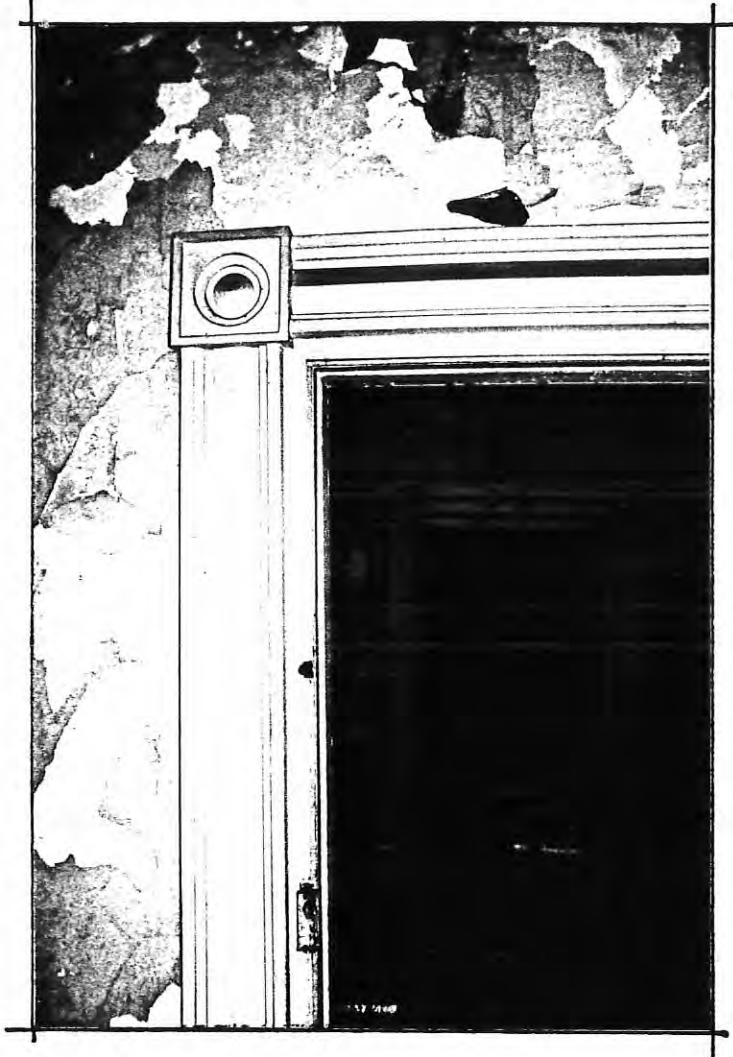
**#42**

**Second Floor East  
Parlor, Detail of  
Door Surround**

**Prior to Rehabilitation, 8/84**

**Note: Molded surround with  
corner blocks**

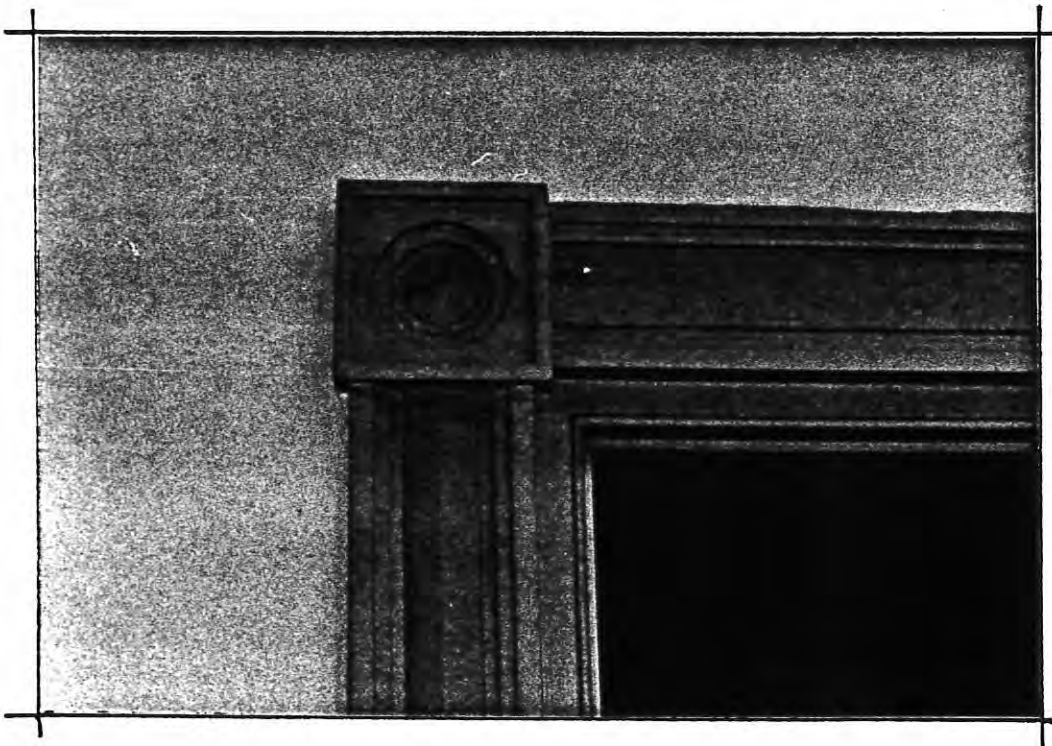
**#43**

**Second Floor East  
Parlor, Detail of  
Door Surround**

**Note: Molded surround with  
corner blocks retained and  
repaired as needed**

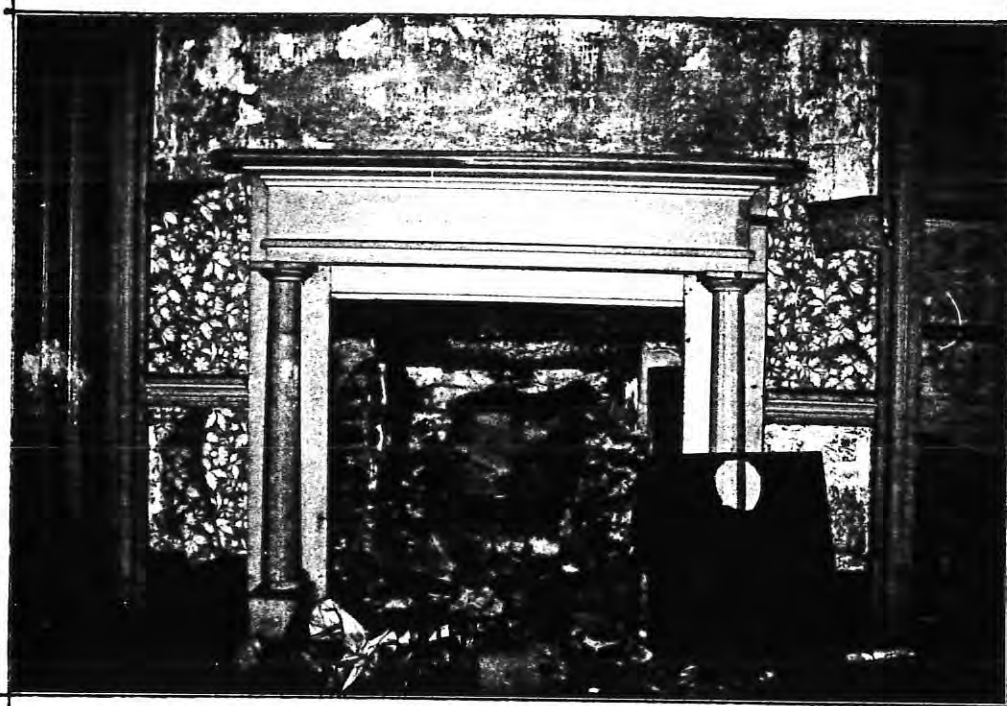
**#50**

**Second Floor West  
Parlor, Detail of  
Mantelpiece**

**Prior to Rehabilitation, 8/84**

**Note: Chair-rail, baseboards**

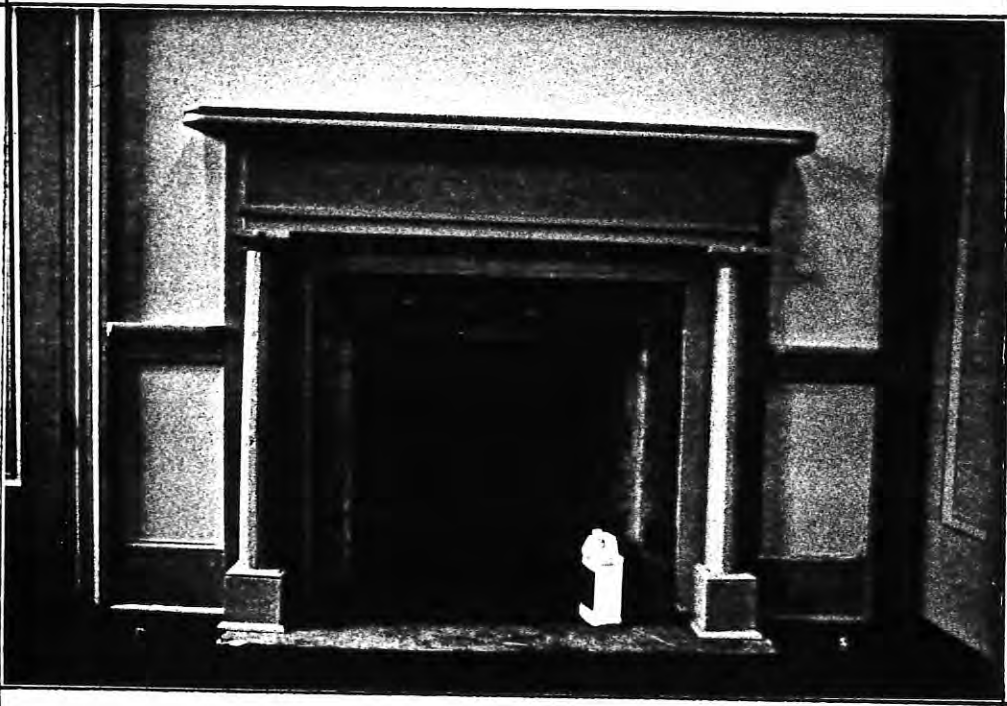
**#51**

**Second Floor West  
Parlor, Detail of  
Mantelpiece**

**Note: Chair-rail and baseboards  
retained and repaired as needed,  
firebox repaired**

Existing fireplaces were repaired as needed. Existing mantelpieces were retained and carefully refinished.

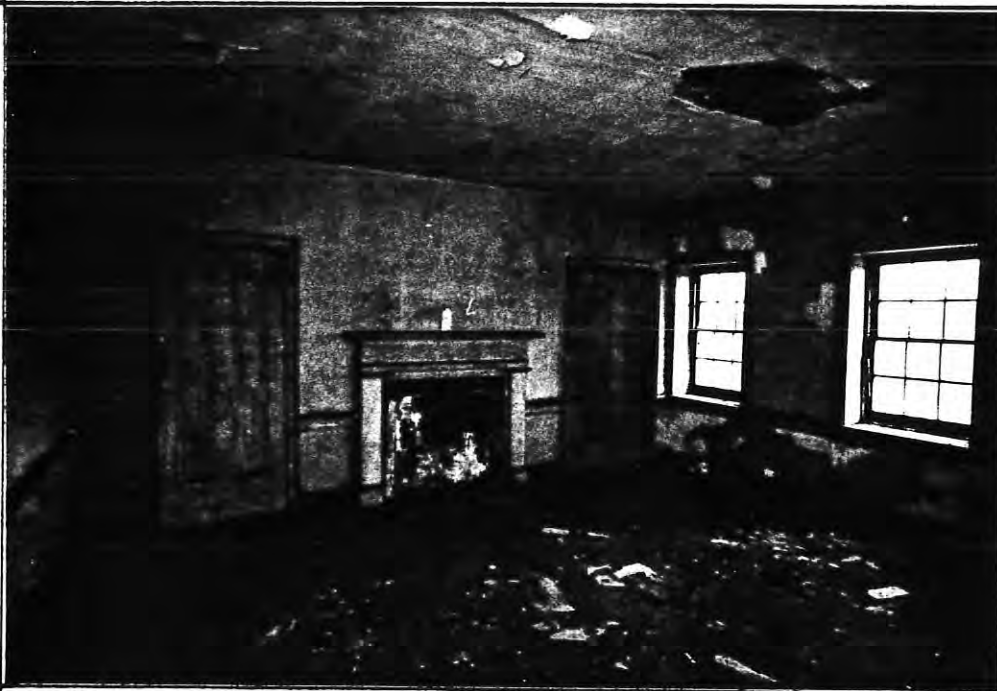
**#52**

**Third Floor East  
Chamber, Facing  
Northeast**

**Prior to Rehabilitation, 8/84**

Note: Original mantelpiece,  
chair-rail, panelled doors, 6/6  
sash, baseboards, hardwood  
floors, and closets

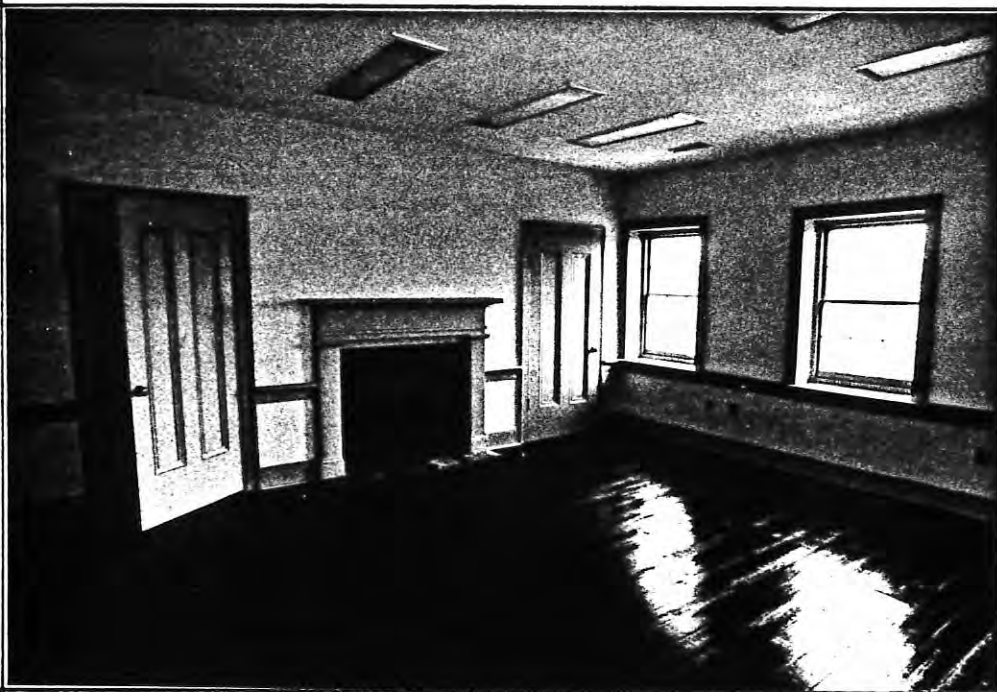
**#53**

**Third Floor East  
Chamber, Facing  
Northeast**

Note: Original mantelpiece,  
chair-rail, panelled doors, 6/6  
sash, baseboards, hardwood  
floors, and closets retained and  
repaired as needed

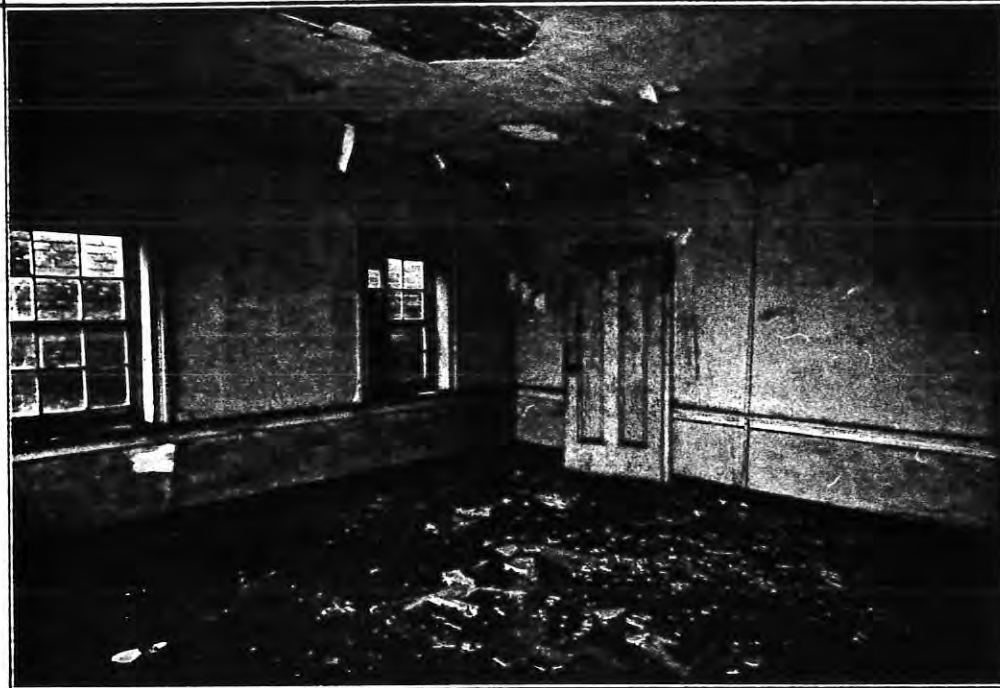
**#54**

**Third Floor East  
Chamber, Facing  
Southwest**

**Prior to Rehabilitation, 8/84**

Note: Original chair-rail,  
panelled doors, 6/6 sash,  
baseboards, and hardwood floors

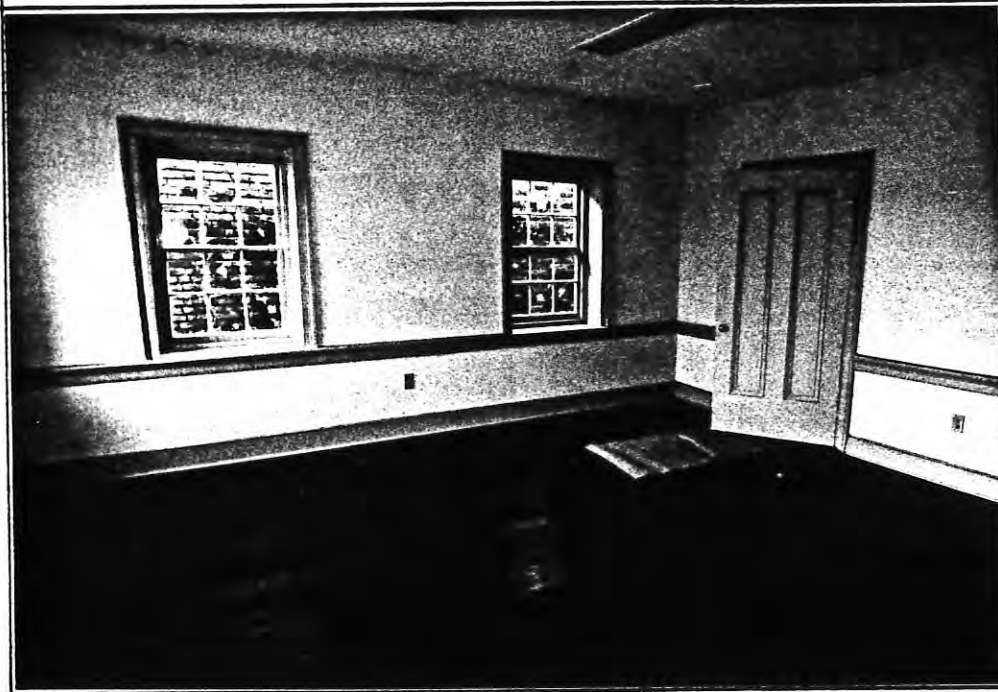
**#55**

**Third Floor East  
Chamber, Facing  
Southwest**

Note: Original chair-rail,  
panelled doors, 6/6 sash,  
baseboards, and hardwood floors  
retained and repaired as needed

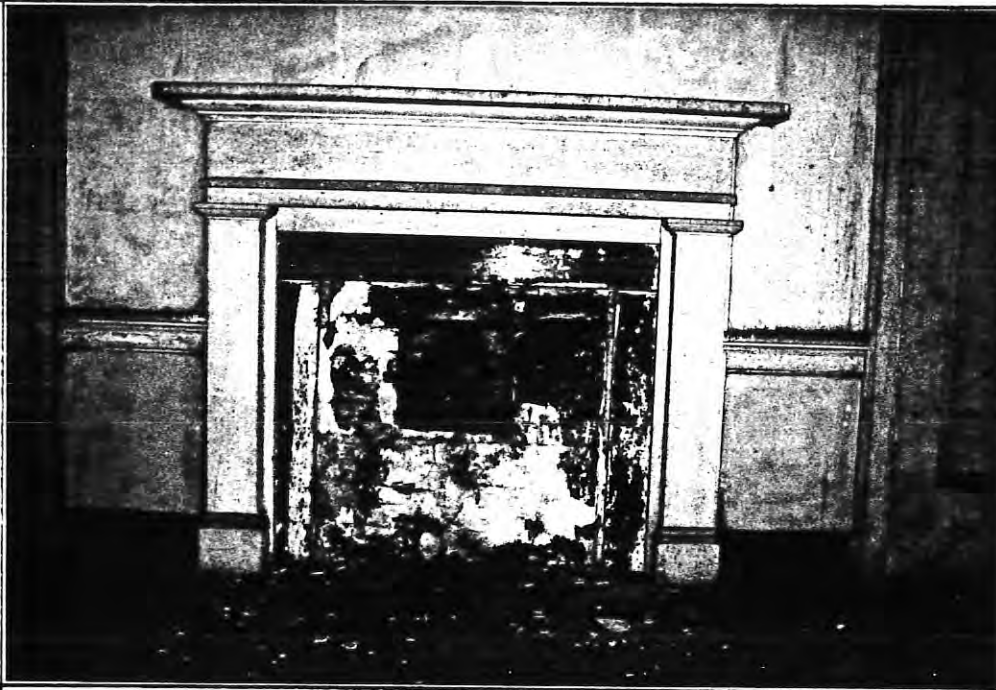
**#56**

**Third Floor East  
Chamber, Detail of  
Mantelpiece**

**Prior to Rehabilitation, 8/84**

Note: Original chair-rail,  
baseboards, and hardwood floors

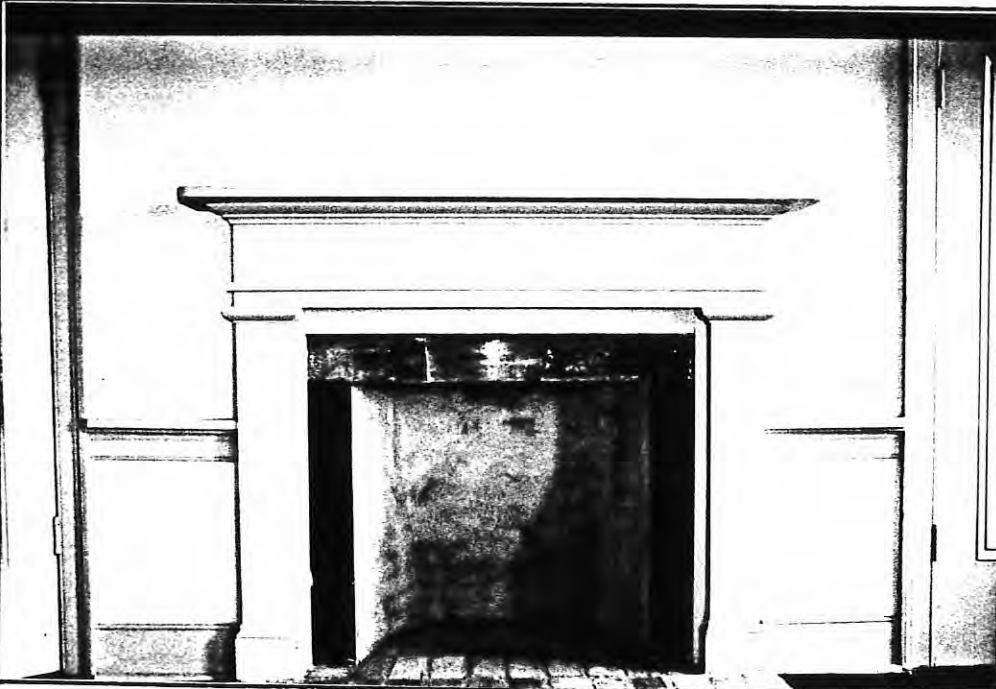
**#57**

**Third Floor East  
Chamber, Detail of  
Mantelpiece**

Note: Original chair-rail,  
baseboards, and hardwood floors  
retained and repaired as needed,  
firebox repaired as needed

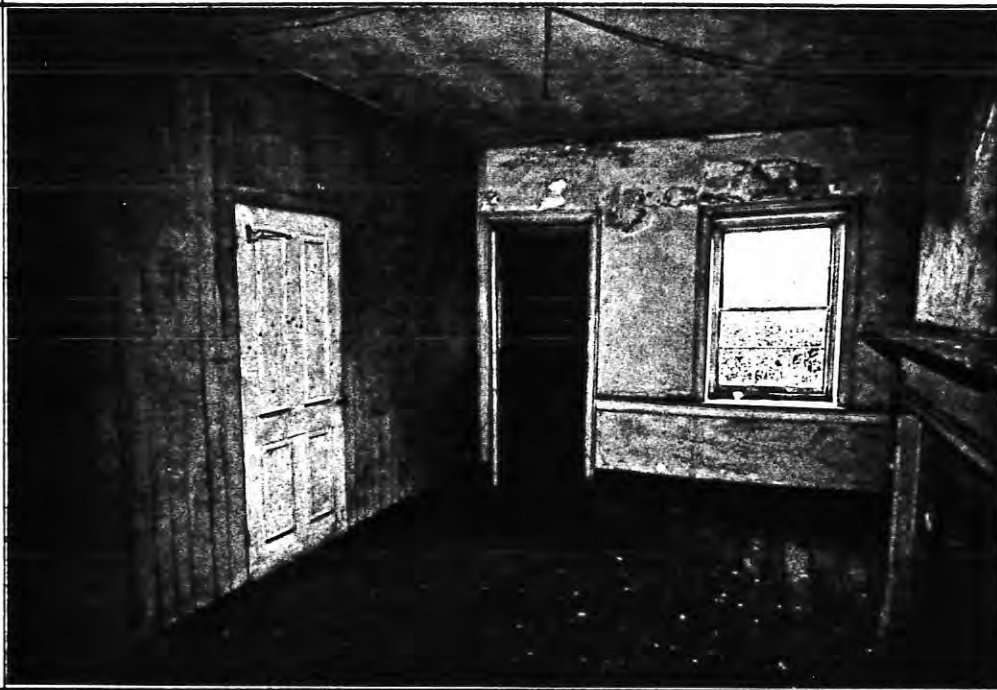
**#58**

**Third Floor West  
Chamber, North Side,  
Facing West**

**Prior to Rehabilitation, 8/84**

Note: Original chair-rail, 6/6  
sash, baseboards, mantelpiece,  
and hardwood floors

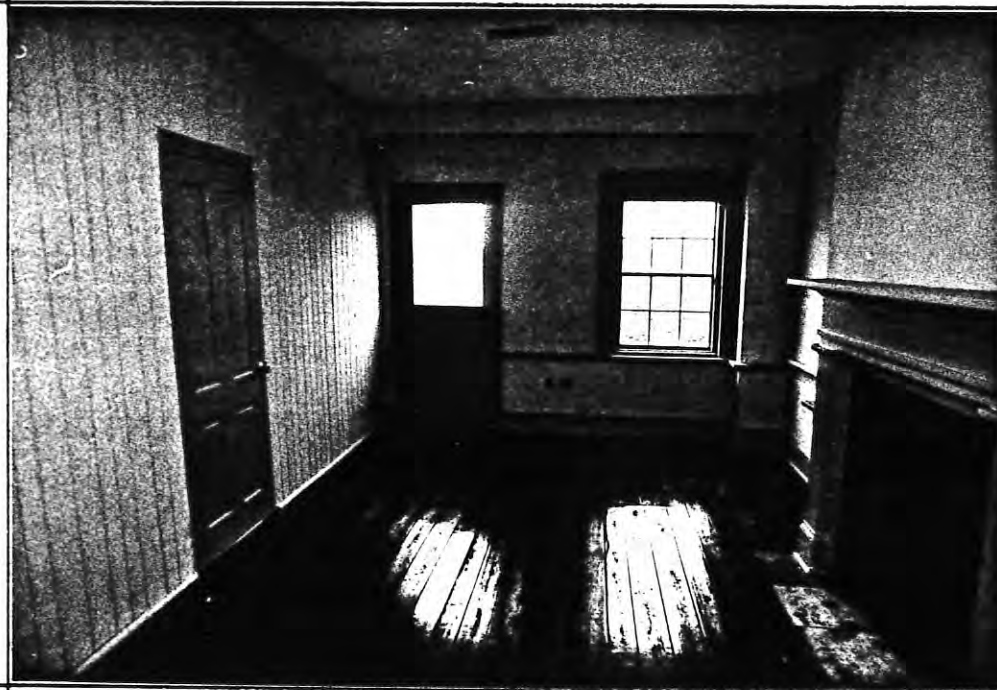
**#59**

**Third Floor West  
Chamber, North Side,  
Facing West**

Note: Original chair-rail, 6/6  
sash, baseboards, mantelpiece,  
and hardwood floors retained and  
repaired as needed; west wall  
reconstructed as per plans and  
Part Two Application submitted

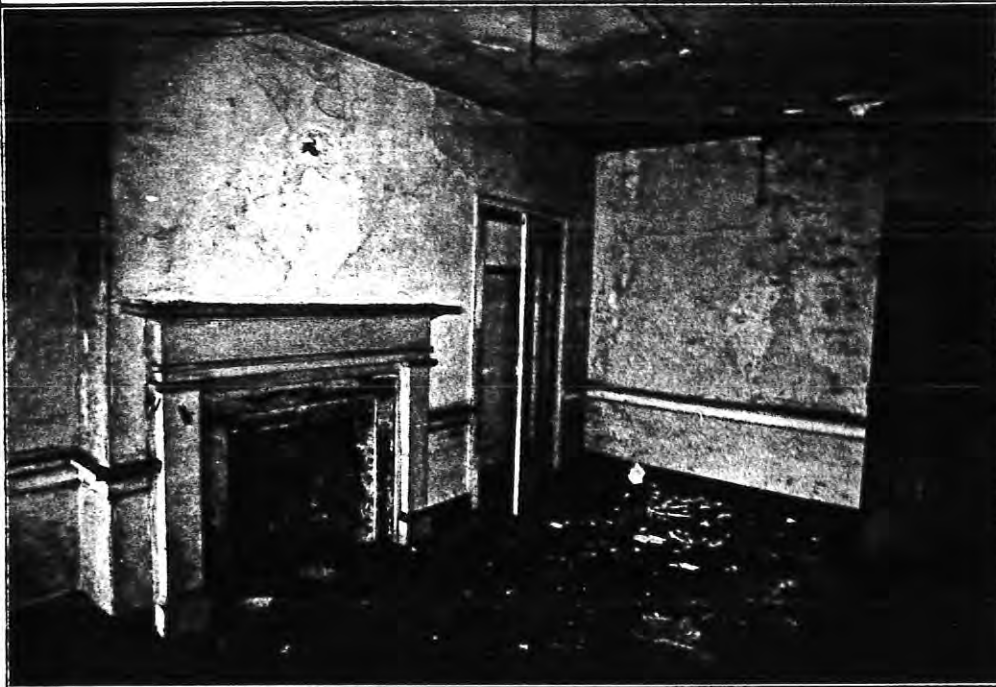
**#60**

**Third Floor West  
Chamber, North Side,  
Facing Northeast**

Note: Original chair-rail,  
baseboards, panelled door,  
mantelpiece, and hardwood  
floors
