HISTORIC PRESERVATION CERTIFICATION APPLICATION  
PART 2 - DESCRIPTION OF REHABILITATION

Address of property: Street 231 King Street

City Charleston County Charleston State SC Zip Code 29401

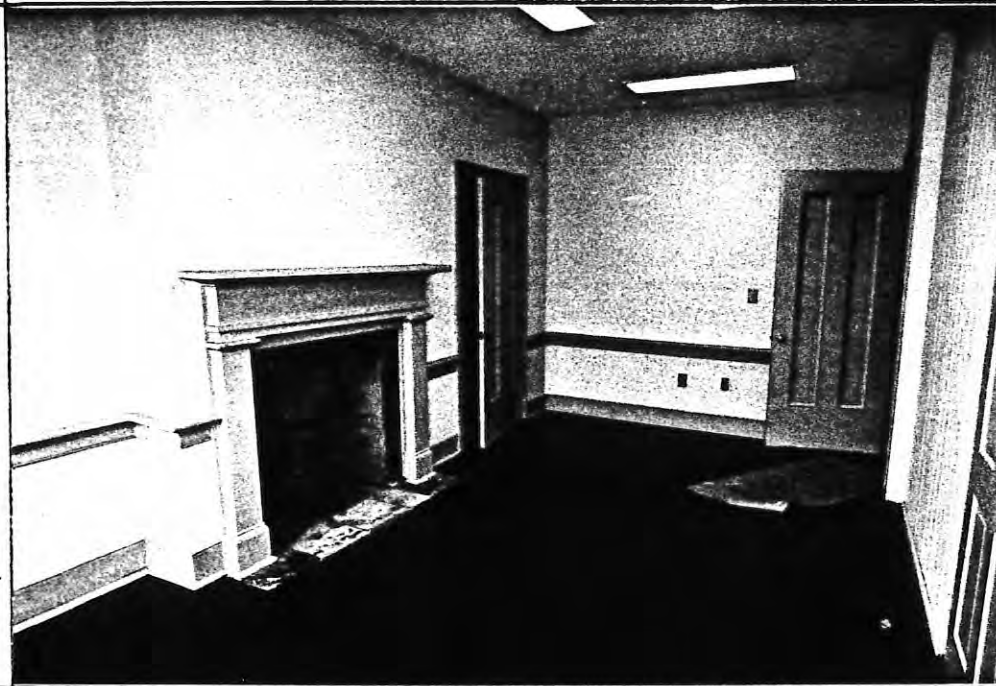
**#61**

**Third Floor West  
Chamber, North Side,  
Facing Northeast**

Note: Original chair-rail,  
panelled door, baseboards,  
mantelpiece, and hardwood  
floors retained and repaired as  
needed

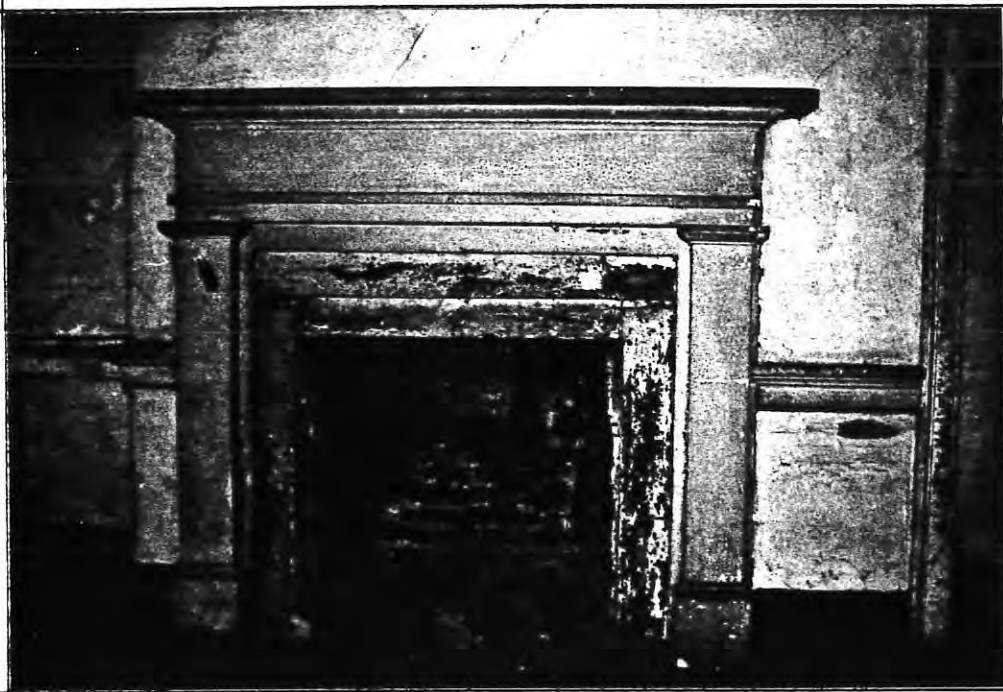
#62

Third Floor West  
Chamber, North Side,  
Detail of Mantelpiece

Note: Original chair-rail and  
baseboards

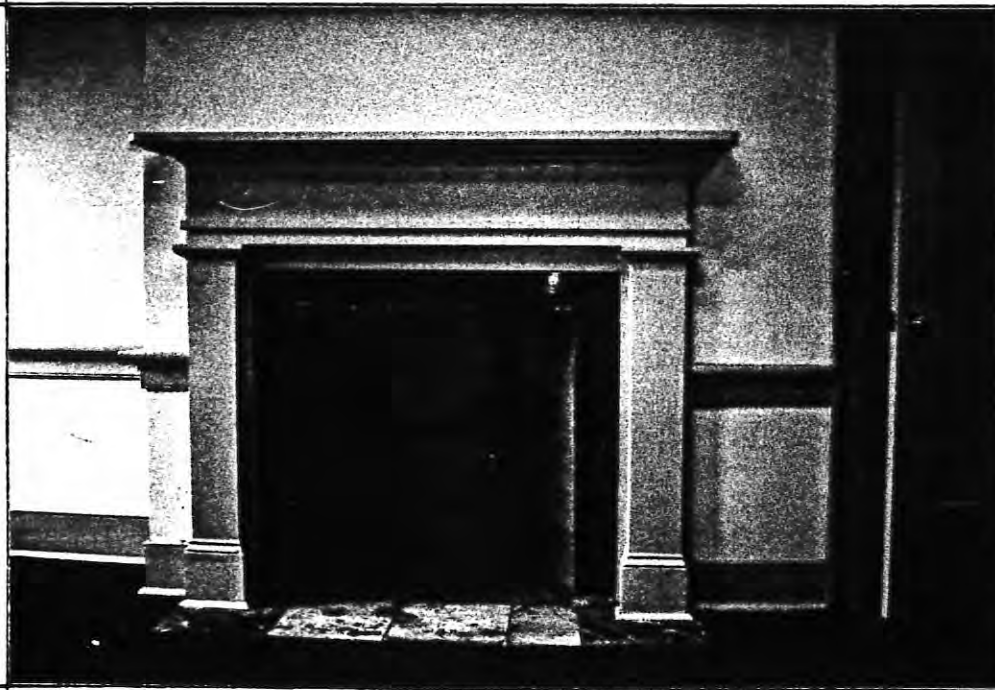
#63

Third Floor West  
Chamber, North Side,  
Detail of Mantelpiece

Note: Original chair-rail,  
baseboards, and mantelpiece,  
retained and repaired as needed;  
firebox repaired as needed

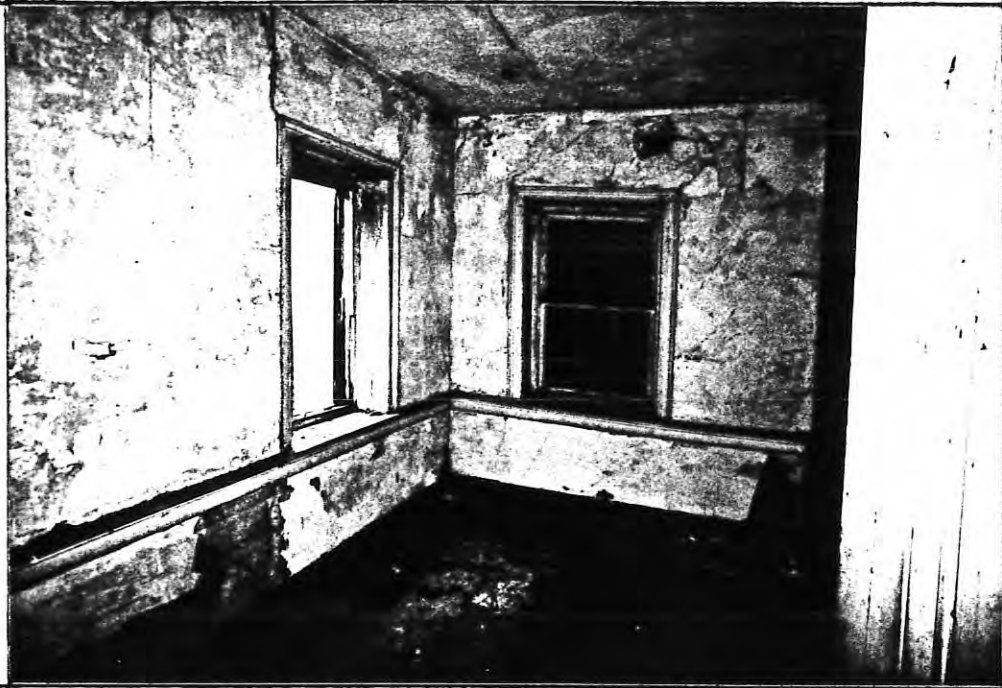
**#64**

**Third Floor West  
Chamber, South Side,  
Facing West**

Note: Original chair-rail, 6/6  
sash, baseboards, and hardwood  
floors

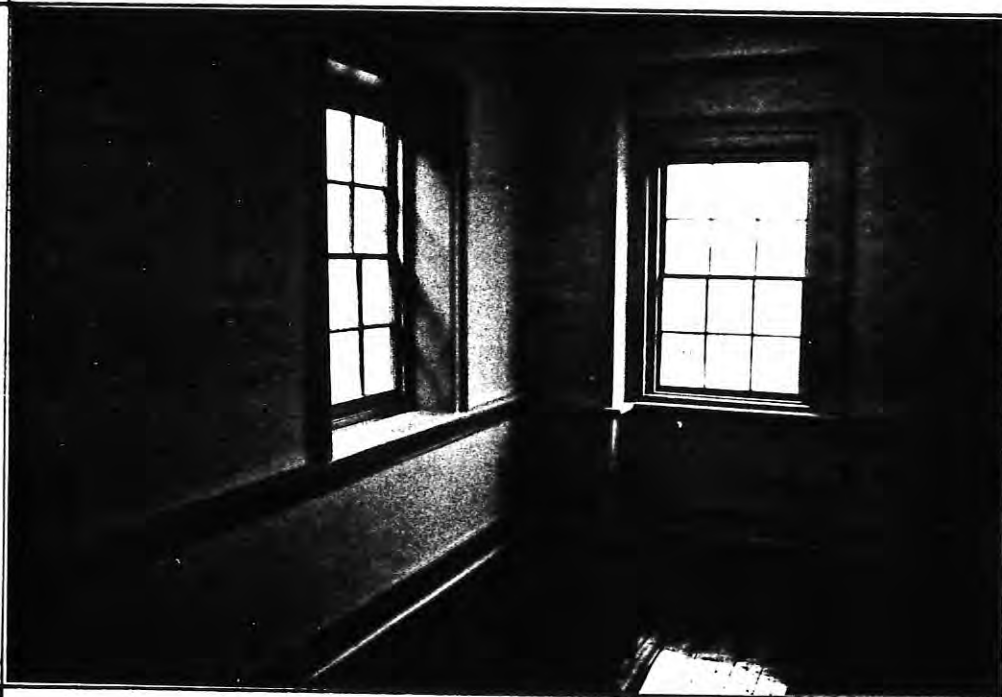
**#65**

**Third Floor West  
Chamber, South Side,  
Facing West**

Note: Original chair-rail, 6/6  
sash, baseboards, and hardwood  
floors retained and repaired as  
needed; west wall reconstructed  
as per plans and Item #9

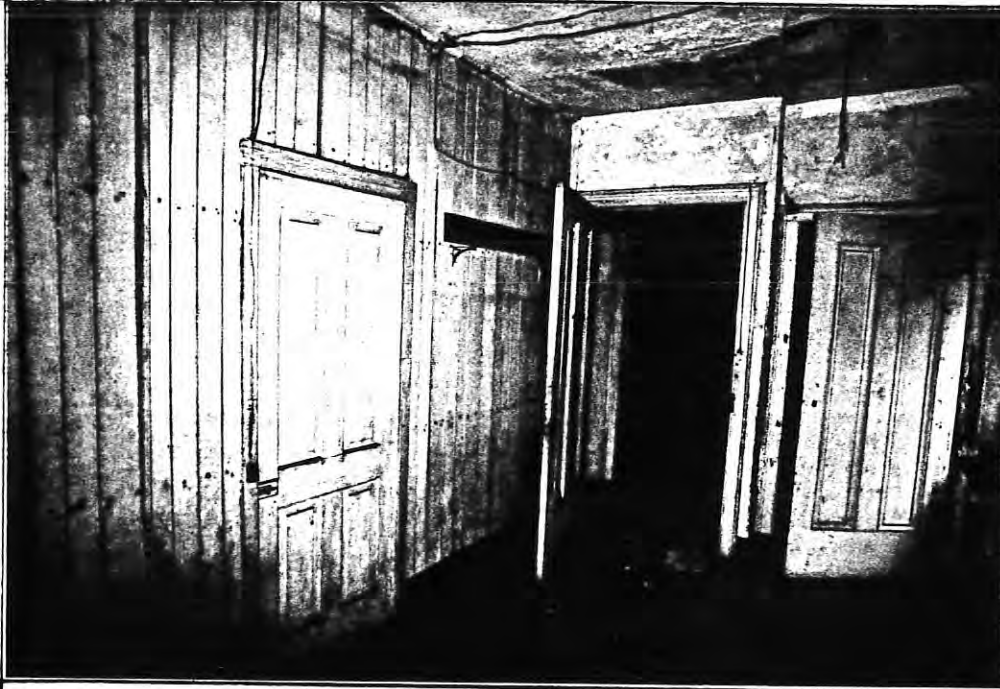
**#66**

**Third Floor West  
Chamber, South Side,  
Facing East**

Note: Existing partition wall at  
right

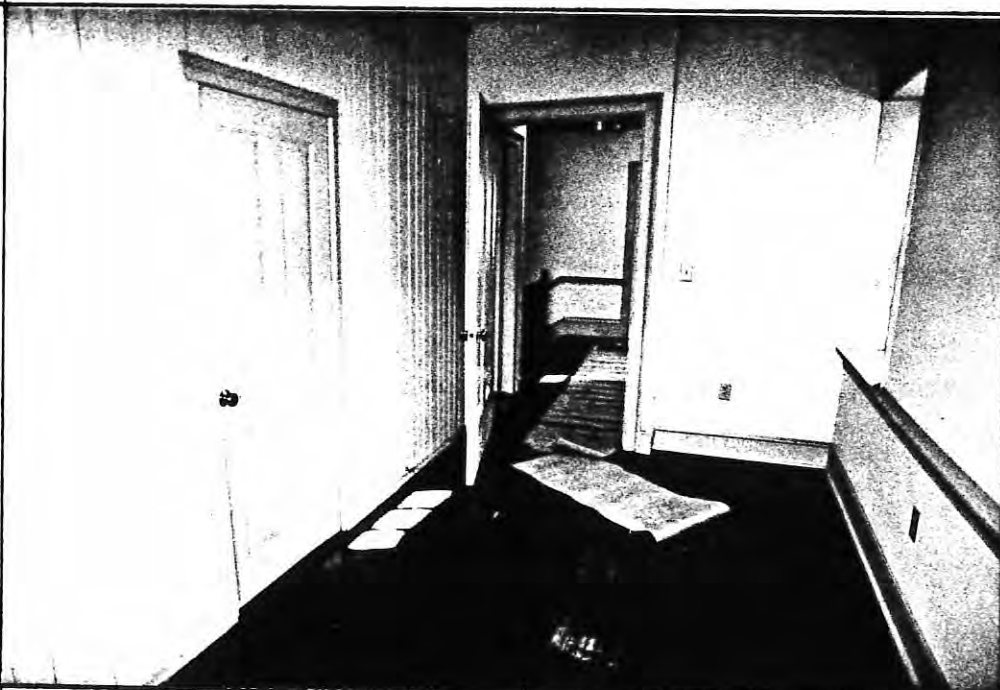
**#67**

**Third Floor West  
Chamber, South Side,  
Facing East**

Note: Existing partition wall at  
right retained and repaired as  
needed
