August 19, 1991

in re: 22 Charlotte Street
Hurricane Hugo damage

List of possible Hurricane Hugo damage found at 22 Charlotte

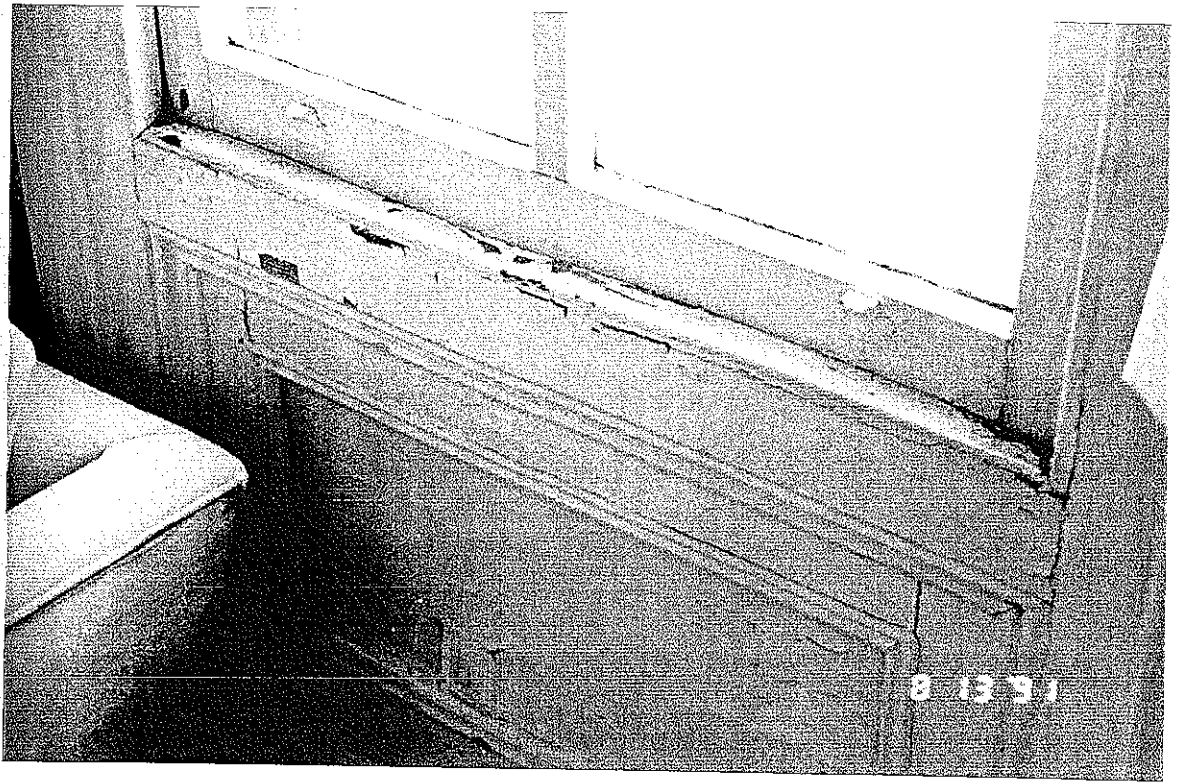
In the Parlor there are separations at the corners of the trim around the ceiling of the room. There are also separations in the panelling beneath the windows in the room. There is minor peeling of paint in the room.

A. Signs of water entry at one of the front Parlor windows.
