# St. John's Reformed Episcopal Church

# Conditions Assessment

Our investigation and documentation of the church includes a report of systems and architectural features observed to be in need of repair.

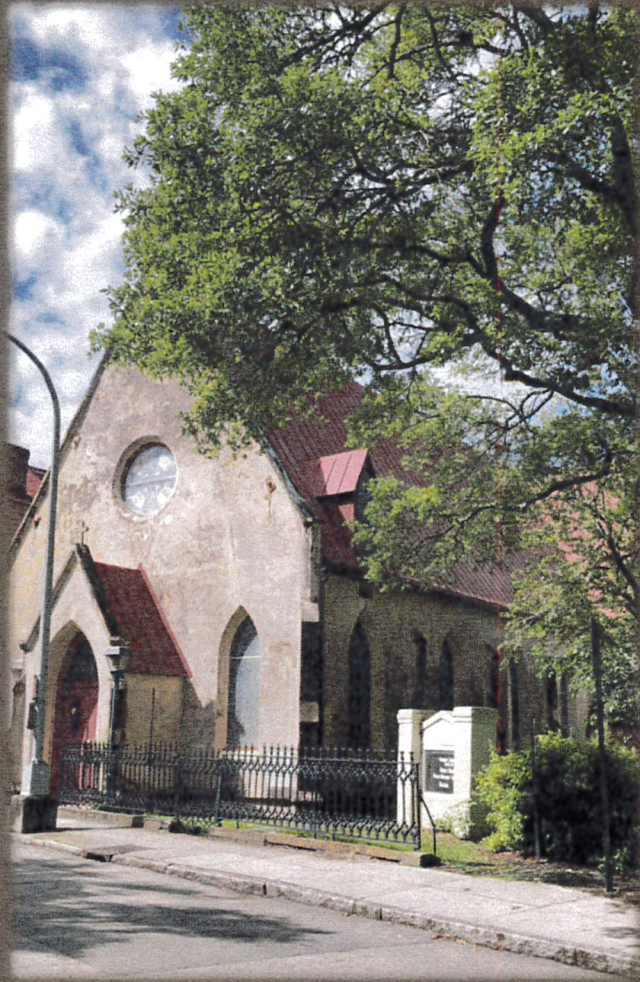
## Window Frames

### Condition: Fair

- Paint delamination
- Deterioration of exterior sills—metal & wood
- Primary facade rose window trim
