HISTORIC CHARLESTON FOUNDATION
ENDANGERED STRUCTURES REPORT
1999

Endangered Structures Survey

Purpose: The object of this survey is to create an inventory of structures at risk by 1) neglect, 2) decay, or 3) development and to protect these vulnerable buildings and monuments and to set priorities for their future care.

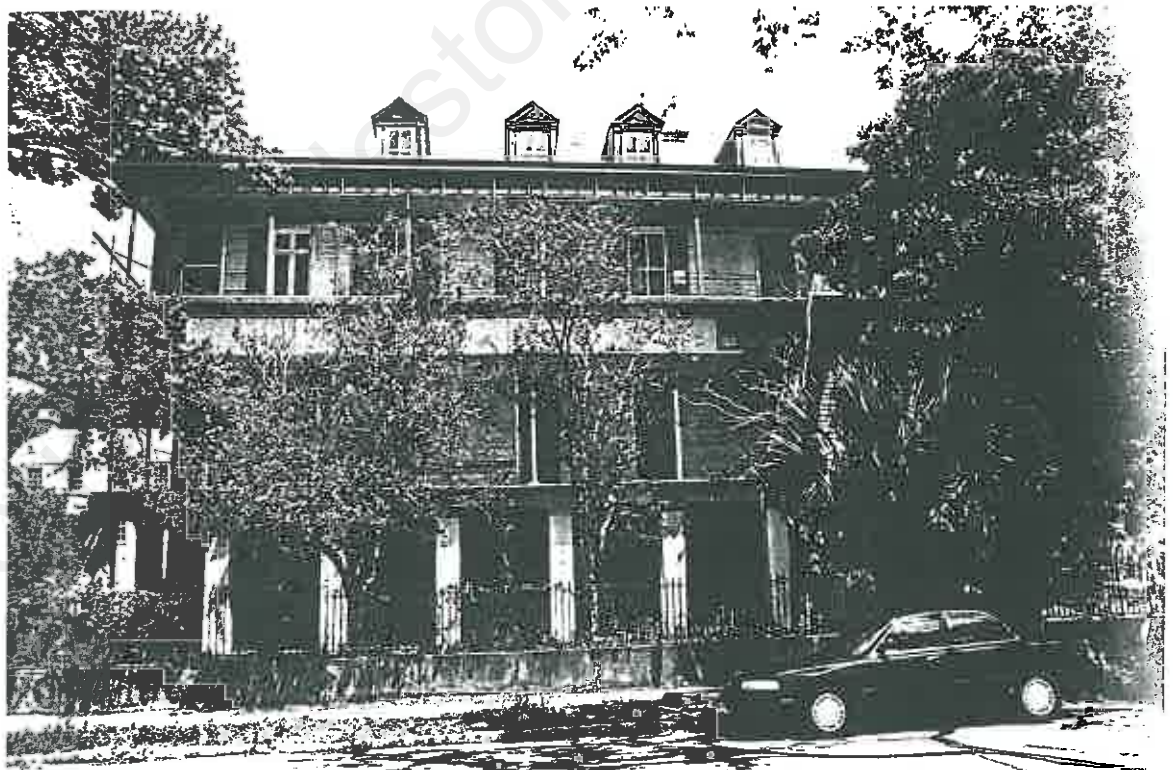
Summary: The structure appears vacant. The porch is braced with supports. The roof is in poor condition. The dormers are deteriorated, and the eaves, clapboards, shutters, and windows display advanced deterioration. The joists and studs are exposed to weather. There are settlement cracks on the ground floor stucco. Overall the structure is in Crisis.

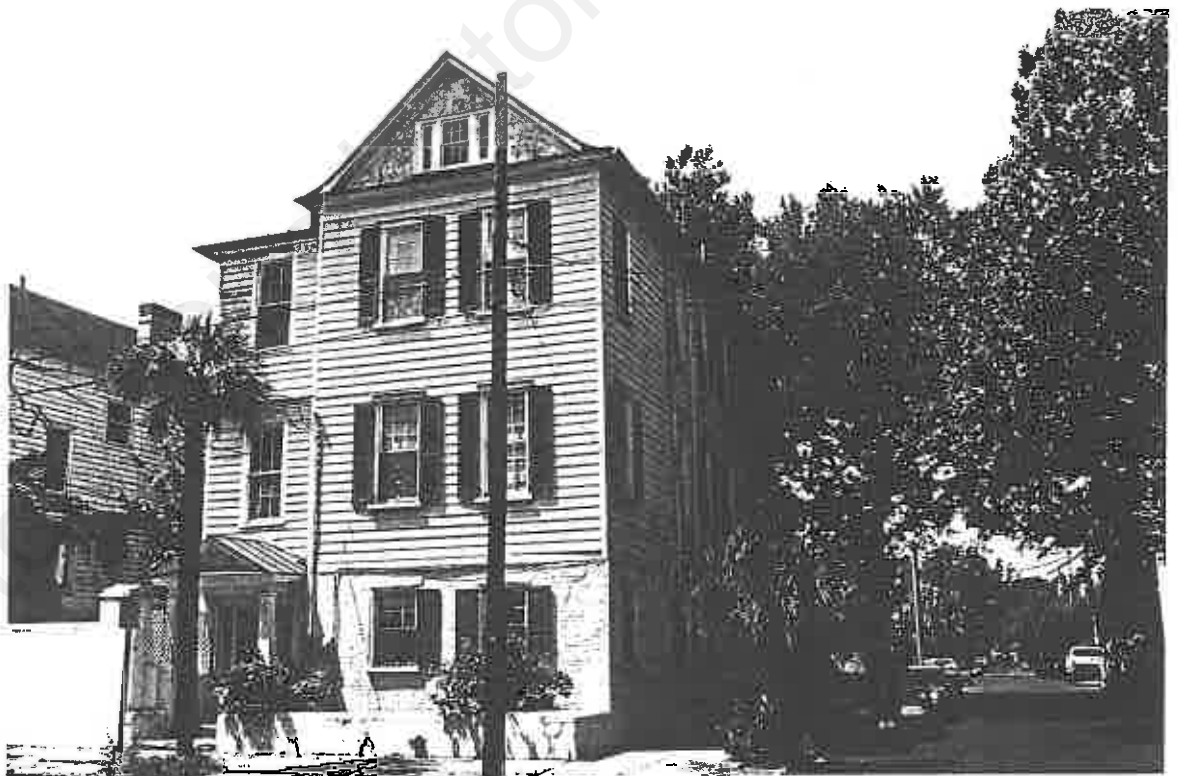
Summary: The roof of this structure is rusted and the flashing is failing. There is visible deflection on the porches, and evidence of rot occurring on the porch, clapboard, eaves, windows, and shutters. The interior of the walls are exposed as some clapboard and foundation brick are missing. Overall the structure is Vulnerable.

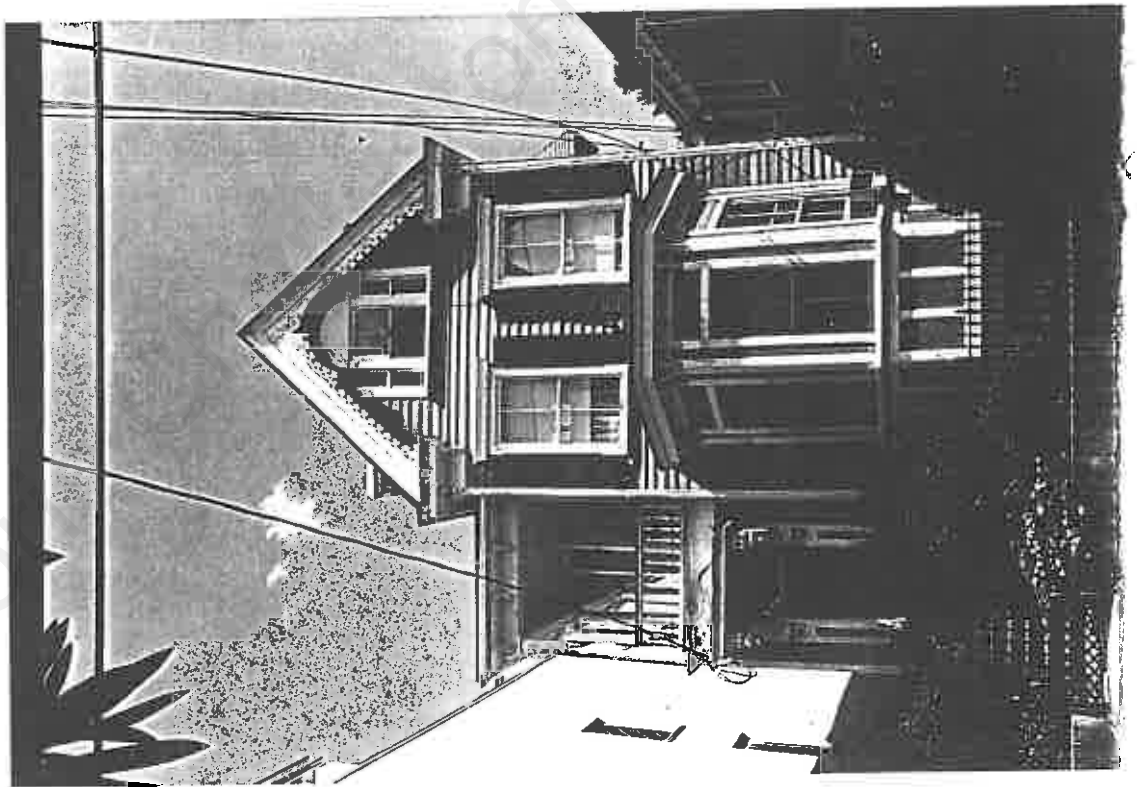
Summary: There is very heavy settlement occurring on the West side of the structure. The entire building leans. There is rot occurring on the clapboard, porches, and windows. The windows and door are warped due to the settlement. The roof is in poor condition. Overall this structure is at Risk.

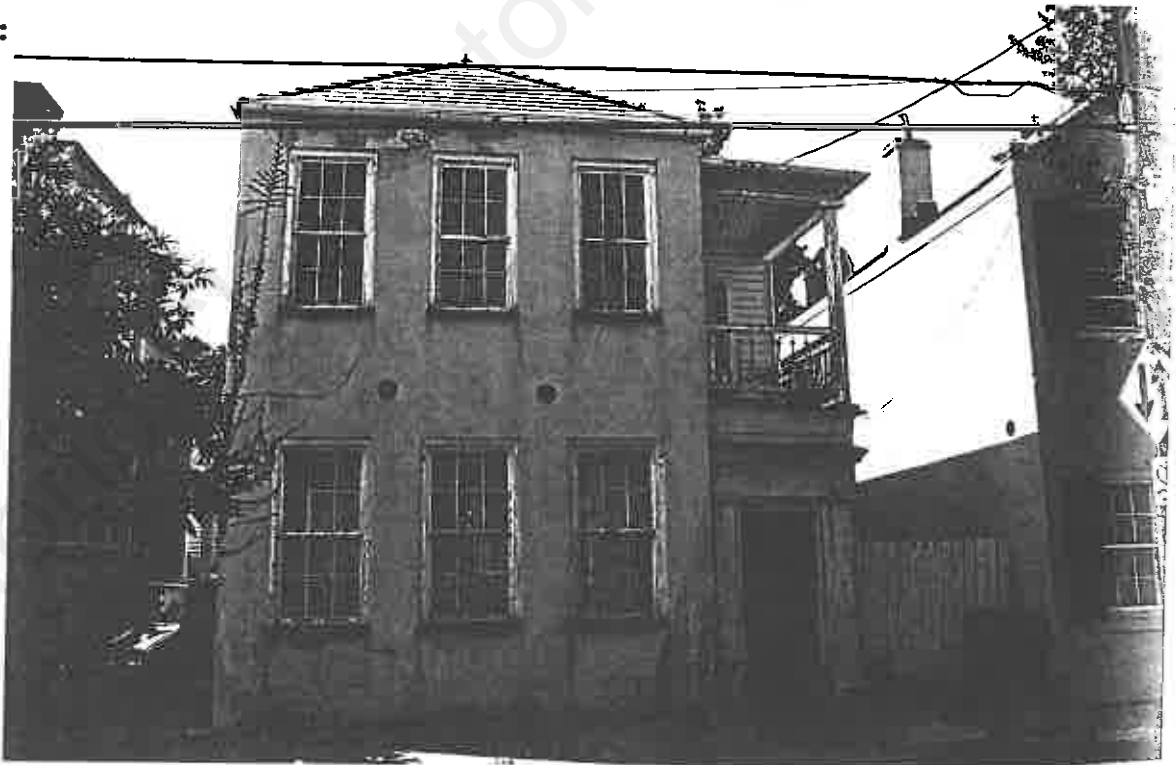
Summary: The roof is in fair condition. There is rot on the side of the structure, the porches, and the windows. The stucco is spalling in areas and there are cracks on the top floor lintels. There is differential settlement occurring on the East side of the structure. The gutters are failing and signs of low maintenance. Overall the structure is at Risk.

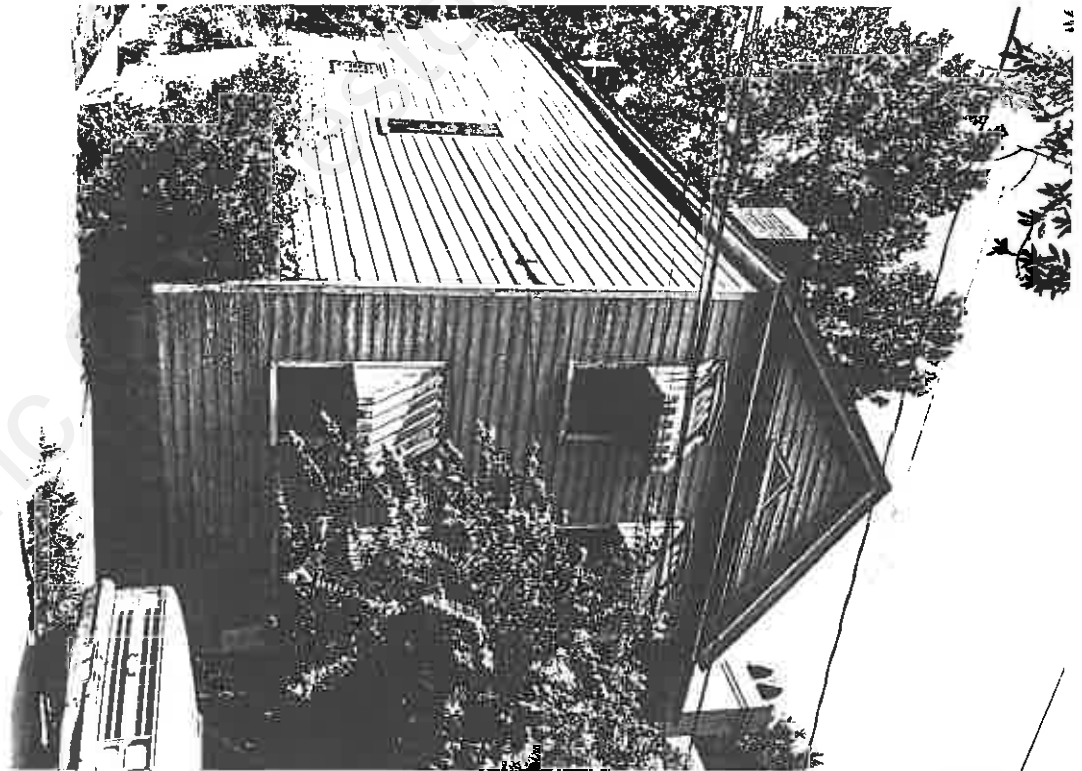
Summary: The structure is vacant. The roof of the structure is in poor condition with rust forming. There is deflection occurring on the eaves and there are signs of rot on the roof eaves and pent eaves. There is severe differential settlement. The windows are boarded. The porch is rotted and failing. There is minor rot on the clapboard and the pointing is deteriorating on the chimney. Overall the structure is in Risk.

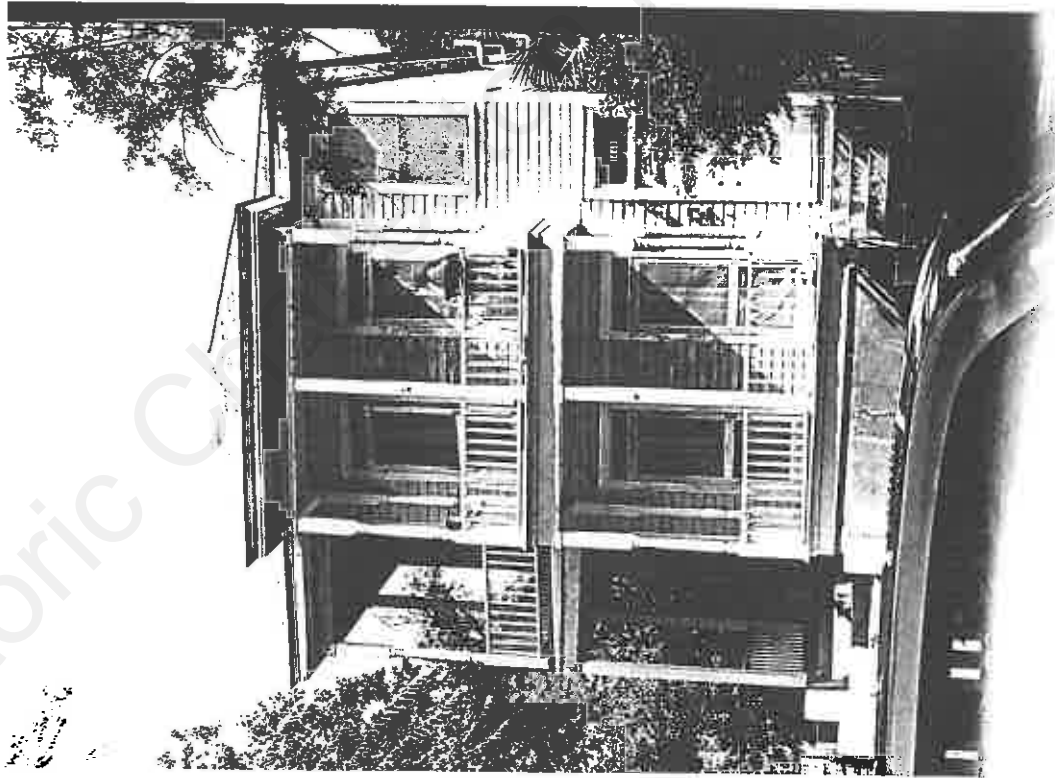
Summary: The roof is in poor condition. There is minor deflection occurring on the roof and the porches. There is rot under the eaves. There is differential settlement on the East wall of the structure. There is minor rot on the clapboard. Overall the structure is Vulnerable.

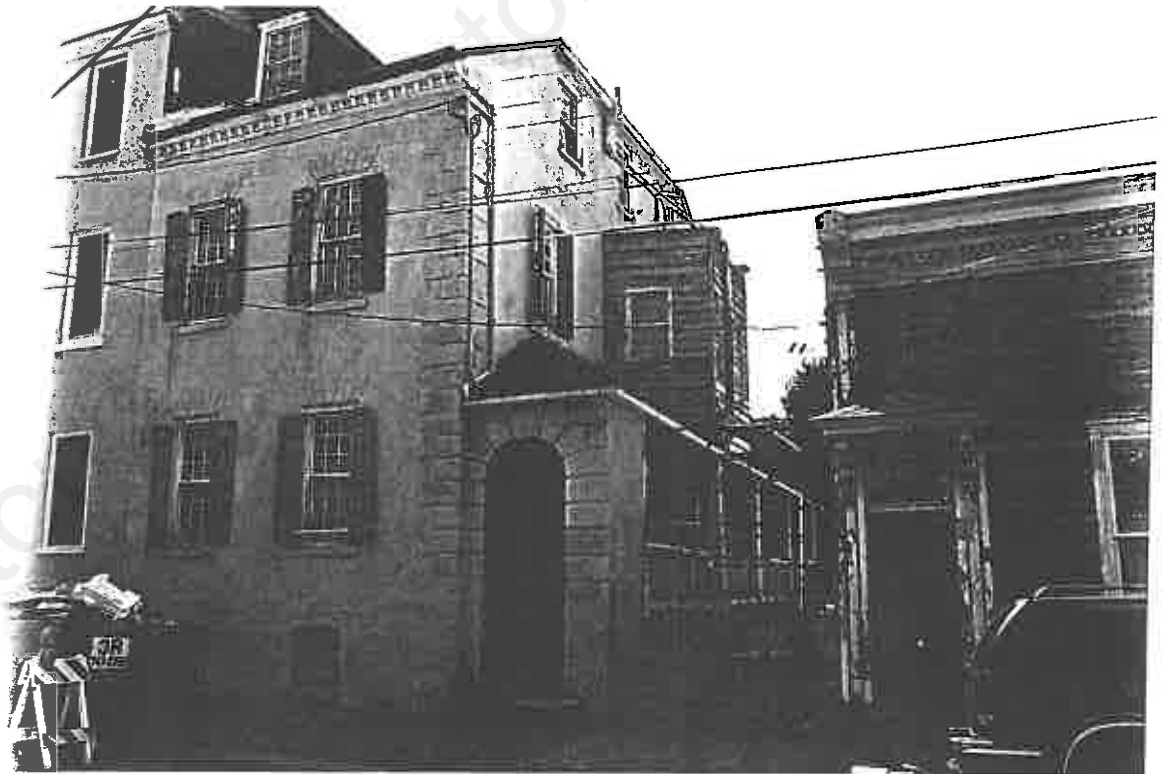
Summary: The structure is currently under repair. The roof is in poor condition. The eaves and details are rotted. The windows and shutters also show advanced rot. The masonry arch is cracking, possibly beginning to fail. The stucco is spalling and the porch is in very bad condition. Overall the structure is currently at Risk.

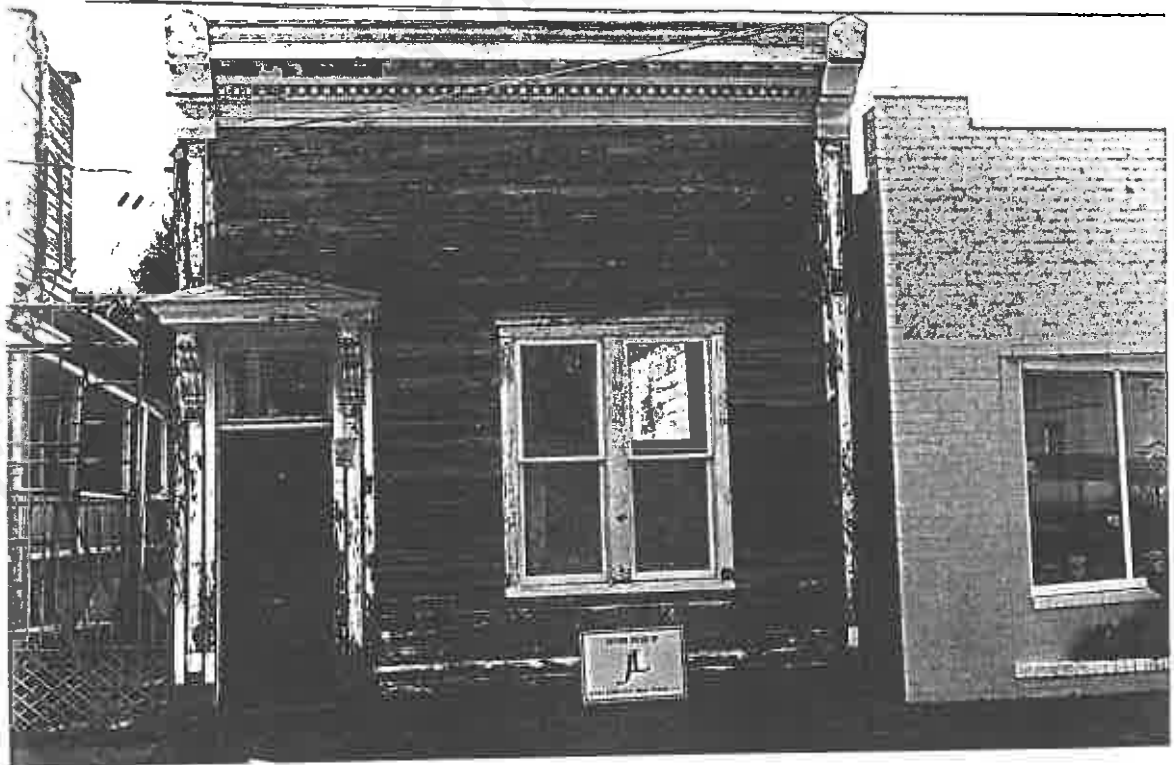
Summary: Currently the structure is under repair. The roof has been removed, and the remaining flashing is completely deteriorated. The interior is completely exposed. There is rot on the floor plate and the foundation is deteriorating. The back wall of the structure has been removed. Overall the structure is in Crisis.

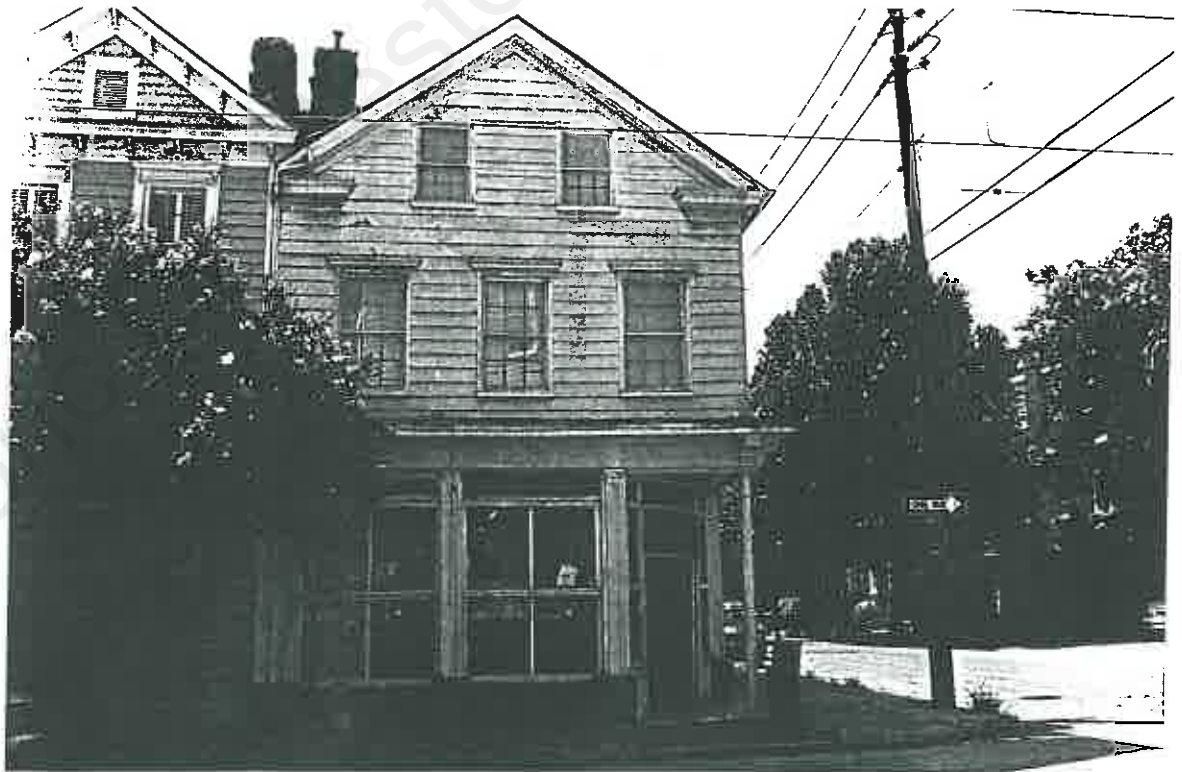
Summary: The structure shows no evidence of maintenance. The roof is in poor condition and there is deflection occurring. The flashing is missing, the gutters have failed, and the eaves are rotting. The 2nd floor cornice displays advanced rot and deflection. There is wood rot occurring throughout the structure and the windows are in poor shape. There is differential settlement on the West wall and the CMU's are cracking. Overall the structure is at Risk approaching Crisis
