Cross-section Microscopy Report

54 Hasell Street Charleston, South Carolina

Investigation of the Interior Paints

Date: August 19, 2018

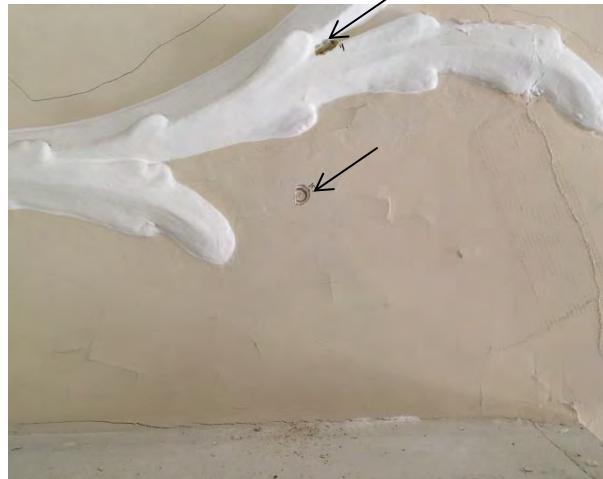
The paints in samples SW-3 from the wall and sample SW-4 from the applied plaster leaf form can be neatly aligned from generations 1 through 20. Sample SW-3 is missing the off-white paint that appears in generation 21. That particular layer contains the pigment zinc white which dates it to after 1845 when zinc white became commercially available. The comparative plaster stratigraphy can be reconstructed to show that 21 generations of paint were applied to the west wall plaster and the raised plaster paneling before the clear sealant layer that marks the 1941 plaster was applied. This sealant layer has a distinctive

The comparative evidence in SW-3 and SW-4 suggests that the applied decorations were most often painted the same colors, beginning with deep yellow in the first two generations of paint, followed by off-white in generation 3. In generation 4 the plaster wall was off-white while the decorations were tan. Then in generations 5, 6 and 7 the plaster and raised decorations were all dull pink, then off-white, then dull pink again. The films of dirt between some of the paint generations, and the subtle darkening of the paint surfaces, help to distinguish the paint generations. These long and intact sequences of paints, with notably coarsely ground pigments from generations 1 through 15, suggests the proposed third quarter of the eighteenth century date for the wall plaster is plausible.

Binding media analysis of the plaster paints in SW-3 suggests that all the early paints are bound in oils (with the fluorochrome DCF), with no other organic additives.

The plaster substrate for SW-3 is a coarse off-white color with clear and tannish sand particles. This plaster matches the plaster substrate in samples SW-1 and SW-2 from the raised paneling on the south wall, helping to confirm that the east wall plaster is the same period as the raised paneling on the south, west and north walls.

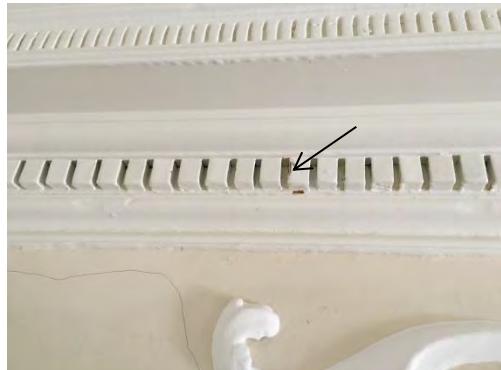
SW-6 cornice

The wood substrate in SW-6 from a cornice dentil is fibrous and disturbed, which is likely the result of aggressive paint stripping. This stripping may have been done in 1941, which would date the off-white primer directly above the wood and the light blue-green finish coat to 1941. It is possible that in 1941 certain elements of the cornice, like the dentils, were picked out in light blue-green, while the rest of the cornice was white. Other elements, such as the north wall door trim, seem to have been off-white in 1941. No early paints were found on the cornice, but stylistically it fits with the rest of the woodwork, and the evidence of thorough paint stripping suggests it was treated harshly in the 1941 restoration.

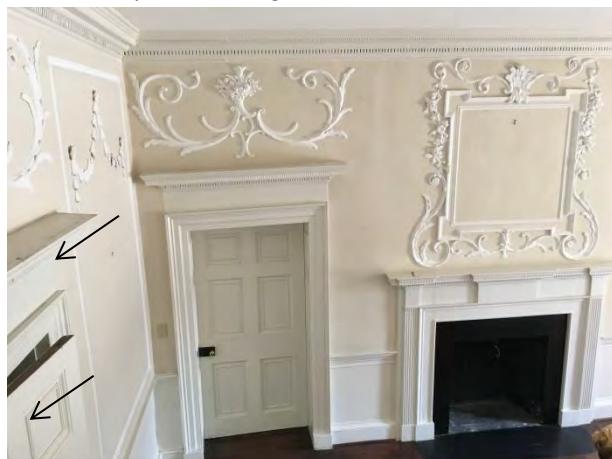
SW-7 and SW-8

Paint Evidence on Southwest Room Woodwork. The only early paint evidence on the woodwork in this room was found in sample SW-8 from the north wall door architrave. There are approximately 21 generations of aged, grimy, white lead-based paints in this cross-section, beginning with cream color, followed by glossy tan paint (which contains a varnish component) in generation 2. Most of the woodwork colors are variations of creams and dull yellows, as shown in the photomicrographs below.

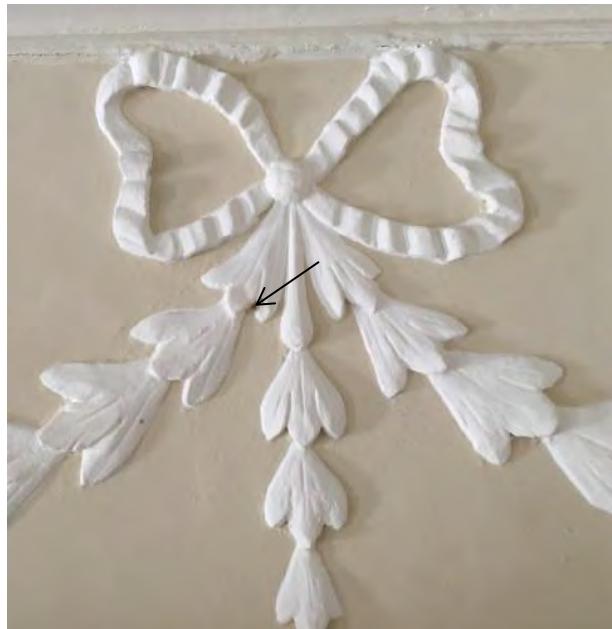
SW-9

One cross-section from the decorative swag about the north door on the west wall retains remnants of degraded paint that appears to be generation 11 – a pigmented glaze on a deep yellow base coat. Uncast portions of from this same area retain remnants of the first deep yellow distemper paint found in samples SW-3 and SW-4. This is followed by the off-white paint identified as generation 21 and then the 1941 coatings. While the early paints in this cross-section are fragmentary, the presence of early hand-ground paints suggests this swag and ribbon decoration is the same date as the more exuberant leafy rococo decoration above the north door on the east wall.

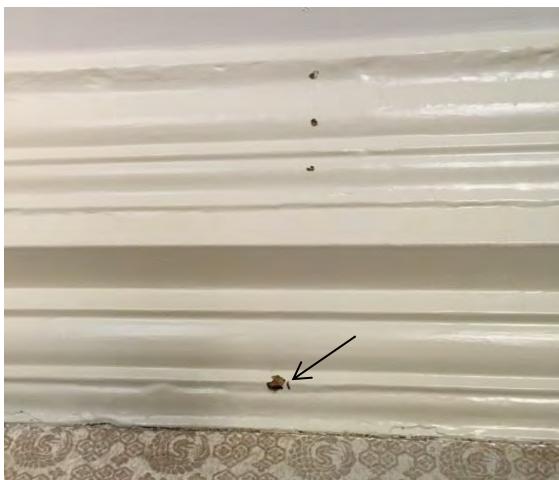
Paint Evidence on the Northeast Room Woodwork. An extraordinarily complete stratigraphy of early paints was found on the cornice, which remains undisturbed and could date to the first period of the house. There are 20 generations of coarsely ground, white-lead-based paints on top of the wood in sample NE-1, beginning with a thinly applied cream-colored paint, followed by deep yellow in the second generation. Most of the earliest colors are creams, tans and dull yellows, as shown in the detail images of NE-1 at 200X magnification below. The most recent green paints, followed by bright whites, cleaved away when the samples were removed, but they are shown in separate photomicrographs on page 23.

The complete stratigraphy of paints on the cornice can be reconstructed from the layers that cleaved apart. There are approximately 29 generations of paint. Generations 21 through 29 can be aligned with the paints found on the wainscoting and chair rail. An uncast portion of this sample was also photographed to help put this complex paint sequence into context.

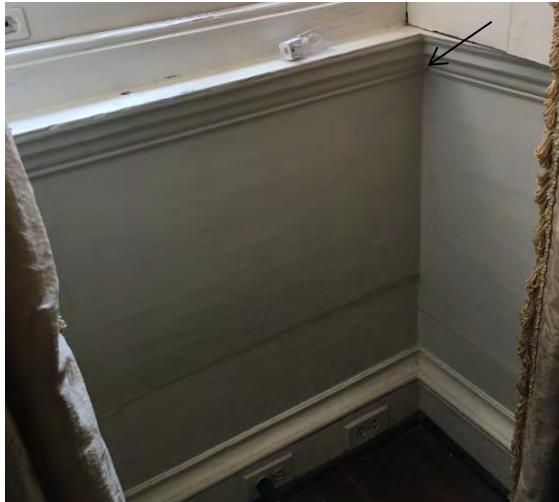
The wainscoting and chair rail were very aggressively stripped, and the off-white paint above the damaged wood (see sample NE-3 from the chair rail) must represent the 1941 layer, which is labeled generation 21 in the reconstructed paint stratigraphy for the woodwork in the northeast room.

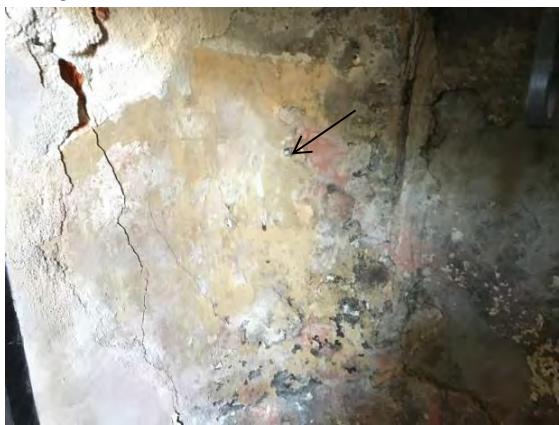
NE-5

The interior of the firebox has a thick accumulation of darkened materials, and there are many patchy colored coatings present. In cross-section there is a darkened plaster or stucco at the bottom of the sample, followed by a thick black layer of burnt plaster, soot and oily materials. There are seven generations of opaque, oil-bound paints on top of the blackened substrate which are mostly variations of yellows. The most recent coating is a thin dull red paint. None of these paints can be dated by composition or context, but the absence of soot between most of the layers suggests that they were applied after the fireplace stopped being used on a regular basis. These paints could all date to the twentieth century.

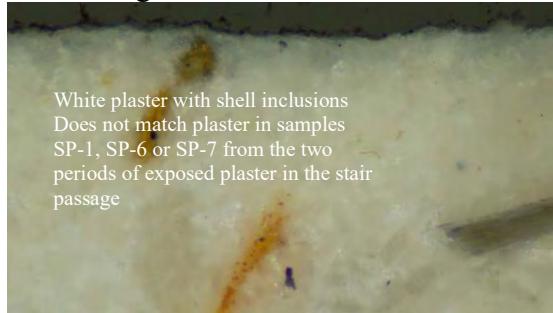
NE-4. East wall, exposed plaster left of closed-up window opening.

White plaster with shell inclusions
Does not match plaster in samples
SP-1, SP-6 or SP-7 from the two
periods of exposed plaster in the stair
passage

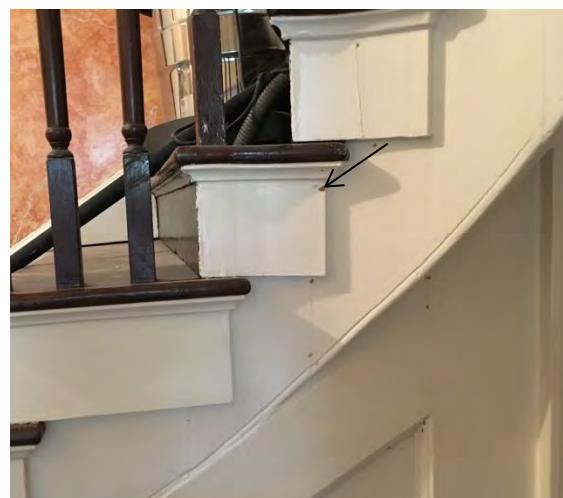
The most intriguing paint evidence was found in sample SP-8 from a curved block below a staircase step. There is less early evidence remaining in SP-4 from a different flat block. The oil-based paints on the curved block are compromised by stripping, but there are still remnants of what seems to be a grain-painting sequence remaining below the post-1941 paints. The graining consists of a dark yellow base coat, a dark red glaze and a darkened varnish. This original decorative treatment became cracked and damaged before it was painted over with a dark brown paint. This second-generation was mostly scraped away and painted over with off-white paint which is likely the 1941 layer. There are eight more generations of paint on this curved block, including a salmon color in generation 6 and bright yellow in generation 7.

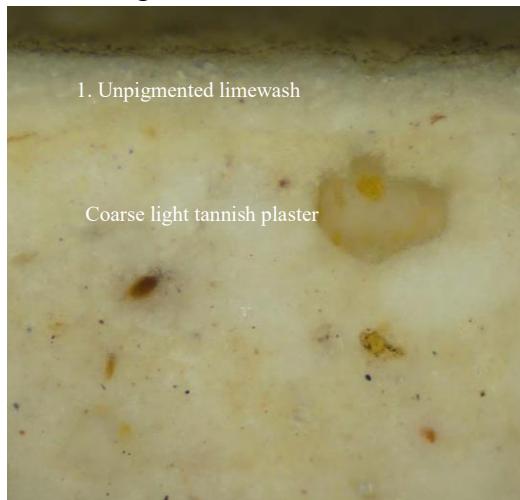
SP-1. North wall, northwest corner, exposed plaster behind wallboard.

Paint Evidence on Stair Passage Plaster. There is intriguing evidence associated with the plasters exposed in the openings on the north wall adjacent to the staircase, and on the underside of the arch. These trapped areas of early plaster yield insights into which surfaces were likely never exposed, and which surfaces received many limewashes and paints. Ed Chappell removed one sample from the underside of the arch and described it as: “Mortar and conceivably plaster on the underside of the brick arch over the door from the first-floor stair passage and the southwest room, 2” from the west face of the arch and 8’8” above the floor. I assume this arch was never exposed, but it seemed prudent to determine whether this white material includes any plaster or is only mortar.”¹ This sample is SP-9 and when it was examined at 45X magnification it was obvious that it is comprised of one tannish, sandy mortar, and there is no finished plaster surface, nor evidence of limewashes. This suggests the underside of the arch was never exposed. By comparison, sample SW-1 from the plaster on the north wall, in the northwest corner, has one layer of unpigmented limewash on top of coarse light tannish plaster. This is from an area believed to have originally been a closet for the northwest room, so it is not surprising that it was only limewashed once before it was trapped when the stair passage was altered. Sample SW-1 is below.

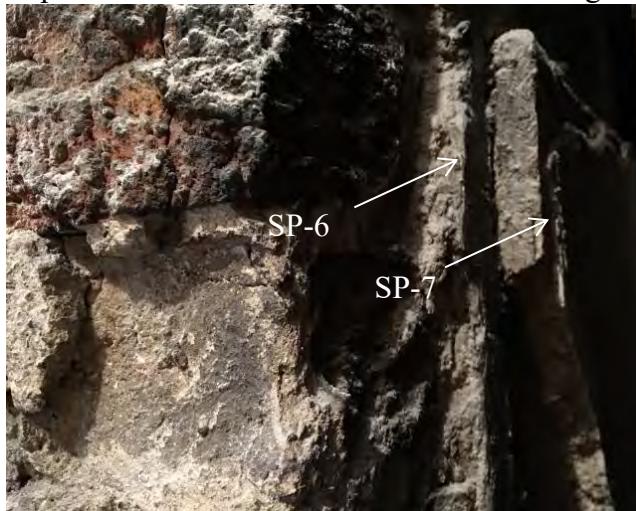
SP-6. North wall, plaster directly on brick face exposed above wainscot in opening.

There are six generations of unpigmented limewash on top of the coarse light tannish plaster substrate in sample SP-6. This suggests this plaster was exposed for a number of years before the second layer of plaster was applied.

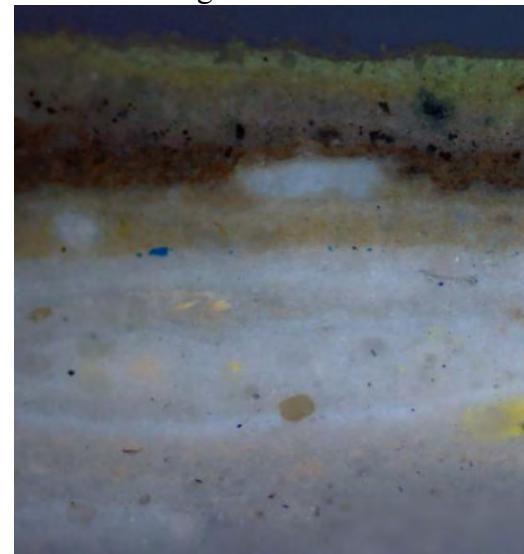
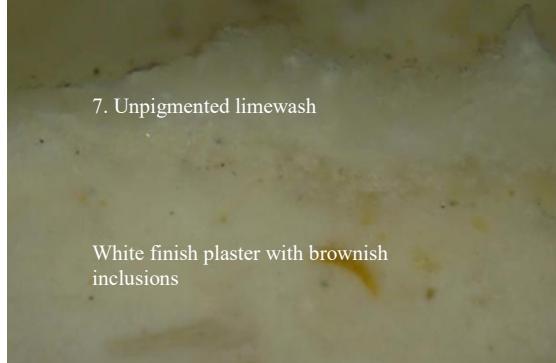
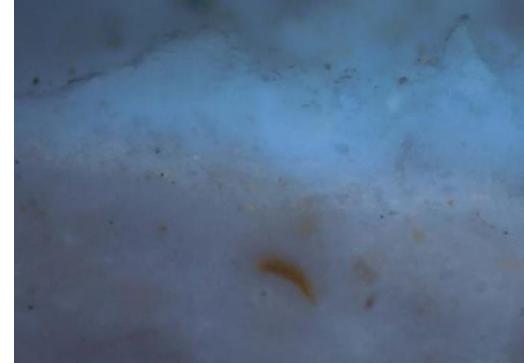
SP-7. North wall, second plaster layer in exposed section.

Staining with biological fluorochrome stains suggests that generations 13 through 15 are traditional distemper paints (bound in dilute hide glue) because of the strong positive reactions with the fluorochrome FITC. Generation 16 must be an oil-bound paint as it reacted strongly positive when DCF, a fluorochrome tag for oils, was applied. Limewashes and distempers were traditional wall paints which were chalky, slightly translucent, and not very durable. Their advantages are that they were inexpensive, easy to apply, and easily painted over.

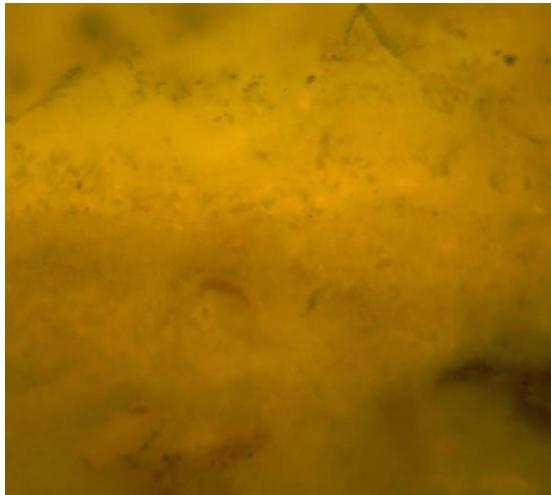
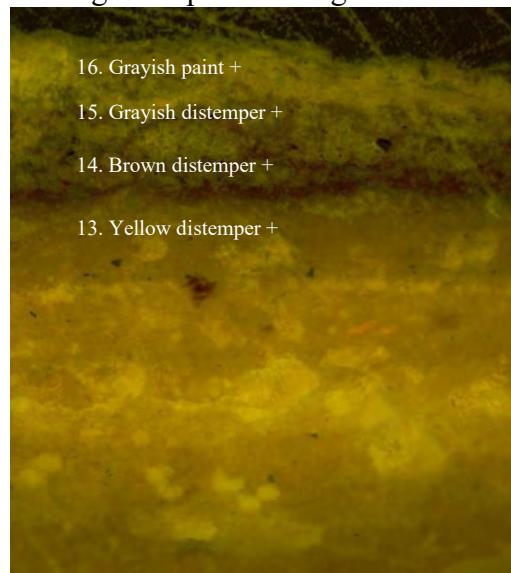
Strong + for proteins in generations 13 - 16

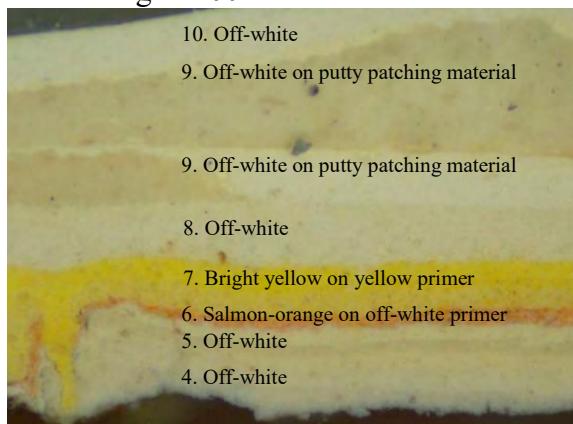
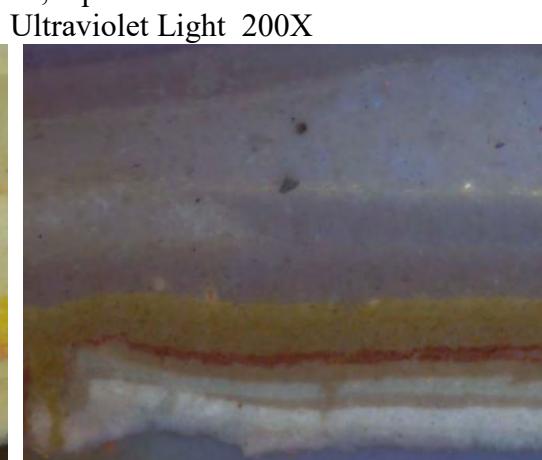
SP-2. North wall, small hinged door under stair, top left corner of left leaf.
Visible Light 200X

The exterior face of the hinged door did not yield any early paint evidence. It clearly had been completely stripped, as shown in sample SP-2. However, the interior surface of this door does retain remnants of early material. Sample SP-5 was taken from protected area of the inside of the door, and while interior door had also been stripped, there are remnant of shellac trapped in the wood (identified based on its characteristic orange autofluorescence in reflected ultraviolet light). There is grit and dirt trapped in the wood as well, so perhaps in the interior of this door was first shellacked, not painted. Then after considerable amounts of grit and soot was trapped on the wood. The door was painted with a dark tan oil-based paint. The paint on top of this dark tan paint is the finely ground, nonfluorescence off-white paint that seems to be the 1941 trim paint in the stair passage.

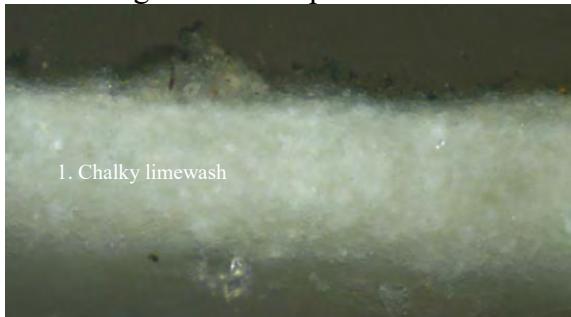
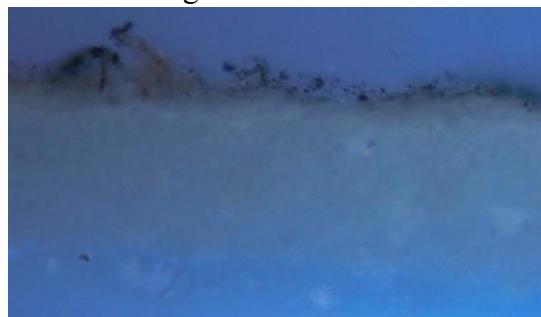
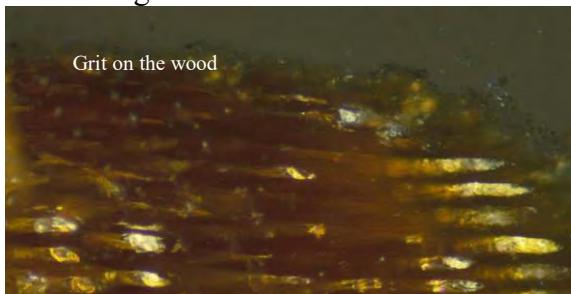
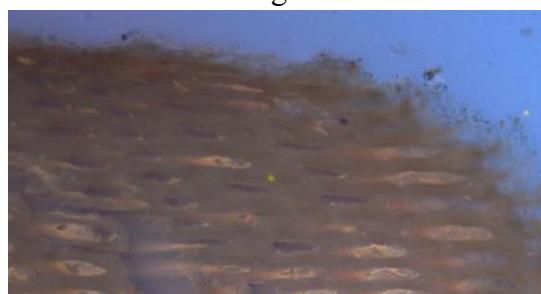
C-1. Central west room, south side, side of exposed joist.

There is only one layer of unpigmented limewash on top of the dirty wood substrate in sample C-1, and in sample C-2 there are two similar layers of unpigmented limewash. There is very little dirt on the surfaces of these limewashes, and they are not notably discolored or damaged. The combined evidence in these two cross-sections indicates that the joists and ceiling (underside of the flooring) were originally left unpainted and the limewashes might not have been applied until later in the nineteenth century. It is more typical to find many, many layers of limewashes on kitchen, cellar, laundry and dairy spaces in the eighteenth and nineteenth centuries as these alkaline limewashes were considered hygienic coatings.
