PAINT INVESTIGATION

Middleton Chair

Object: Middleton Chair
painted wood, c. 1800
2019.002.001

Date: November 30, 2023

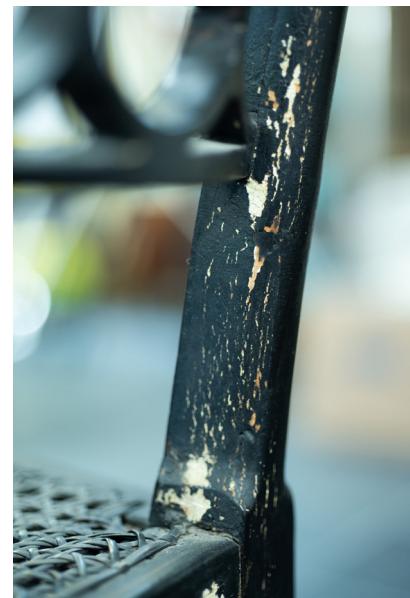
2019.002.01-2, visible light, 200x

Location: Proper right stile, inner side below lowest back splat. Taken from area of existing paint loss that exposes wood substrate with non-original black paint covering nearby losses.

Notable Observations: The early white primer layers are present here, in part. The top surface of the white layer looks uneven, suggesting that it has been abraded. The black paint appears to be two thin layers of Generation 4 and 5.

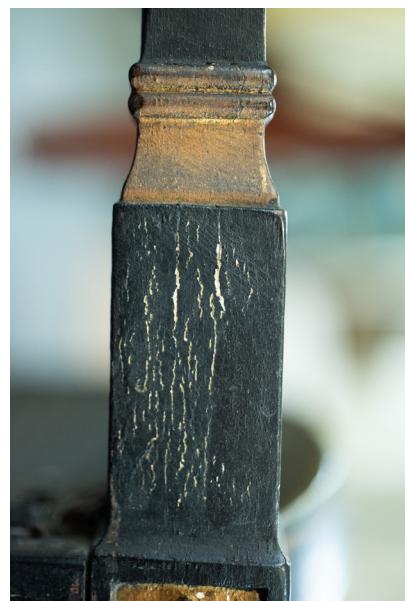
2019.002.01-3, visible light, 200x

Location: Proper right arm, outer face of the block, plain black-painted surface with numerous linear paint losses.

Notable Observations: This area of the arm showed some paint build-up so it was thought that the original scheme may be intact. The early layers are present but compromised. In one part of the sample, the yellow-tan bole survives (no gilding), and in another part of the sample, Generation 1 is abraded and incomplete.

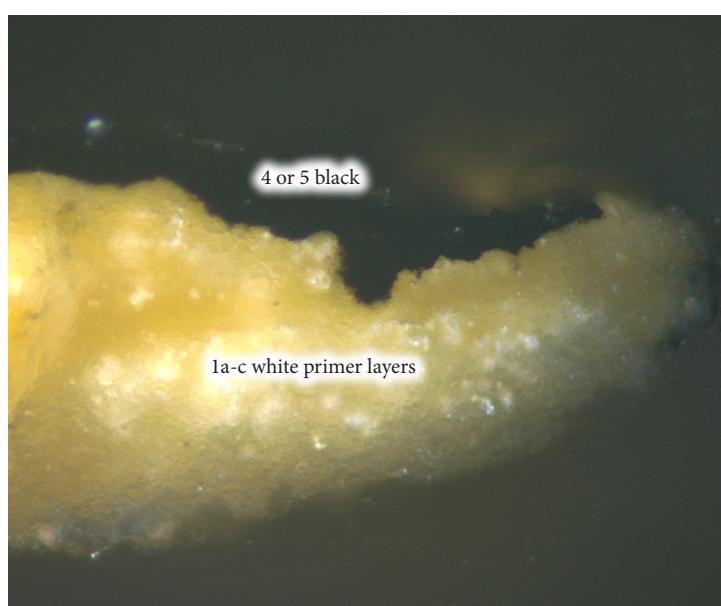
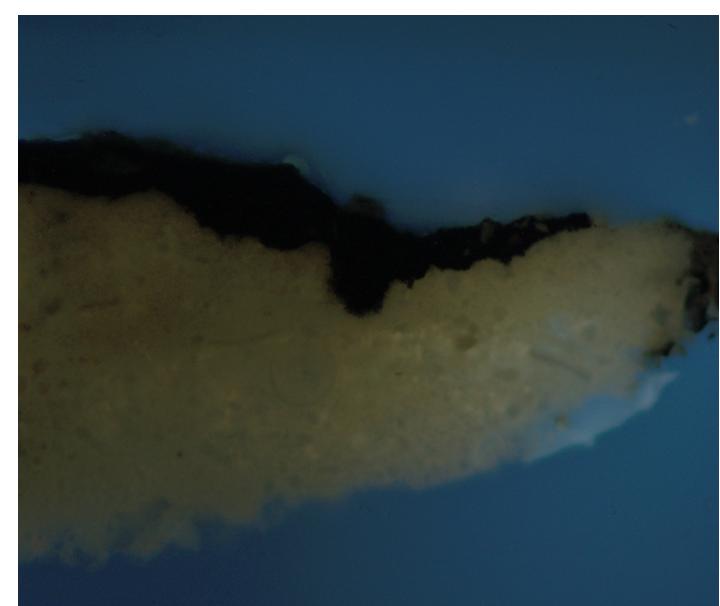
Sample # 2019.002.001-4

Location: Front proper left leg, front-facing rosette. Taken from existing loss in the gold-painted field (background).

The white paint in this sample is not fully understood. It is likely that the white paint is part of the original paint scheme, such as white-painted background or highlights. The paint evidence does point in this direction: there is no dirt accumulation or signs of age between the white primer and the white paint. Or, it could be part of a repainting campaign (Generation 2). Further sampling or reveals could inform on this.

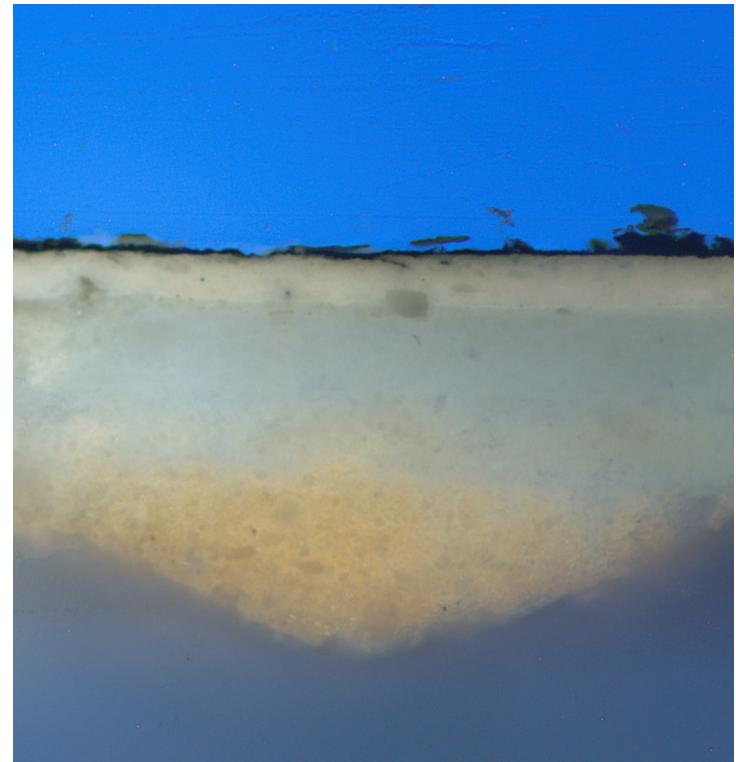
Sample # 2019.002.001-5

Location: Lower back slat, top surface of lowest rail (in the triangular-shaped space between the 1st and 2nd ring from the proper right)

Notable Observations: The early white primer layers are present here, though the original scheme does not survive on the front of the ringed slat. The black paint appears to be two thin layers of Generation 3 and 4. This sample also contains a thin layer of shellac, as indicated by its orangish autofluorescence in UV light.
