## **Part II – Stable**

### **Background:**

The paints on the interior of the stable were not studied as part of the Phase I dissertation research, so all the sample locations were selected based on discussions with Graham and Ridout, who had specific questions about how the building interior had been altered. Representative elements (woodwork, plaster, doors) in each room were sampled to document and compare their paint stratigraphies.

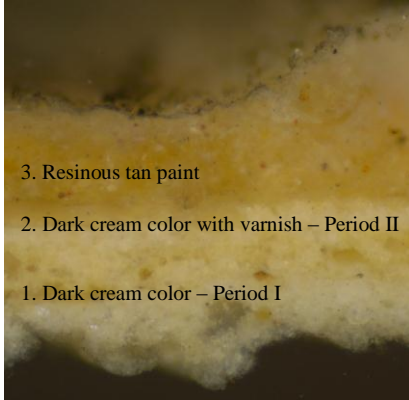
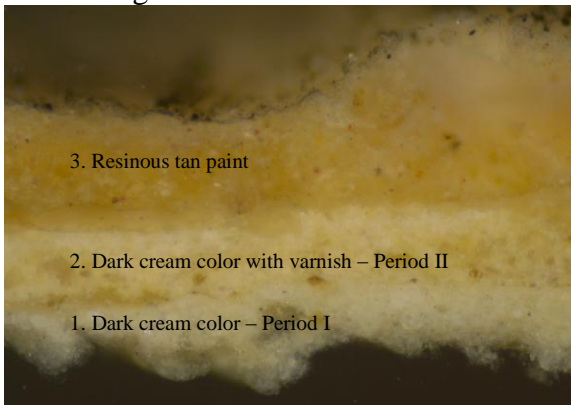
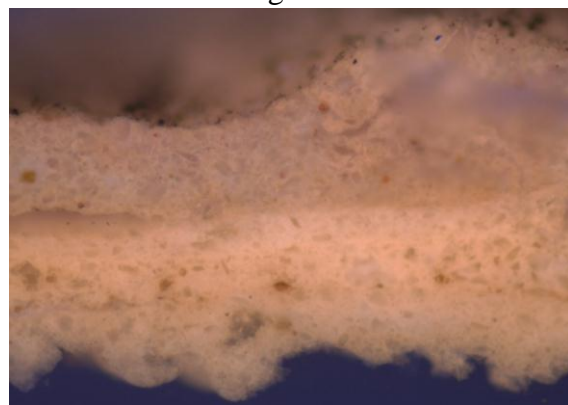
Sample S101-1. Original window, south wall, east window (Period I) left side of frame, about 4' up, to establish woodwork paint chronology for original elements.

The samples taken from the interior of the original window show that (remarkably) the frame was only painted three times and the sash was only painted five times. The first generation on the frame (S101-1) is a dark cream-colored, oil-bound paint, while fragments of original paint on the sash (S101-2) suggest it was lighter cream color. There is no evidence to indicate the windows were originally left unpainted as the wood substrates are clean and unweathered. The second generation on the frame is a dark cream-colored paint with a plant resin varnish coating, while the sash was painted gray-blue. This could be the Period II palette. The third generation in both samples is a dark tan, resinous paint which is now darkened and degraded. The sash was then repainted with two generations of finely ground off-white and white paints which are likely twentieth-century coatings.

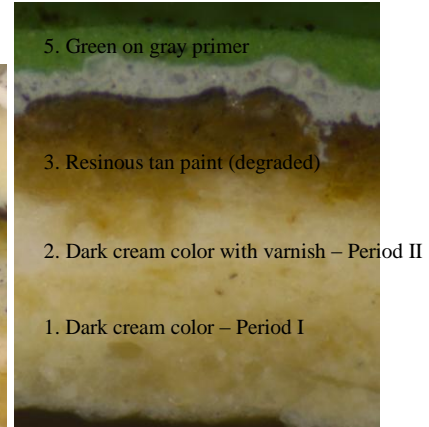
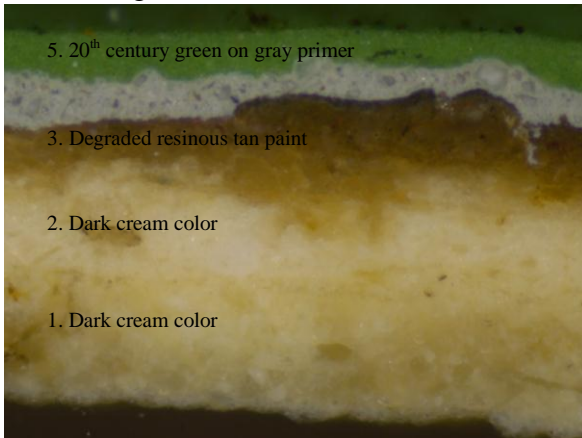
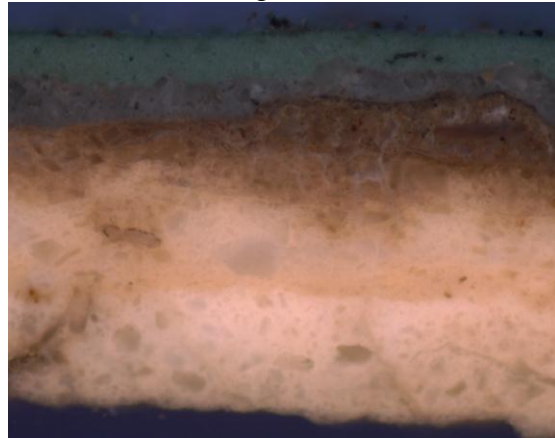
Sample S101-3. Original window, south wall, east window (Period I) original exterior window frame paint, left side.

One sample was also taken from the exterior frame of the same window (S101-3) and the comparative evidence suggests that the exterior of the window was painted in the same manner as the interior window frame in generations 1 through 3. The most recent paint on the exterior window frame is a finely ground green finish coat on a gray primer which appears in the fourth generation (see the comparison of all three samples below).

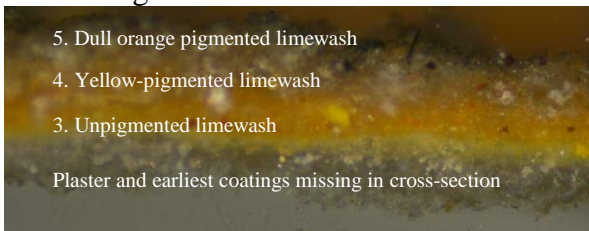
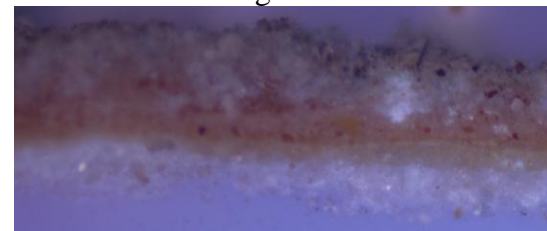
Sample S101-6. West wall ceiling plaster at north side of upper ceiling.

One sample from the Period II painted ceiling shows that it was initially limewashed, followed by a yellow-pigmented wash and then another unpigmented limewash. The fourth generation is also a yellow-pigmented limewash, followed by the most recent dull orange-pigmented limewash. This sequence of coatings is very similar to the accumulation of pigmented and unpigmented limewashes found on the ceiling in the stable (S104-10), suggesting these two ceilings are contemporary and date to Period II. Photomicrographs of the uncast sample and the cross-section show this accumulation of chalky coatings.

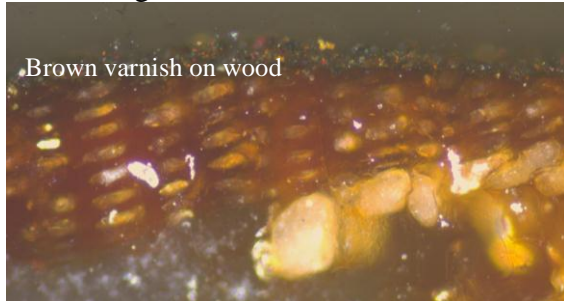
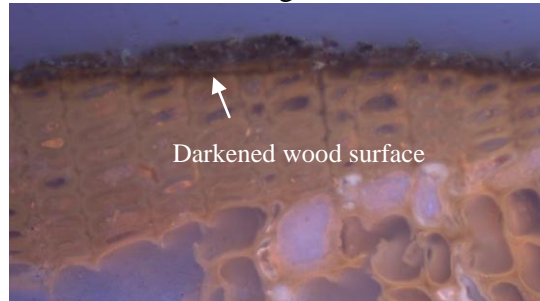
Sample S202-1. Stair riser, just below top step.

One sample (S102-1) taken from a protected area of a stair riser suggests this element was originally left unpainted as the surface of the wood substrate is darkened and grimy. This is followed by a brown-pigmented resinous varnish layer which is the current dark brown coating on all the staircase elements. This brown varnish could be Period III (1858) or before, but it is difficult to provide a solid date with this limited evidence.

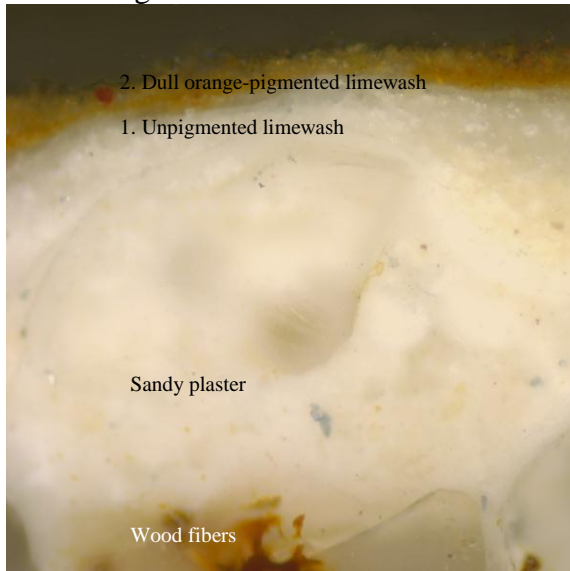
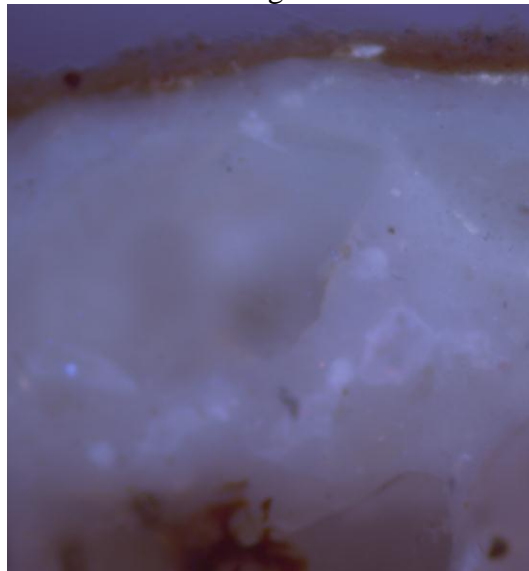
Sample S202-2. South side of stair, painted board along staircase, above lower bead molding, above stair landing.

The lower edge of the wide board that runs east-west along the south side of the stair was also sampled (S202-2) to see if any early coatings remain. When this sample was analyzed in cross-section it became apparent that there is an overlap of sandy white plaster and limewashes from the adjacent wall on top of the wood. The substrate in this sample consists of wood fibers followed by an uneven layer of white plaster. This is followed by one layer of unpigmented limewash, then the current dull orange-pigmented limewash. When this area was rechecked on-site with a 30X microscope it was found that this board retains early unpigmented limewashes along its protected edges. This evidence, in combination with the ceiling paint evidence in sample S202-2, suggests that when the stair passage was completed in Period II it was simply limewashed white with unpainted woodwork. Then, perhaps before or during Period III, the woodwork was varnished brown and the walls and ceiling were coated with the current dull orange-pigmented wash.

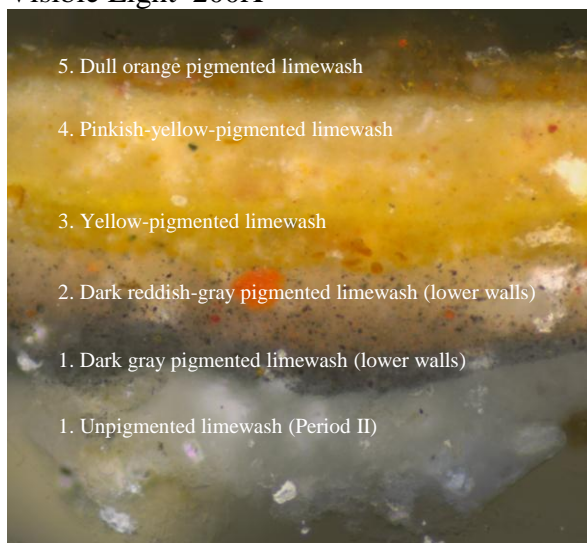
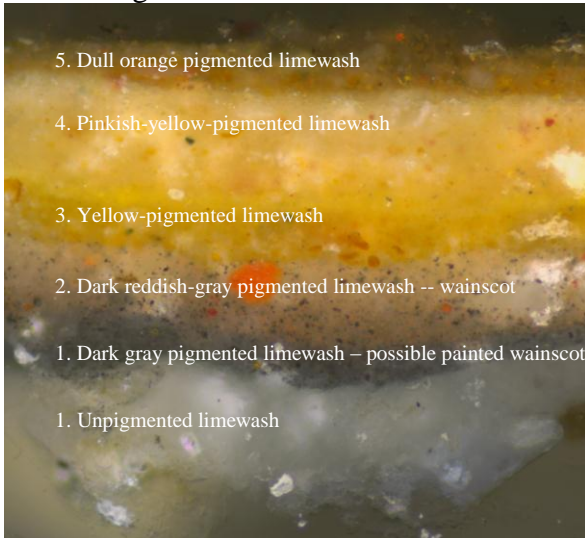
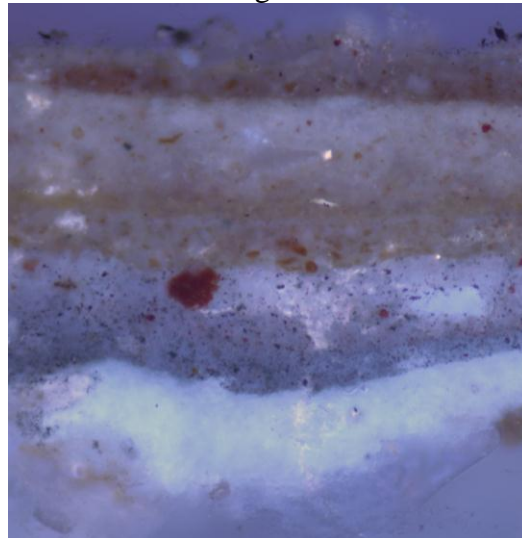
Sample S103-1. East wall, crude board wall about 5' up.

The comparative evidence suggests that the Period II wide board wall for the stair enclosure on the east side of the room was painted in the same manner as the plaster walls in room S104. The coatings in sample S103-1 from this wall begin with an unpigmented limewash. This is followed by a dark gray pigmented limewash which may have been used to create a painted wainscot like those found in the passages and some of the chambers in the kitchen/laundry building. This dark gray limewash seems to be the original treatment for this lower board wall. The second generation is a reddish-gray limewash that was also found in S104 on the lower walls. This is followed by a yellow-pigmented limewash that was also found in the stable space S104 as the third generation on the walls. The fourth generation is a pinkish-yellow limewash and the fifth generation is the most recent dull orange-pigmented limewash. It is not possible to determine exactly when the dark gray-painted wainscot was applied, but the limewash below it is clean and unweathered, so this gray wainscot could have been created soon after 1835-6.

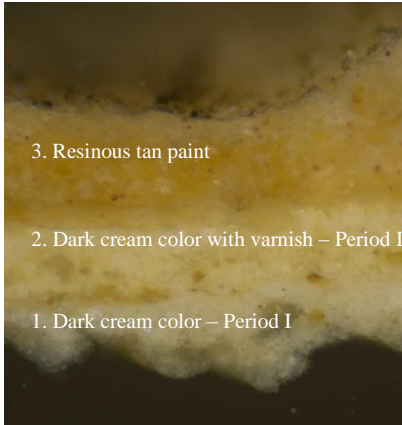
Sample S101-1.  
Period I window on S. wall

The paint history on the stile for the door opening in the northeast corner (S103-4) retains a degraded sequence of paints that seems to match up with the Period I window and the north-facing beadboard, suggesting it is a Period I element. A comparison of the paints in samples S101-1, S103-3 and S103-4 follows.

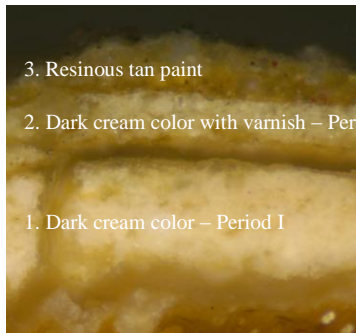
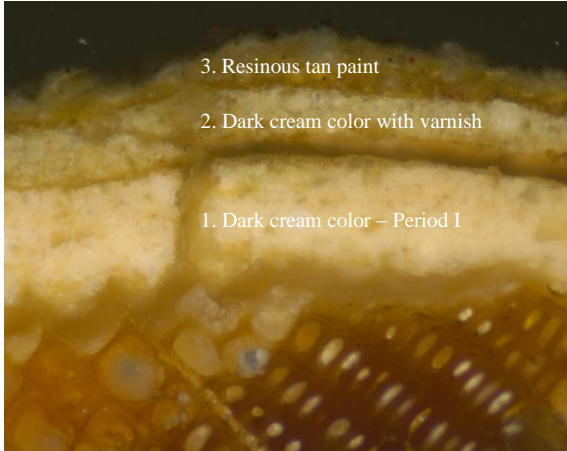
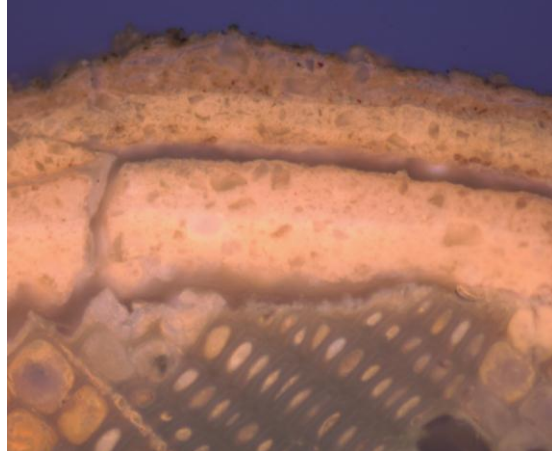
Sample S103-3. East wall, north side of enclosure for stair, finer beaded board on top of rougher board, later installation?

One sample was taken from the higher quality north-facing board wall of the staircase enclosure (S103-3) to see how its paint history compares to S103-1 from the cruder board wall. Graham wondered whether this north side of the staircase enclosure might be a later installation. The paints in S103-3 are very, very similar to the three generations of coatings found on the Period I window frame in the carriage bay (S101-1). In fact, they are similar enough to suggest that this section of board wall is an earlier element from

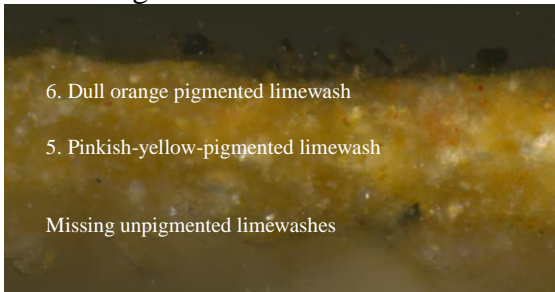
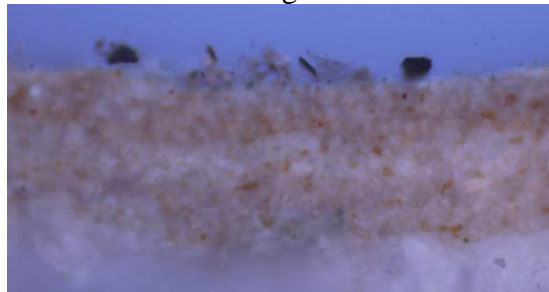
Sample S103-5. North wall, northwest corner, framing member for dividing wall, right side of narrow section of board wall, east face, about 5' up (initially just whitewashed).

The framing element for the narrow board wall (S103-5) in the northwest corner was first limewashed white, followed by two pigmented limewashes that can be aligned with the pinkish-yellow limewash and the dull orange-pigmented limewash coating found as generations 4 and 5, respectively, on the wide board wall at the east side of the room. These elements seem to have both been installed in Period II. A comparison of the pigmented limewashes is shown below.

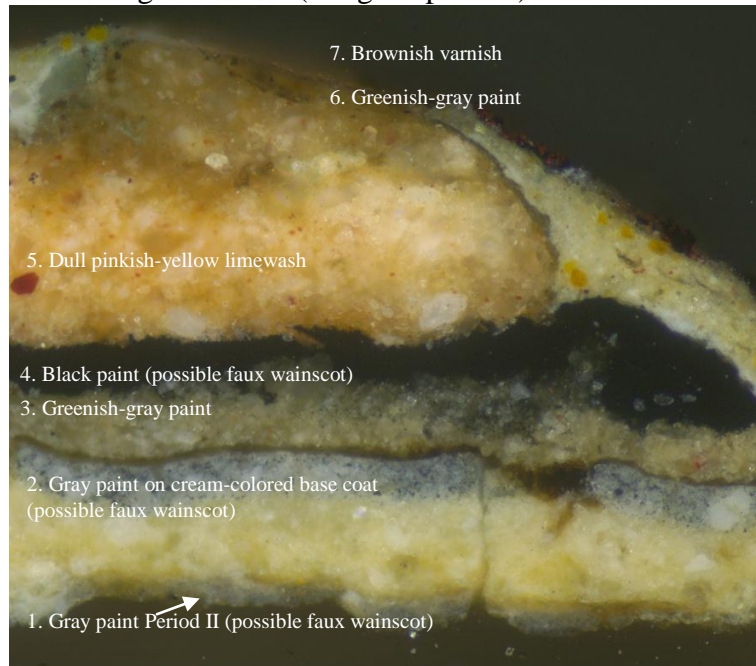
The most complex paint stratigraphy on the woodwork was found in sample S104-3 from an original column. Graham hoped that the paints on this Period II column could be used as a reference sample for the paints on the other areas of woodwork. There are seven generations of paint on the column, beginning with a medium gray paint directly on top of the wood. The coating stratigraphy is shown in the chart below. The sample from the column is the only one in which a gray paint also appears in generation 2 and a black paint appears in generation 4, so perhaps this column was painted with gray and black up to about the top of wainscot level during these times, possibly to match the painted plaster. Comparison of the woodwork paints suggests that with the exception of the long stall divider board and the original Period column, all the other elements sampled date to after Period II.

Sample S104-3. Original Period II column, first column from the south end, west face, about 4' up.

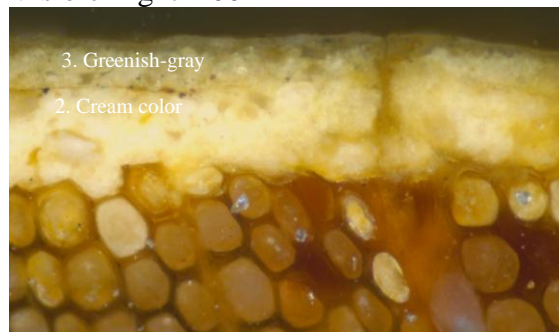
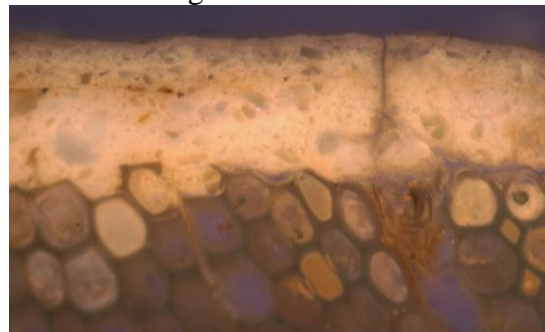
Sample S104-1. Small detached board from underside of stall arch – Period II element.

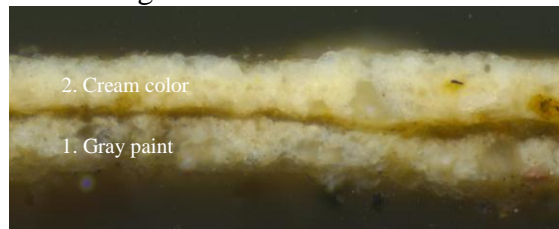
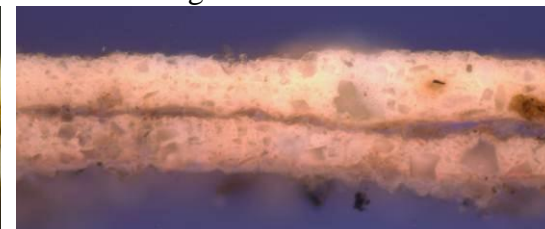
Sample S104-2. Detached long board used to divide stalls.

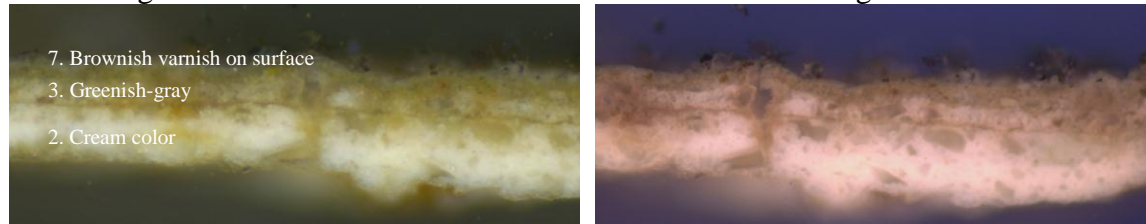
Sample S104-4. North end, stair enclosure, board door, right stile, about 4 ½' up.  
Visible Light 200X Ultraviolet Light 200X

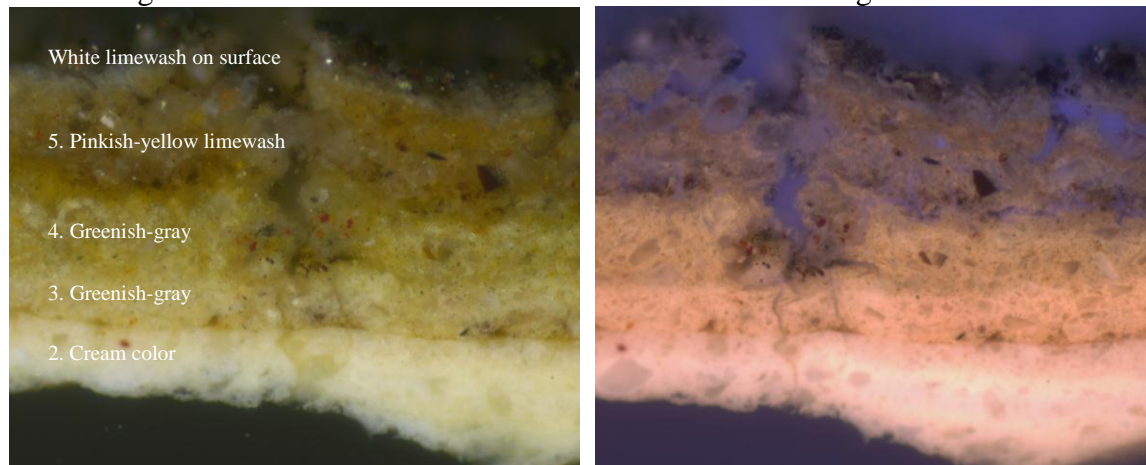
Sample S104-5. North end, stair enclosure, left side of door frame, about 4 ½' up.  
Visible Light 200X Ultraviolet Light 200X

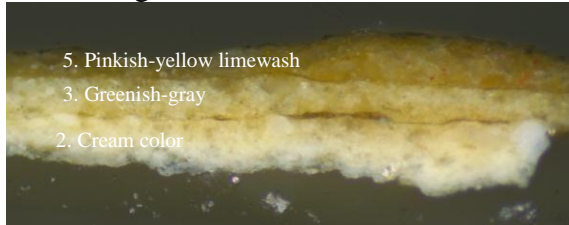
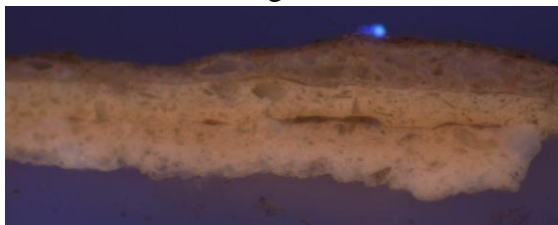
Sample S104-6. North end, west side of board wall, along stair.

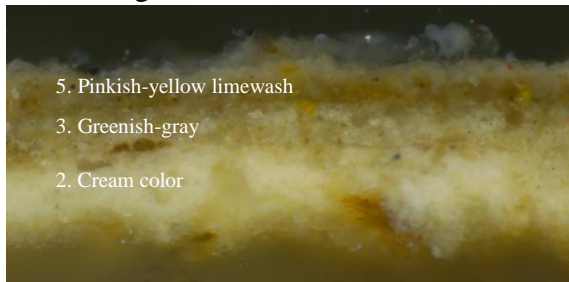
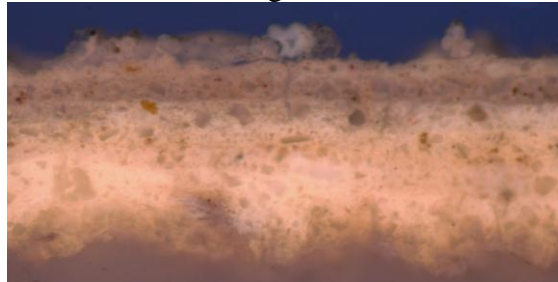
Sample S104-9. West wall, painted panel above second arch from the south (washes flake away).

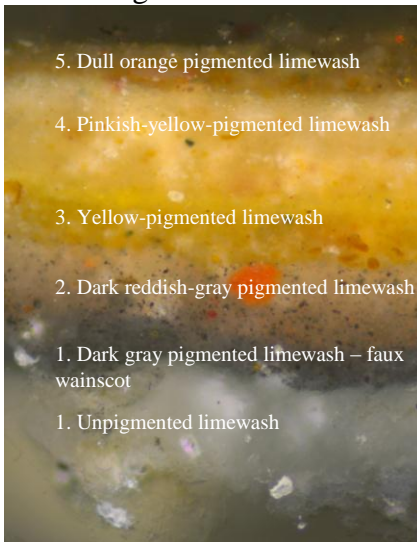
Sample S103-1. Crude board wall  
Visible Light 200X

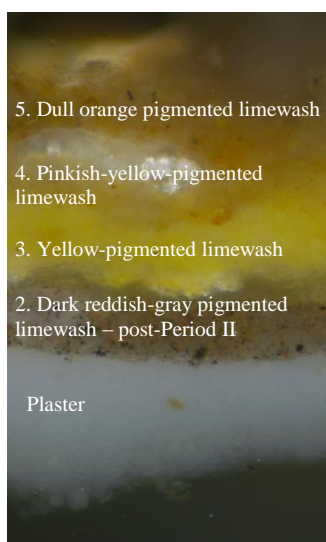
S104 Plaster. When the walls in this Period II space were examined on-site, it became clear that the lower portions of the walls were once painted with a darker color than the upper parts. But the limewashes are now so degraded and worn on the lower portions of the walls it was difficult to determine by eye how often this practice of painting a faux wainscot was employed. The samples taken from below (S104-7) and above (S104-8) wainscot level help to confirm that there was originally a faux reddish-gray wainscot on the walls which lines up with generation 2 in S103 from the former tack room (see sample S103-1 below). The coatings on the ceiling (S104-10) are virtually identical to the coatings found on the upper walls, suggesting they were always repainted in the same manner.

S104-7.  
W. wall wainscot

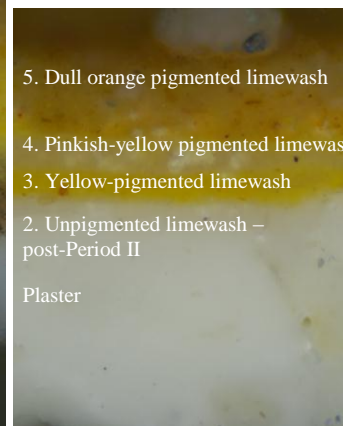
S104-8  
W. wall above wainscot

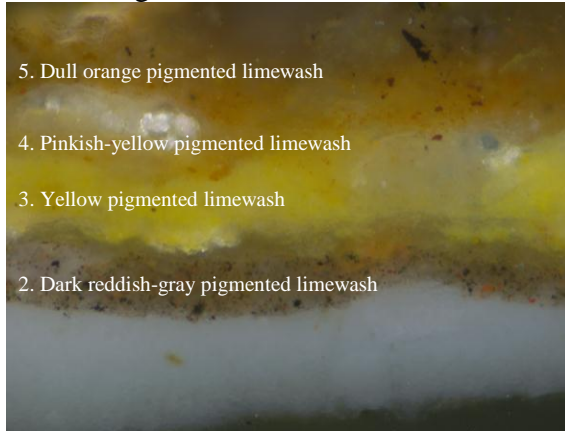
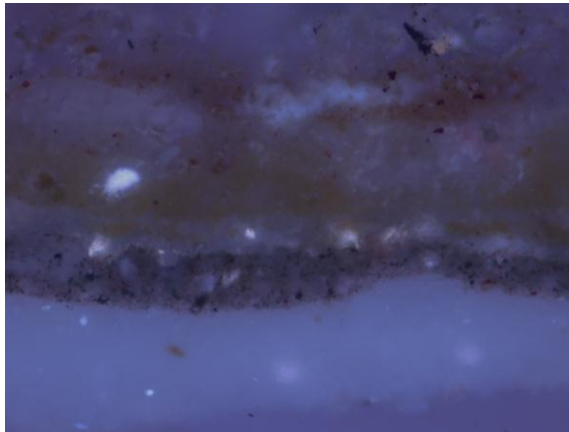
Sample S104-7. West wall, stall third from the north, on gray-painted wainscot.

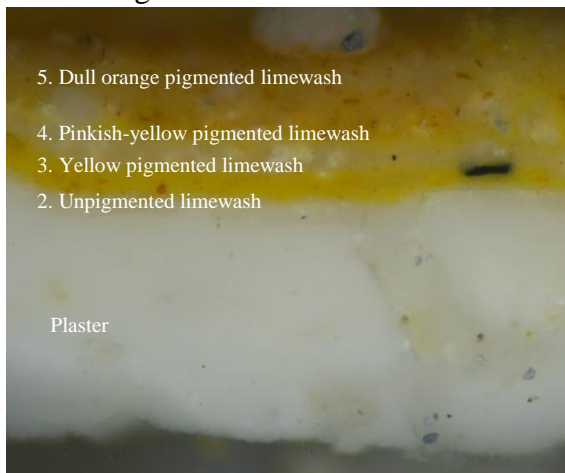
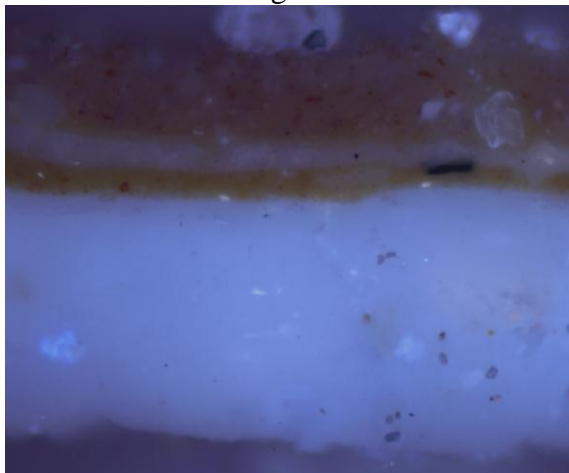
Sample S104-8. West wall, stall third from the north, on the yellow-painted wall above the gray wainscot.

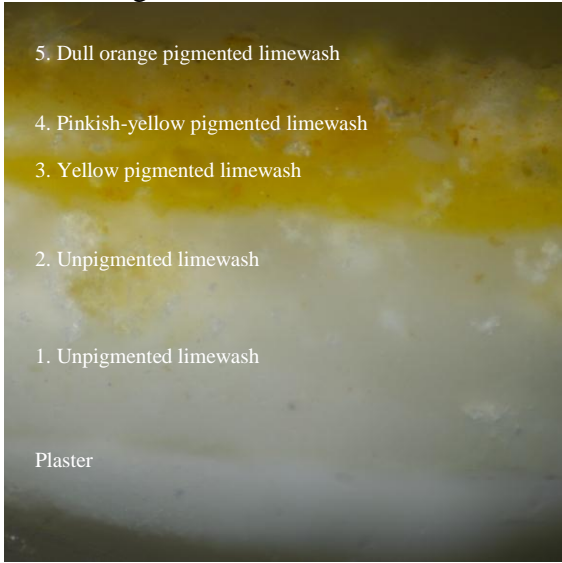
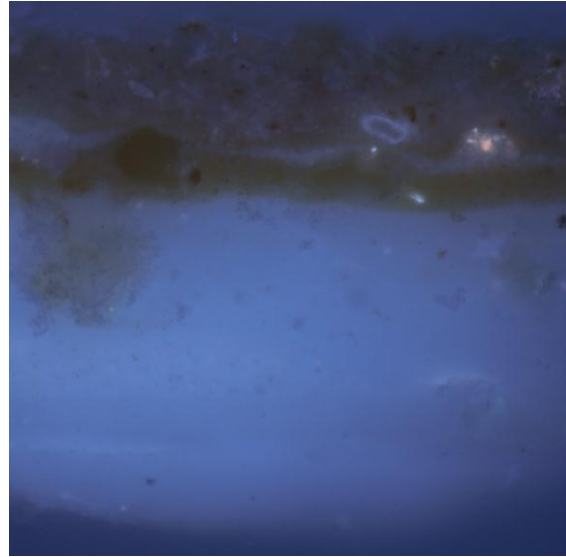
Sample S104-10. Ceiling near west wall, above second arch from the south.

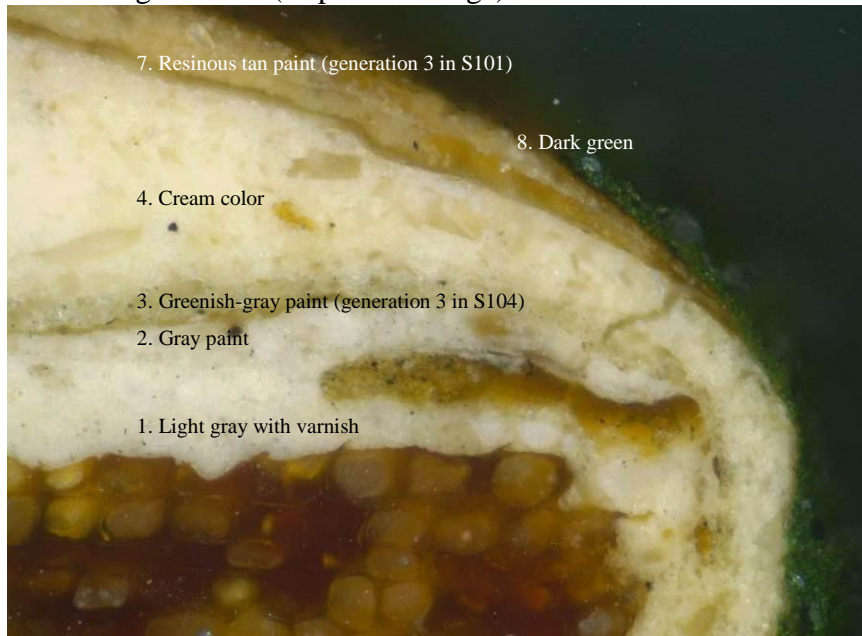
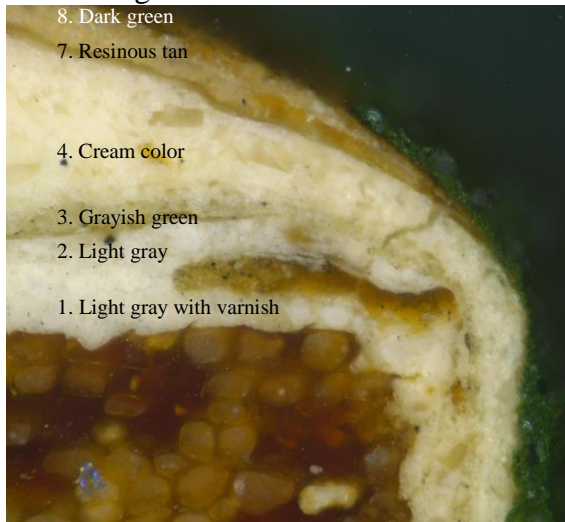
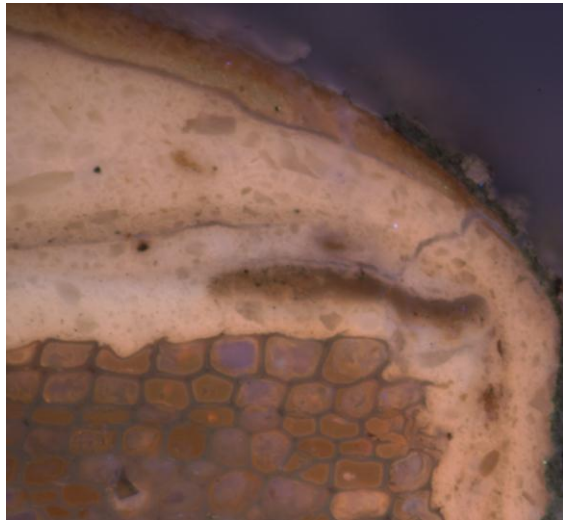
S201 Window. Three samples were taken from different elements of the Period I window W202 on the south wall to identify the complete paint sequence and to hopefully help determine when the closet and mantel were installed in this room. The most complete cross-section is S201-8 from the rail below the transom window and it contains eight generations of paint. The original paint on the architrave and window frame is a light gray layer. A varnish coating was found on this light gray on the rail and the architrave (S201-10). This is followed by another light gray paint in generation 2 and a then a greenish-gray paint in the third generation, which seems to be the same as the greenish-gray paint found in the same position on the woodwork in S104. Generations 4 through 6 are cream-colored paints, and generation 5 is notable because it contains zinc white, dating it to after 1845. Generation 7 is a resinous tan paint (like the third paint generation on the window in S101), followed by the most recent dark green paint. Generations 5 and 6 are missing in sample S201-8, but are present in S201-9 and S201-10 (see below). The paint history in S201-9 from a window architrave begins at the second generation light gray, but the other sample S201-10 begins at the first light gray.

Sample S201-8. South wall, east window, rail below transom window, left side above bead molding.

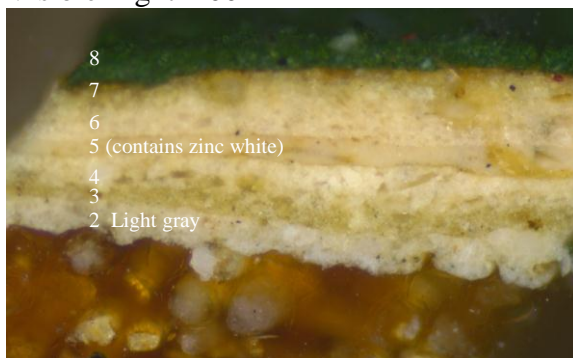
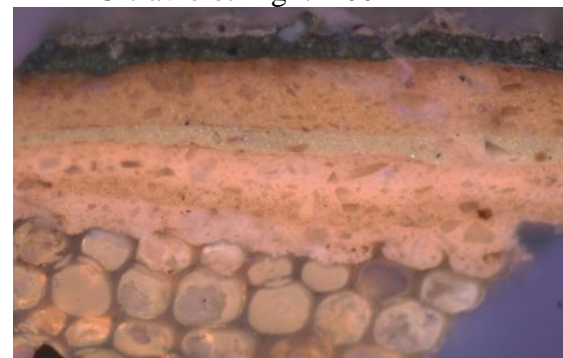
Sample S201-9. South wall, east window, architrave left side above bead molding.

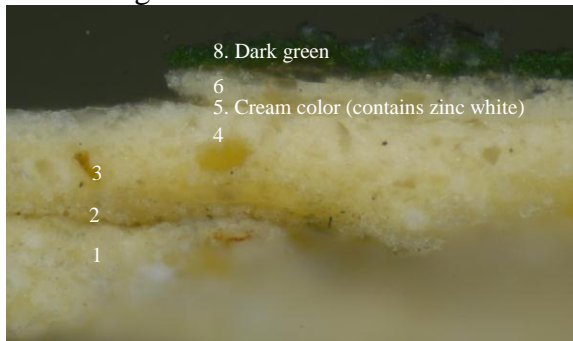
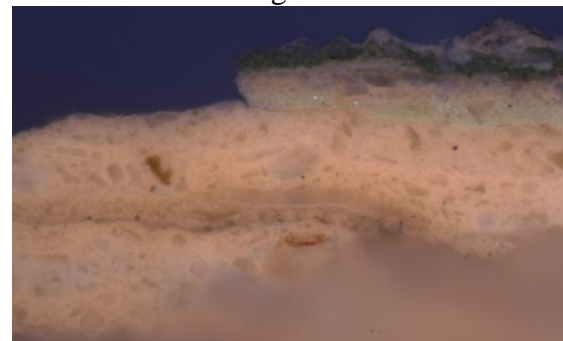
Sample S201-10. South wall, east window, window architrave, left side, at inside edge, about 4' up.

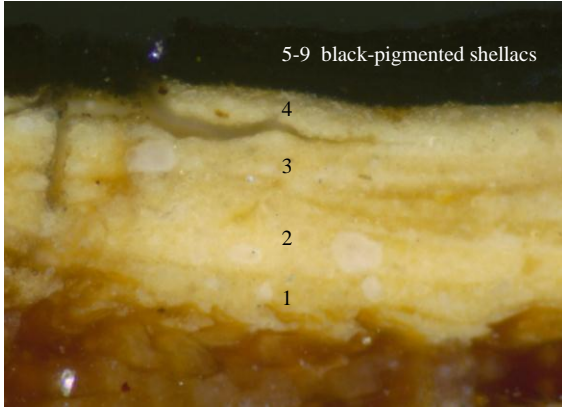
When the paints in the sample from the mantel (S201-7) are compared to the Period I sequence shown below, it appears that the mantel retains the same four generations of early cream-colored paints. Then it was recoated with approximately four generations of black-pigmented shellac. So, it is likely the mantel was moved from the house in Period II and recoated with a glossy black shellac when it was installed in S201. However, the strong similarities between the coating generations on the original woodwork in the first, second and third floors of the house make it difficult to determine where this mantel came from.

Sample S201-7. Architrave for fireplace, Period I woodwork from main house, at fluting along bottom edge.

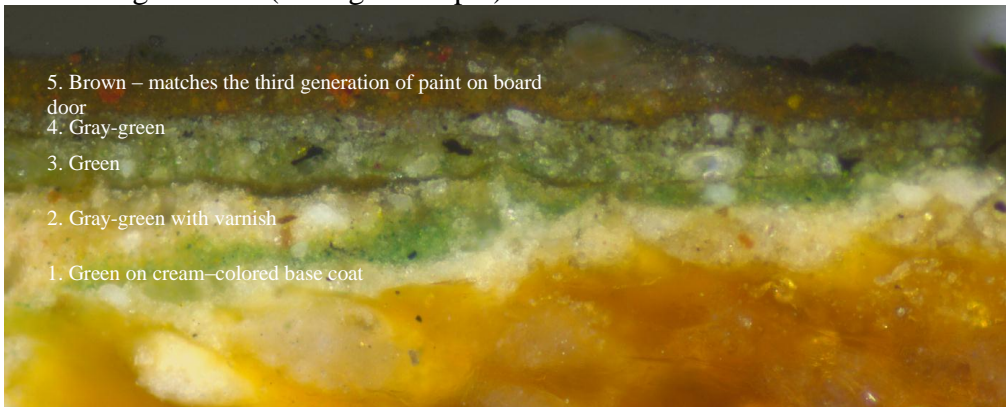
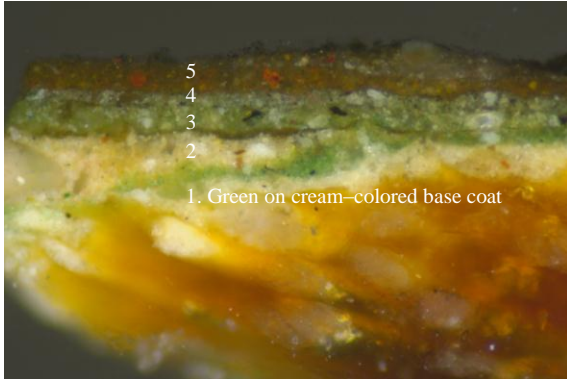
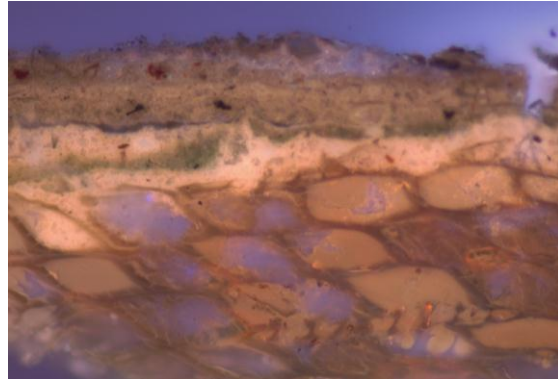
Sample S201-3. West wall, Period I louvered door moved from house, half-round molding, right side of louvers (early bright green paint present).

S201 Louvered Door. There are five generations of paint on the louvered door, beginning with a bright green paint on a cream-colored base coat. This green paint contains chrome green (a synthesized mixture of Prussian blue and chrome yellow), a pigment not in wide use commercially until about 1825. The presence of chrome green suggests this louvered door may date to Period II. Generations 1 through 4 are all variations of green paint, likely applied while the door was still in its original location. The first paint on the louvered door that can be matched with woodwork in this room is the uppermost brown paint which is the same as the third generation paint on the board door. Thus, the evidence suggests that the louvered door could have been moved to this room after Period II. The greens on this louvered door do not match any of the exterior shutter paints examined as part of research on the exterior paints, as all the early shutter paints are thickly applied, coarsely ground, verdigris-based green paints. The paint sequence on the louvered door does not help to place it in any particular location in the Period I or II forms of the house.

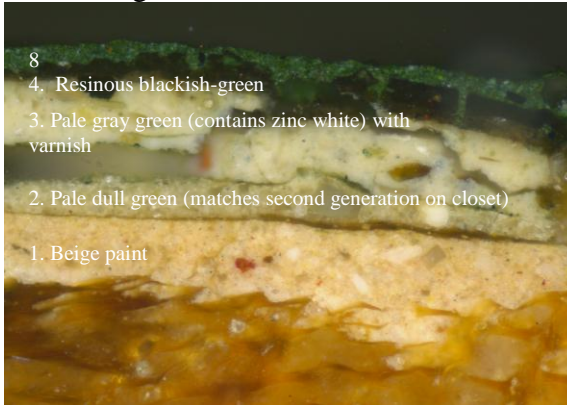
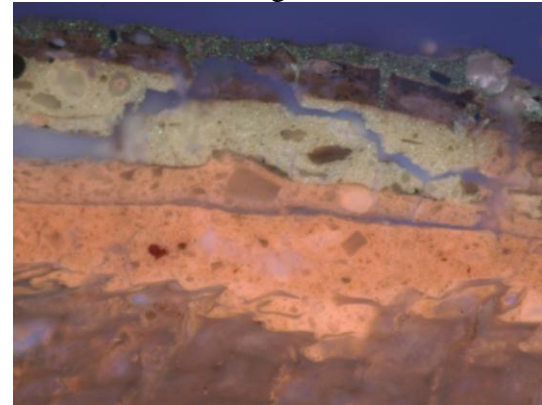
Sample S201-11. North wall pegrail, lower edge at join with door architrave.

S201 North wall Pegrail. The paint history on the north wall pegrail is perplexing because it cannot be aligned with most of the coatings found in this room, nor can it be aligned with other paint sequences in this building. The exceptions are the second-generation dull green, which was also found on the closet (S201-4), and the most recent dark green. The pegrail was first painted with a thick layer of beige paint, followed by a pale dull green paint. The third generation is a thick layer of pale gray-green which contains zinc white, dating it to after 1845. The fourth generation is thick, cracked, resinous blackish-green paint. The dark green found on the Period I window as generation 8 is the most recent green paint in cross-section S201-11.

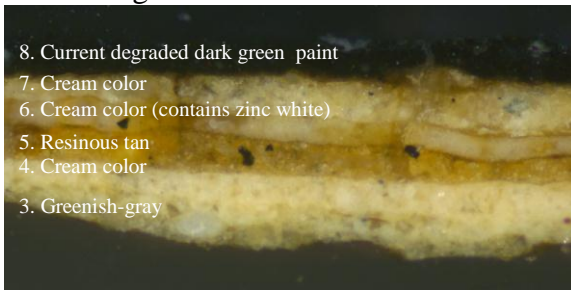
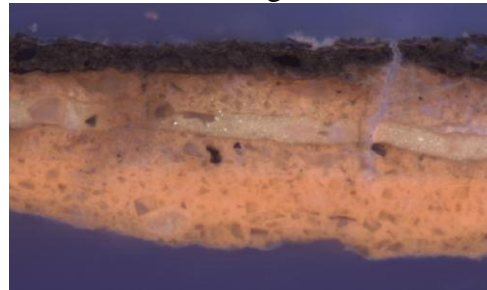
Sample S201-12. North wall door frame, above angled join on door frame that might have been intended for transom window.

S201 North Wall Door Frame and Door. The paint histories on two areas of the door frame were compared to see if there are differences between the area above the angled join on the door frame, which Graham thought may have been made to accommodate a transom, and the area just below the angled join. The two samples have quite different paint histories. Sample S201-12 from above the join contains seven generations of paint, with the first layer being the greenish-gray paint found as the third generation on the Period I window (samples S201-9 and S201-10). In sample S201-12 from above the join, the cream-colored paint with zinc white appears one generation later than on the Period I window, suggesting that the windows were not repainted with the resinous tan paint observed as generation 5 in sample S201-12 (see below).

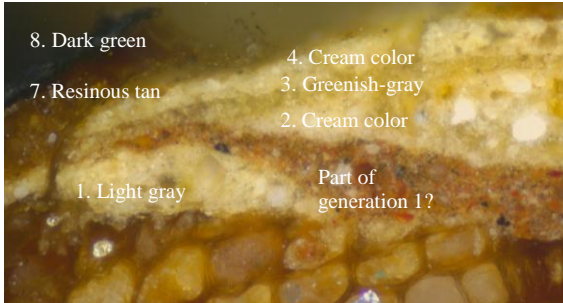
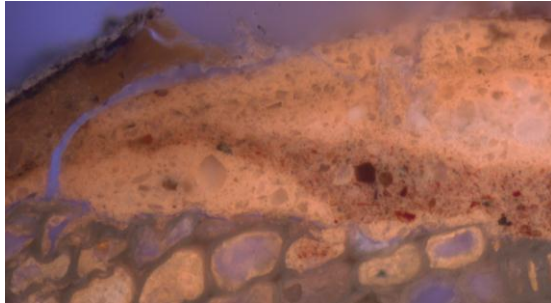
Sample S201-13. North wall door frame, below angled join on door frame that might have been intended for transom window.

When the paints on the architrave below the angled join are compared to those above, it appears that the full chronology of paints, beginning with the generation 1 light gray, remains below the join (sample S201-13). There is also a brown paint in this cross-section above the gray that does not appear elsewhere in the room; it is possible that this is a later paint that seeped into a crack in the earlier paints, based on the disruption in the left-hand side of the cross-section. The presence of the Period I light gray below the angled join suggests that this door frame could date to Period I and the alteration at the top was made perhaps in Period II.

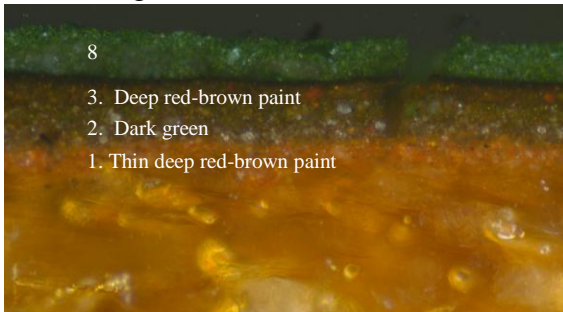
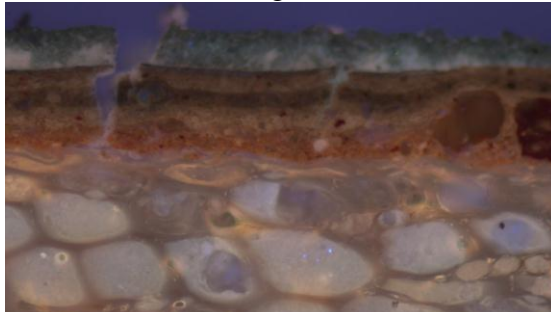
Sample S201-14. North wall board door.

The paints in the cross-section from the interior surface of the board door do not match any of the other elements in the room in the initial two of four paint generations. The first generation is a thin deep red-brown paint, followed by a dark green paint, then a deep red-brown. Generations 2 and 3 on this door resemble generations 2 and 3 found on the Period II board door leading from room K102 into K101 (see the comparison below). The third generation on the north wall board door is the same red-brown paint found as the eleventh generation paint in room K102. This suggests the door may not have been installed in this room until the deep red-brown paint in generation 3 was applied, as that paint matches generation 5 on the louvered door from the house.

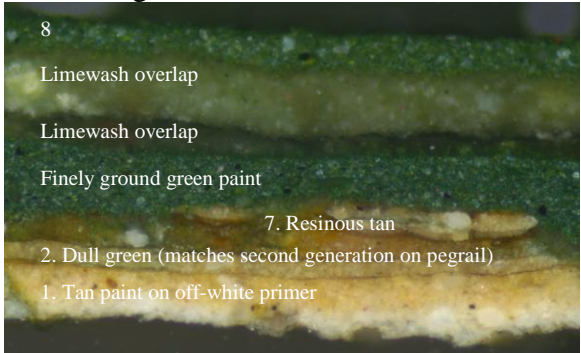
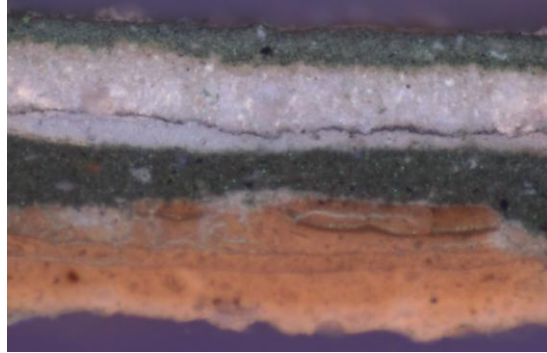
Sample S201-4. West wall, closet surround, right side, below ghost for mantel shelf.  
Visible Light 200X

S201 West Wall Closet Woodwork. The paint sequence on the closet woodwork is problematic because it is disturbed, and it cannot be clearly matched with the early coatings on most of the woodwork. The first generation is a tan paint on top of a white primer which was not found elsewhere in the room. The second generation is a dull green paint which matches the second generation on the pegrail (sample S201-11), and this is followed by a resinous tan layer that was found as the seventh generation on the Period I window. The most recent green paints are finely ground and evenly mixed, consistent with twentieth-century coatings.

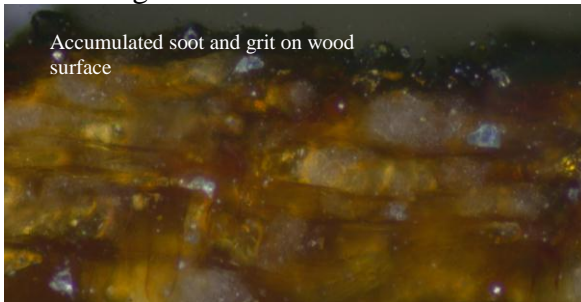
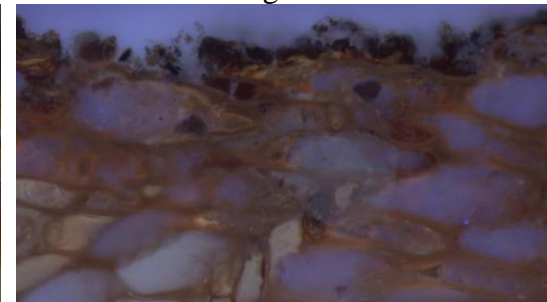
Sample S201-5. West wall, closet surround, right side, on ghost for mantel shelf (is there paint on this area of the shelf?).

The cross-section from the blackish “ghost” for the edge of the mantel shelf consists only of a thick layer of soot and grit on the surface of the wood. This suggests the closet enclosure was not painted until after the mantel was installed.

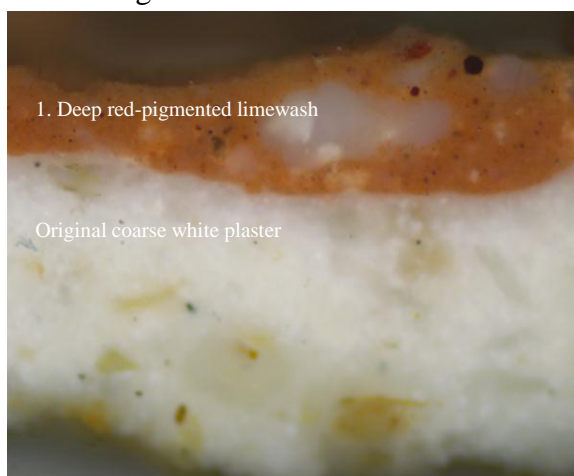
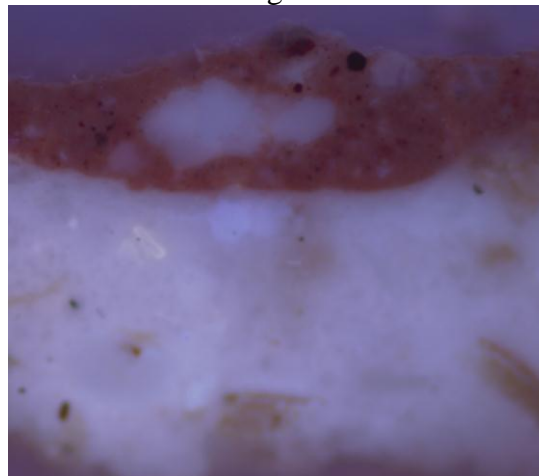
Sample S201-1. South wall, east of east window, Period I deep red wash on coarse plaster.

The walls in S201 are patchy and uneven, with at least several campaigns of replastering for repairs. The first paint on top of the earliest plaster is the deep red that is most obvious near window W202 on the south wall. Sample 201-1 is the best example of this thickly applied red-pigmented limewash on top of a white coat of plaster that contains sand and tan fibers. This same red was found as the original paint on the plaster in room S203 (sample S203-1). The evidence suggests that the original palette of this room consisted of cream-colored woodwork and deep red-pigmented limewash, although the cross-section evidence cannot show exactly when this room was first painted and plastered.

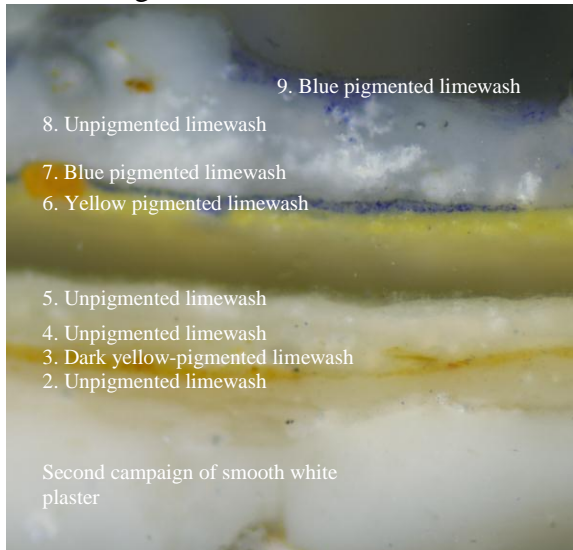
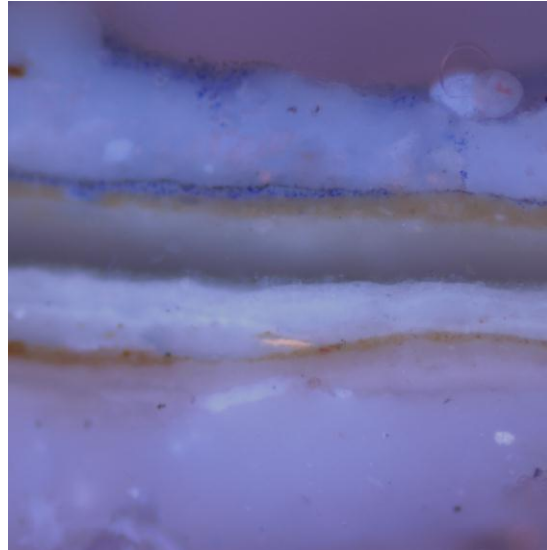
Sample S201-2. South wall, east of east window, sequence of later washes on top of smoother plaster (used super glue to keep layers together), about 5' up.

The second campaign of smoother white plaster has a longer and more complicated paint history and the limewashes applied after the replastering are chalkier and more ephemeral than the first deep red limewash. However, the limewash sequence on the walls can be mostly reconstructed based on samples from three plaster samples. No clear evidence for a dark painted faux wainscot was found on the walls in this room.

The coating sequence can be reconstructed to show that this room was often quite colorfully painted, and that the walls were repainted at least twice with a distinctive blue-pigmented limewash. A similar blue-pigmented limewash was found in room 203. In cross-section these blue limewash pigments are consistent with synthetic ultramarine, and polarized light microscopy analysis confirmed that both blue limewashes are pigmented with synthetic ultramarine, a relatively expensive pigment in the mid-to-late nineteenth century. There are more than nine generations of limewash on the walls in this room, as shown in samples S201-1 from the original plaster and S201-2 and S201-6 from the later, smoother plaster.

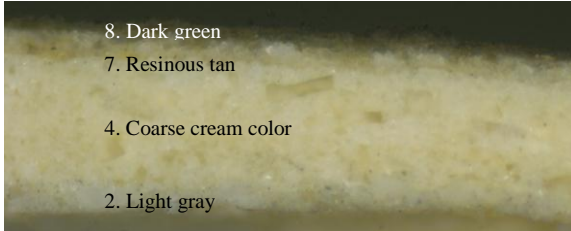
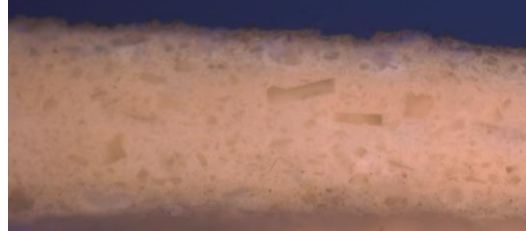
Sample S203-10. South wall door architrave, left side.

S203 Board Door and Architrave. The paints on the architrave for the board door consist of the same sequence of four generations of paint found on the Period I window elements and the lower sash. This suggests that either the door architrave was initially left unpainted, or it is a Period II element.

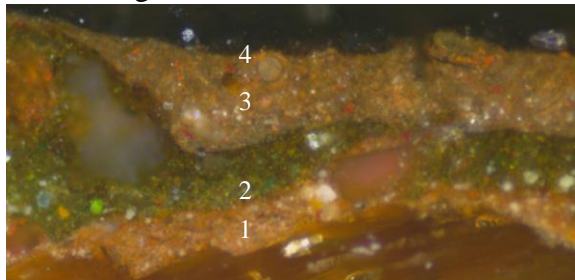
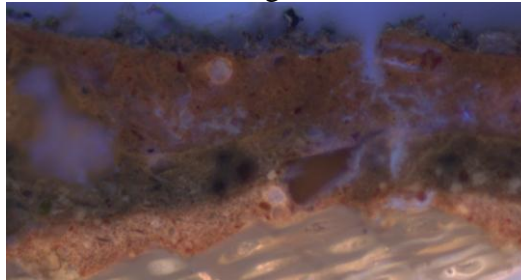
Sample S203-11. South wall, board door, left board, about 4' up at edge.

It was interesting to find that the board door was painted four times (S201-11) and generations 1 through 3 can be precisely aligned with the first three generations of paint on the Period II board door leading from K102 to K101. This indicates these doors were painted at the same time and may have initially been installed in the same space, or at least in the same building. The paint generations noted for sample K102-II-11 show how the paints on this board door relate to the chronology of woodwork paints found on the Period I window bar in room K101, and how they relate to the board door in this chamber.

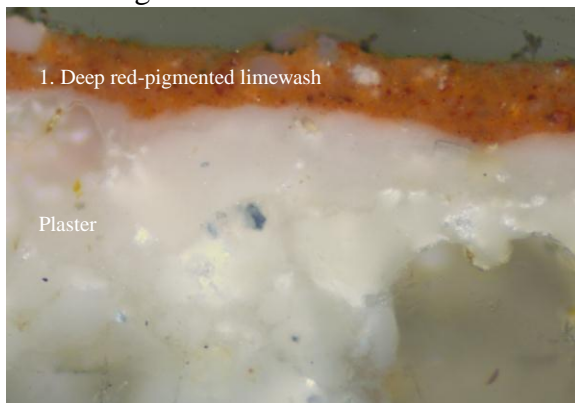
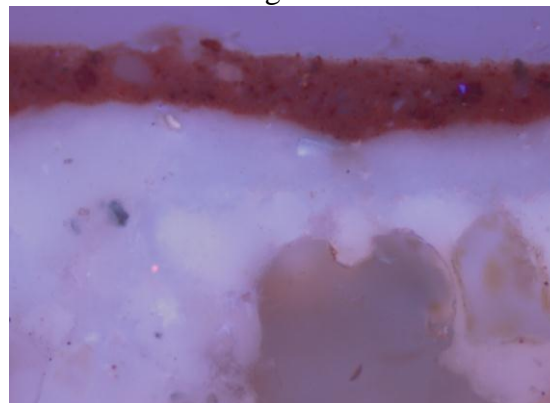
Sample S203-1. West wall, northwest corner, early deep red at large plaster loss, about 3' up.

When the walls of S203 were examined with a 30X monocular microscope there appeared to be no evidence for a dark faux-painted wainscot, and no evidence was found in the plaster samples for early dark limewash layers, with the exception of the original deep red-pigmented limewash which was applied from floor to ceiling on the Period I plaster (sample S203-1). This same red-pigmented limewash was found as the first layer on the plaster in S201. So the walls in this space were always painted in solid colors, beginning with the first deep red.
