## **Part II – Stable**

### **Background:**

The paints on the interior of the stable were not studied as part of the Phase I dissertation research, so all the sample locations were selected based on discussions with Graham and Ridout, who had specific questions about how the building interior had been altered. Representative elements (woodwork, plaster, doors) in each room were sampled to document and compare their paint stratigraphies.

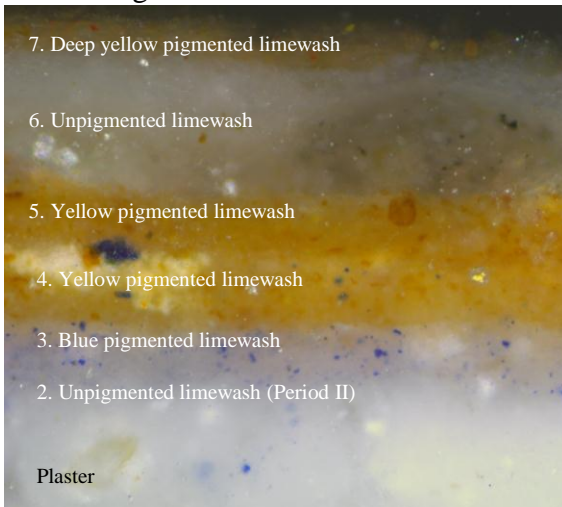
Sample S203-2. West wall, northwest corner  
Visible Light 200X

When the walls of S203 were examined with a 30X monocular microscope there appeared to be no evidence for a dark faux-painted wainscot, and no evidence was found in the plaster samples for early dark limewash layers, with the exception of the original deep red-pigmented limewash which was applied from floor to ceiling on the Period I plaster (sample S203-1). This same red-pigmented limewash was found as the first layer on the plaster in S201. So the walls in this space were always painted in solid colors, beginning with the first deep red.

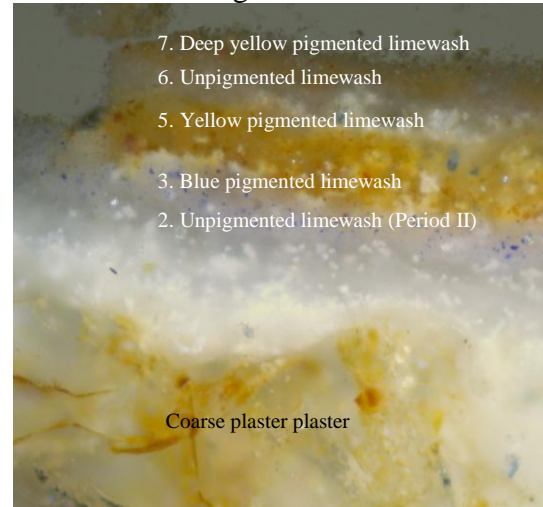
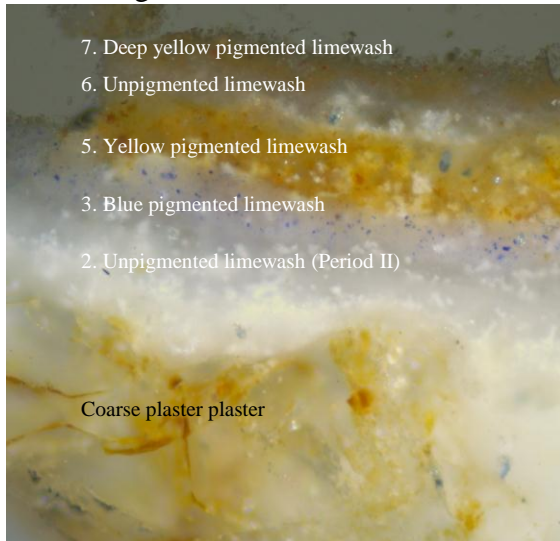
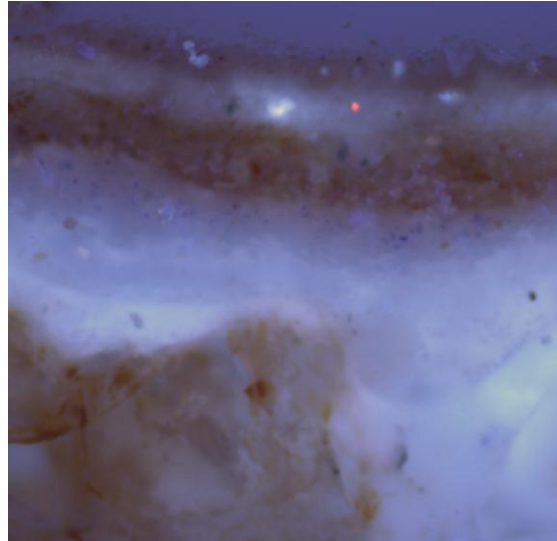
S203-4. Plaster, northeast corner  
Visible Light 200X

There is a ghost for a former shelving unit in the northeast corner of the room. Sample 203-5 from the south partition wall plaster has the same paint history as S203-4 from adjacent to the shelving ghost, so this wall paint history starts at Period II, which indicates the unit was installed in Period II. When the paint history in the sample taken just adjacent to the ghost is compared to that of sample S203-2, it is apparent that there one yellow pigmented limewash missing in generation 4. This comparison seems to indicate that the shelf was removed only after the last layer of dull yellow limewash was applied.

Sample S203-4. Plaster wall, northeast corner, yellow paint adjacent to ghost for former shelving unit (it is bare plaster on the ghost).

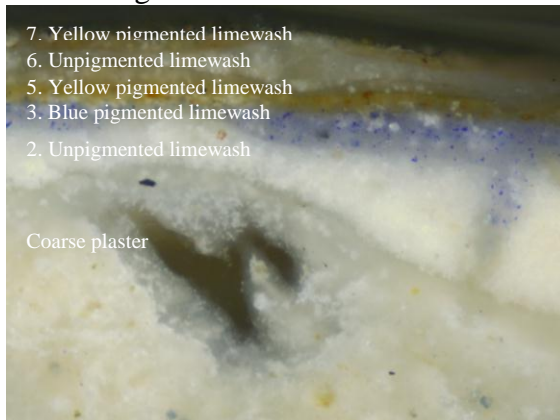
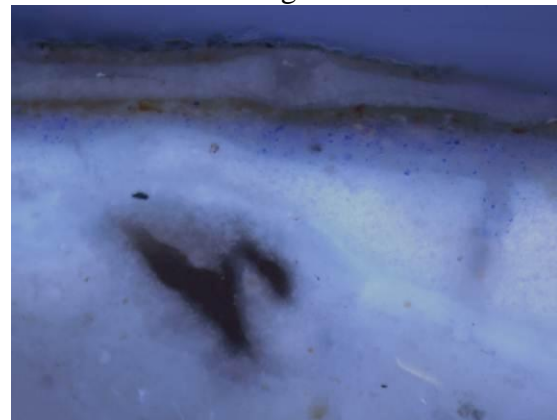
Sample S203-5. Coarse plaster on south partition wall for staircase.

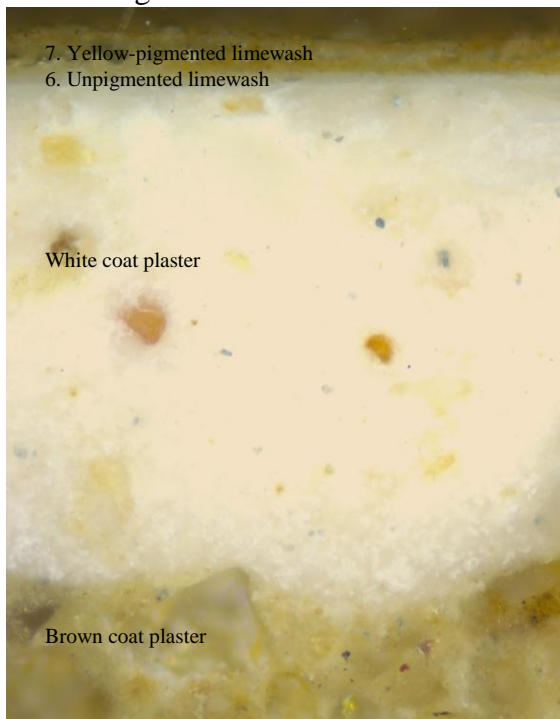
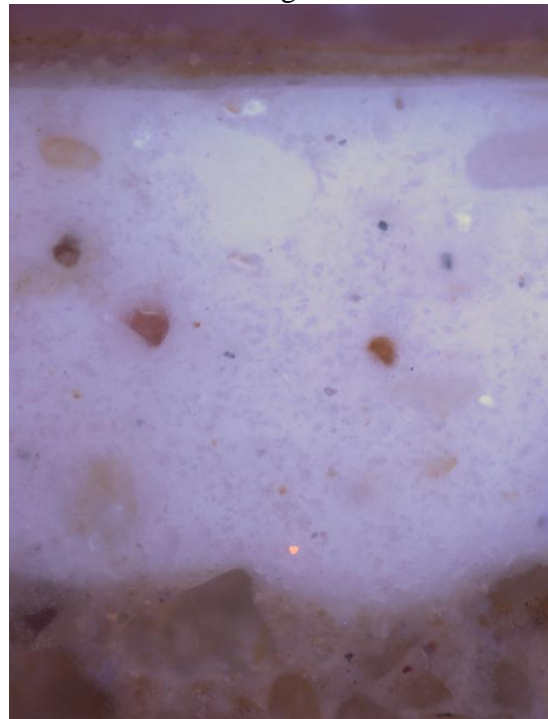
The ceiling in S203 was painted less frequently than the walls as there are only two generations of limewashes on the plaster. There is an unpigmented limewash above the plaster, followed by the current yellow-pigmented wash. These layers can be aligned with generations 6 and 7 on the wall plaster, suggesting the plaster is later, possibly Period III.

Sample S203-3. Center of ceiling, plaster at edge of big loss.

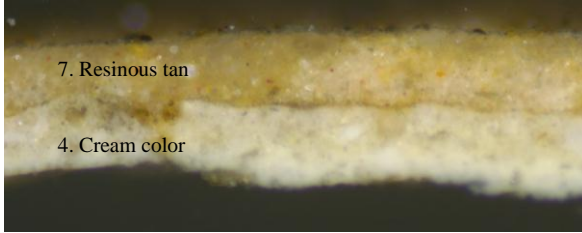
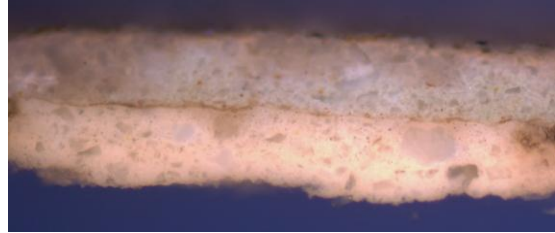
The paint history on the stair rail (S204-2) begins with the generation 4 cream color found on the Period I windows, which is consistent with its later installation. A comparison of the paints on the hayloft window (S204-3) with those on the underside of the arch (S204-4) suggests that the two most recent brown paints on the arch are exterior paints carried over from painting the exterior of the arched opening, as they do not appear elsewhere in this room.

Sample S204-2. North end, rail for stair enclosure, west face of north-south rail.

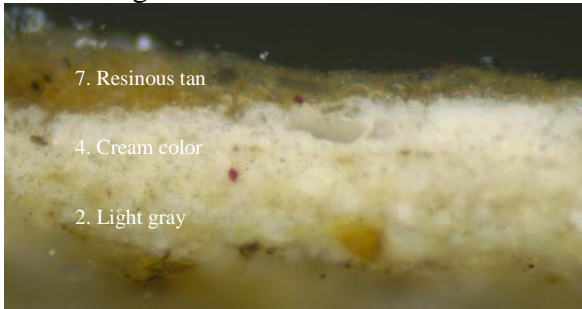
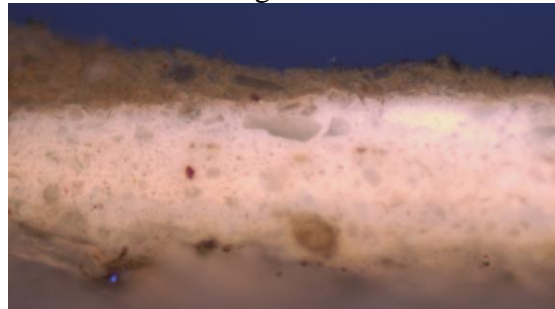
Sample S204-3. East wall, south window, painted frame, left side.

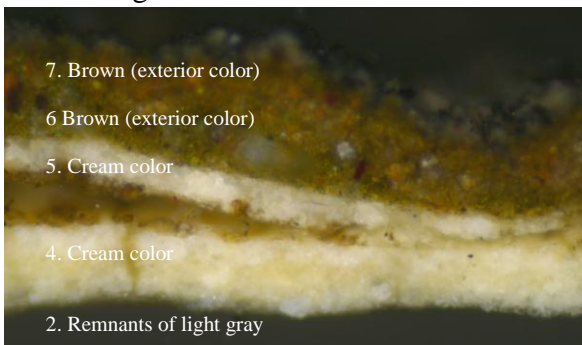
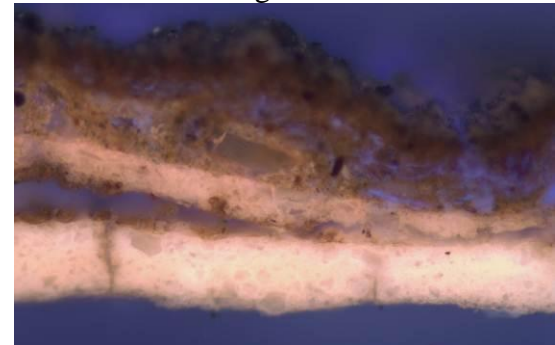
Sample S204-4. North wall, exterior paint exposed on underside of arch, left side.

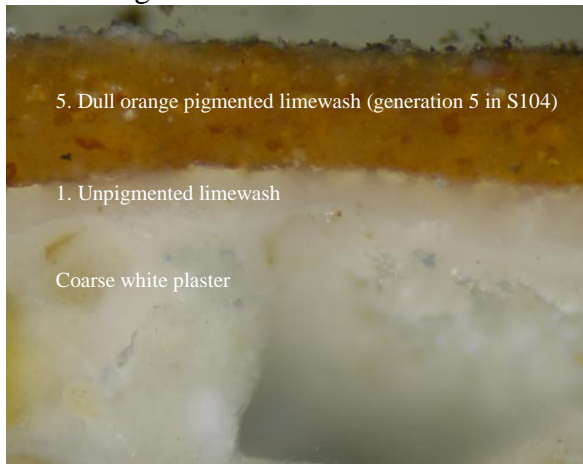
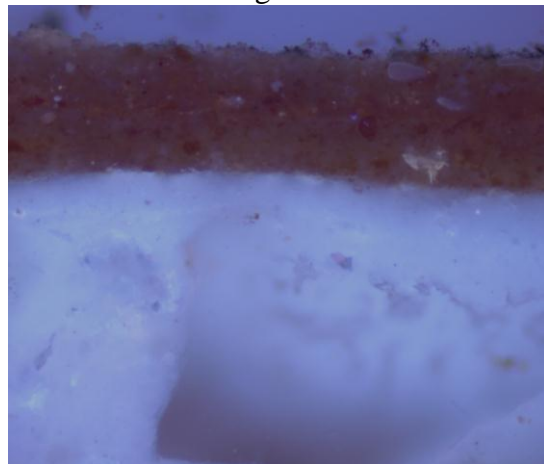
The walls in the hayloft were painted only twice, compared to at least nine times in room S203. The first layer on the coarse white plaster is an unpigmented limewash, followed by a thick deep orange-pigmented limewash. This same coating is the most recent paint in the stable space below (S104).

Sample S204-1. South end partition wall (orange and yellow washes), about 5' up, left of opening on east side.

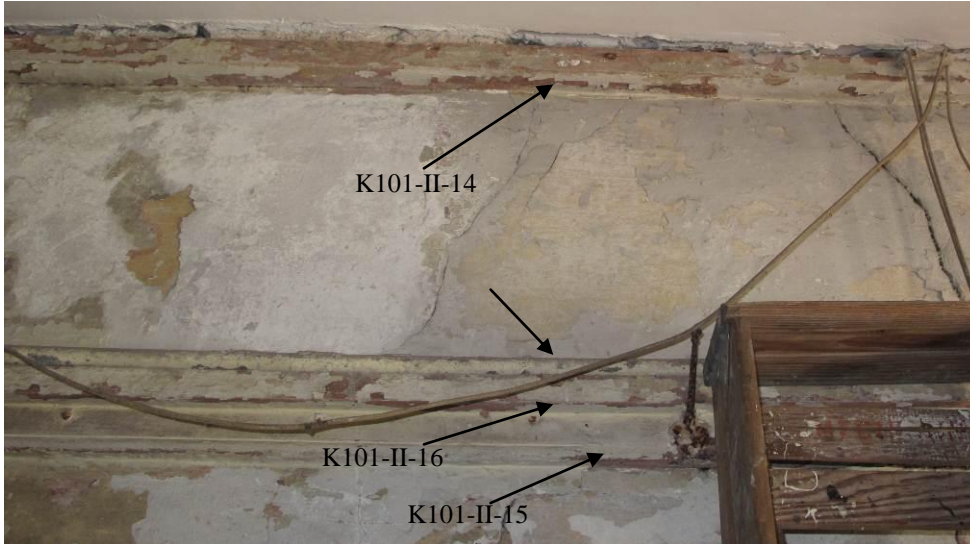
K101-II-14. Water pipe support board, above south wall door, just below ceiling level, starts with deep red wash on top of wood.

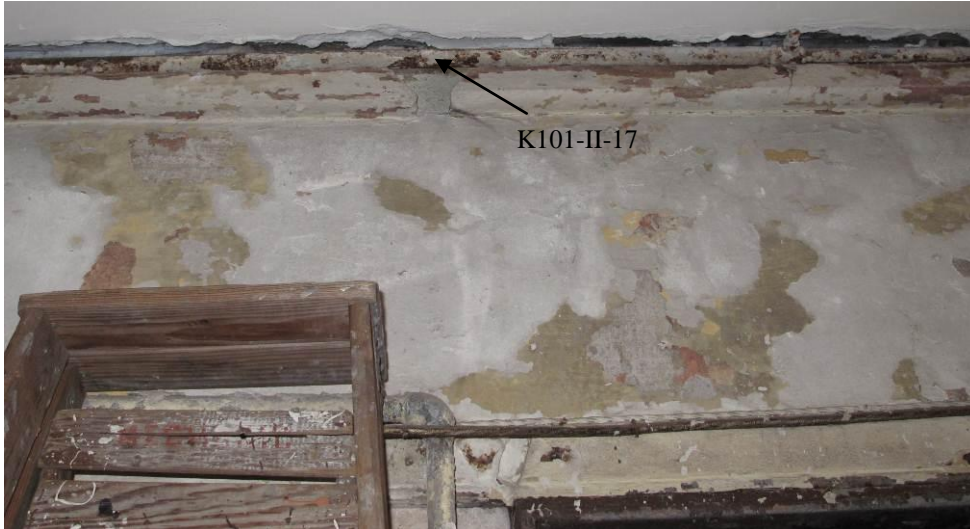
K101-II-17. Paint on gas pipe, south wall, above door (surface is corroded). K101-II-18. West wall, paint on gas pipe just above opening where water pipe dropped down.
