**Paint Investigation
Aiken-Rhett House
Charleston, South Carolina
REVISED DRAFT
Kitchen/Laundry and Stable
Interior Paints**

For: Winslow W. Hastie
Director of Preservation and Museums
Historic Charleston Foundation
40 East Bay Street
Charleston, South Carolina 29401

Conservator: Susan L. Buck, Ph.D.
303 Griffin Avenue
Williamsburg, VA 23185

Date: January 2, 2013

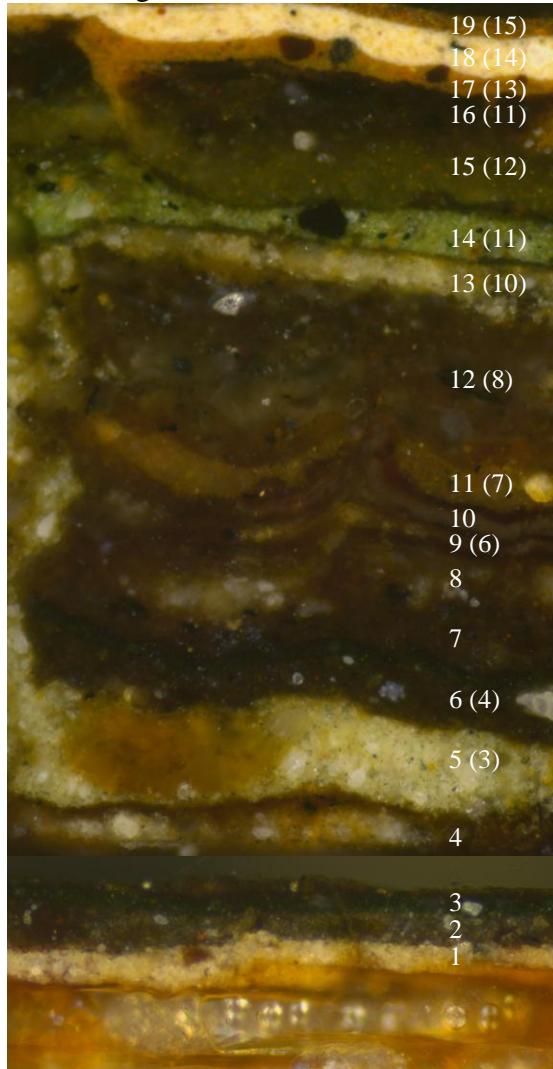
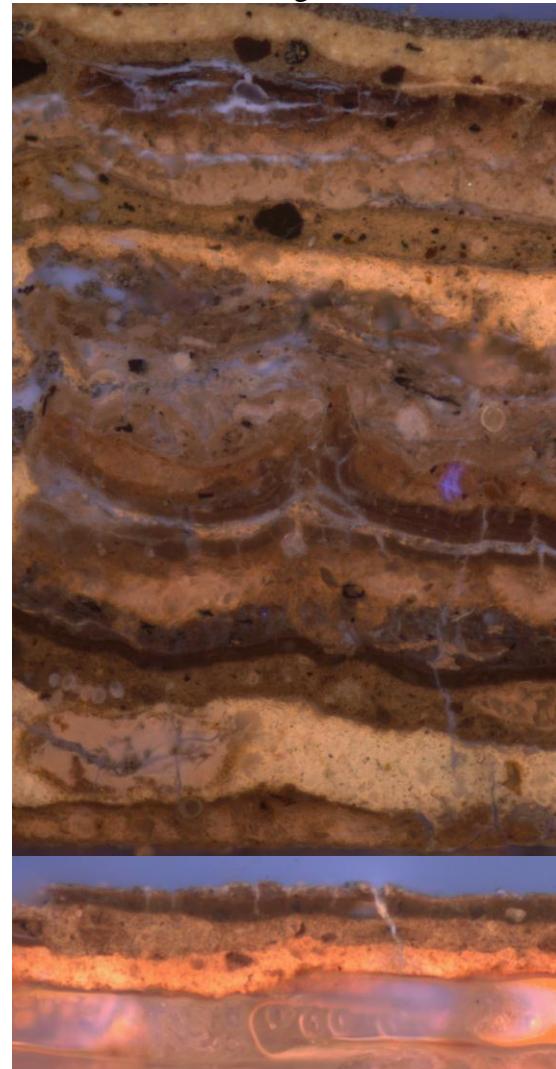
The most complete woodwork sample in K101 was found to be K01-II-11 from the lower bar across the center window, which is believed to be original. This cross-section has 19 generations of paint, compared to the 15 generations of paint identified during the dissertation research. There are 21 generations of paint on the woodwork in this room, including the most recent green found only on the window sash (K101-II-12). Cross-section K101-II-11 provides an almost complete stratigraphy for comparisons of original and later woodwork. The coatings are degraded and uneven, due to weathering and grime, but the sequence can be readily deciphered, beginning with the first layer of light tannish or cream-colored paint on top of the wood. The wood substrate is not grimy or darkened, suggesting that the first paint was applied in Period I. The layers are identified by generation in the photomicrograph below, with the earlier designations for the generations noted in parentheses. A chart comparing the paints found on each sampled section of woodwork follows.

Sample K101-II-11. West wall, center window, lower bar across.

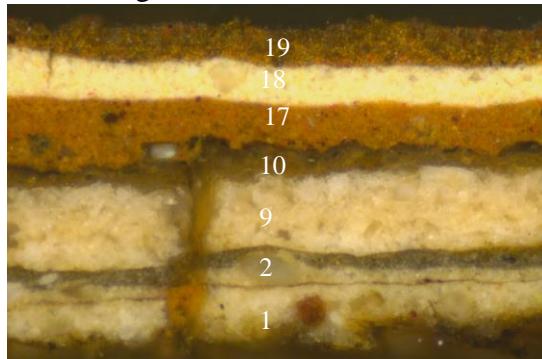
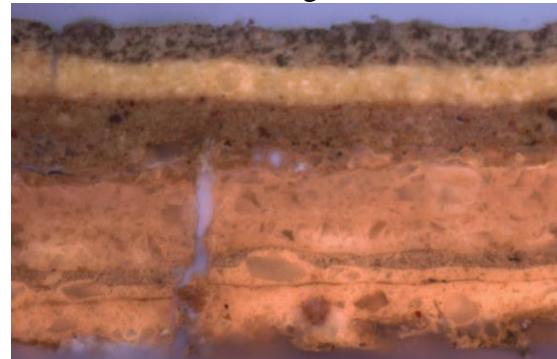
Comparisons of the paints on the original south door reveal (K101-II-1) show that it was originally painted the same tan as the window bar, followed by dark gray on top of an off-white primer. This cross-section is missing generations 3 through 8 and 11 through 16, likely because of flaking and abrasion (see below).

Sample K101-II-1. West wall, south door, original door reveal, left side about 4' to confirm Period I woodwork chronology.

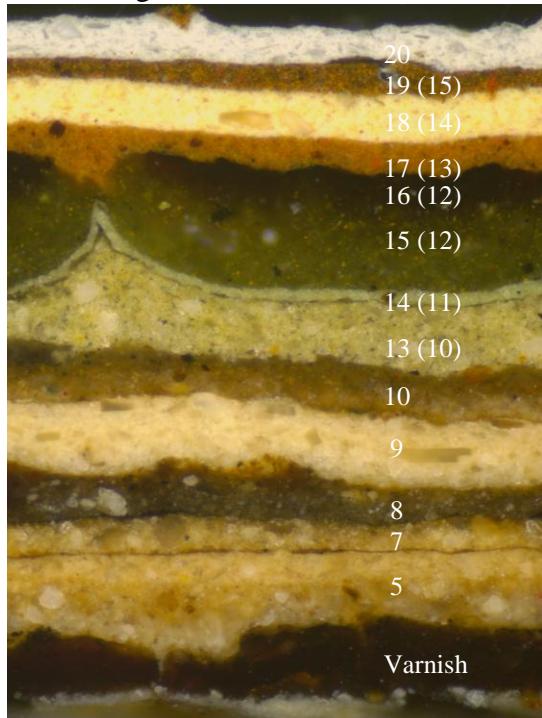
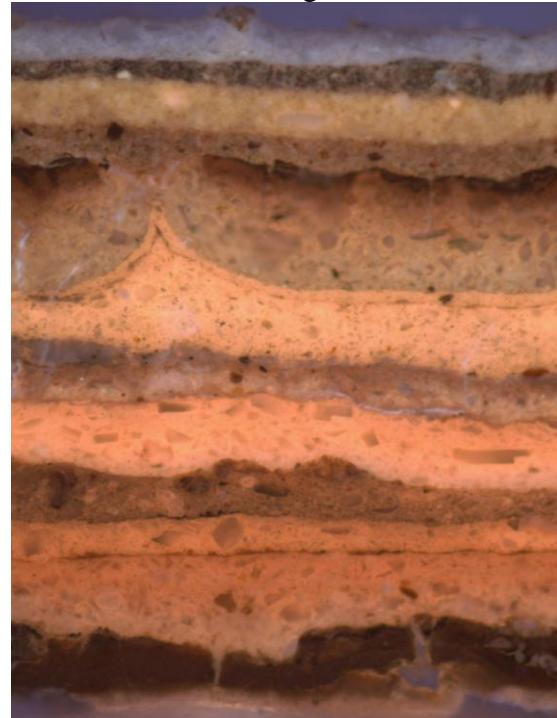
By comparison, the paints on the door in the Period II partition wall begin with a darkened pigmented varnish coating that seems to line up with generation 4. This suggests that the kitchen woodwork was repainted twice before William Aiken, Jr. expanded the building to the south in Period II. The layer identification in parentheses below relate to the earlier identification of the paint generations.

Sample K101-II-2. North wall, south door, later door in Period II partition wall, left side.

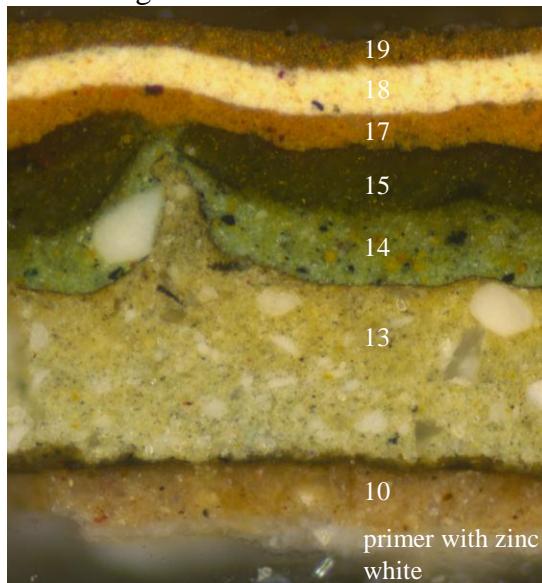
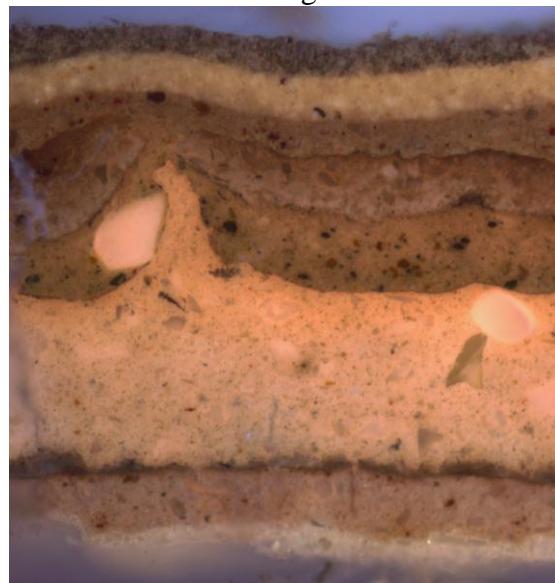
The paint sequence on the later glazed door on the west wall (K101-II-3) begins at generation 10, and this first coating consists of a brown paint on an off-white primer that contains the pigment zinc white. The presence of zinc white indicates this door could not have been installed before about 1845 when zinc white became commercially available. This door was likely installed considerably after 1845 as generation 4 seems to indicate Period II in the coating stratigraphy.

Sample K101-II-3. West wall, south door, later glazed door, left stile about 4' up.
Visible Light 200X

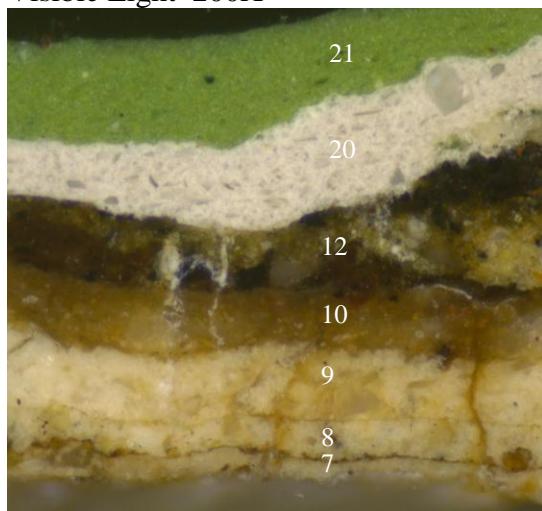
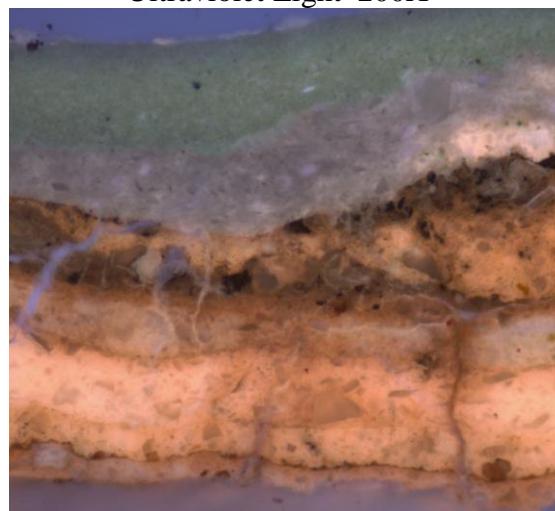
Not surprisingly, the window sash paints are more degraded and disrupted than the other coatings, but the stratigraphy in sample K101-II-12 from a later window sash seems to begin with generation 7, a cream color. The sash was initially painted with lighter colors than the rest of the woodwork.

Sample K101-II-12. West wall, later window sash.

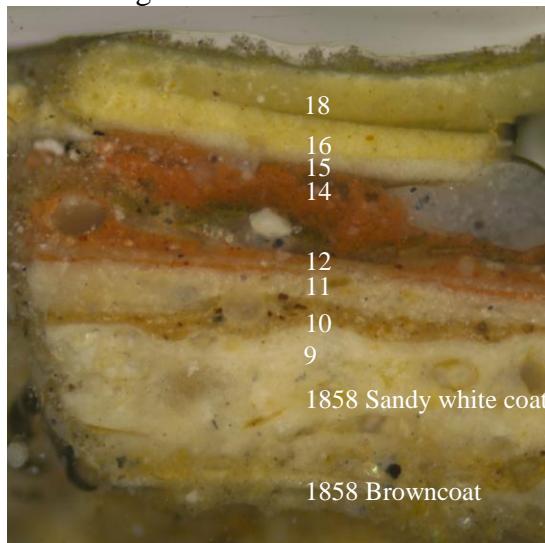
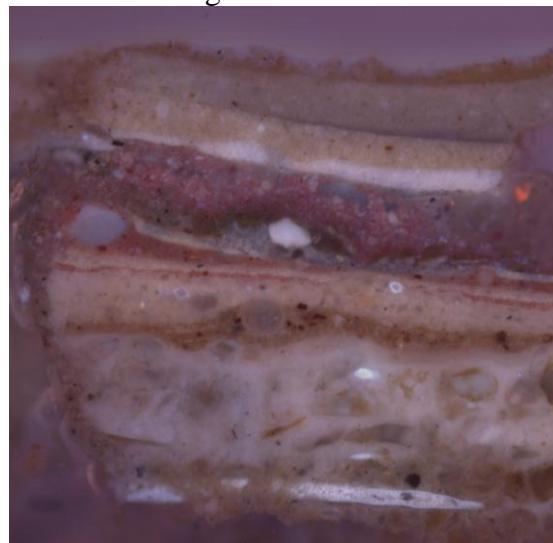
Sample K101-II-5. East wall, plaster above later installation of stew stove, 1858 plaster on circular sawn lath, for comparative dating.

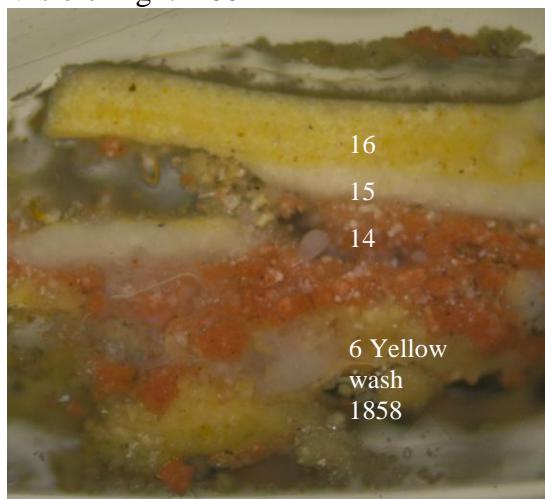
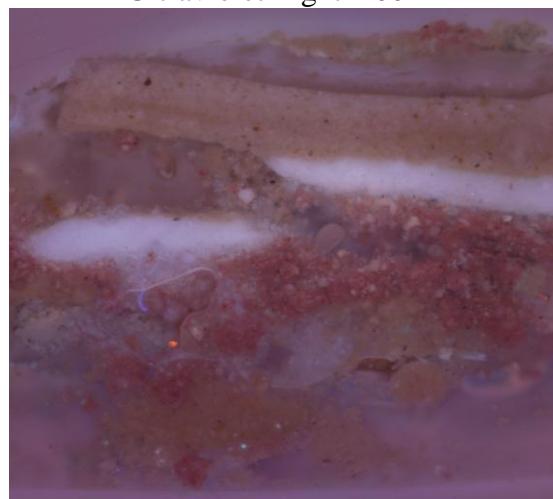
Sample K101-II-8. East wall, 1858 infill right of stew stove (location of former fireplace).

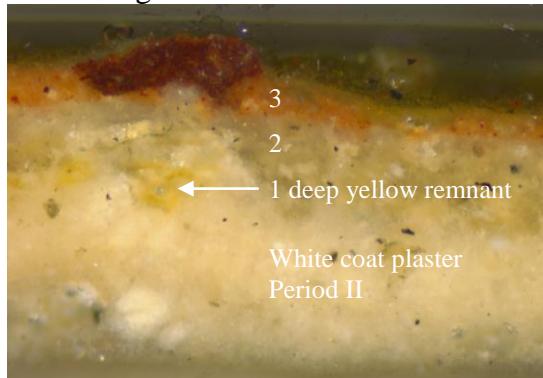
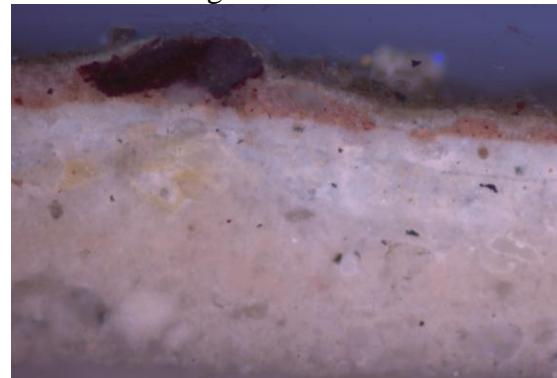
The coatings on the north wall pegrail (K101-II-6) and the wide board below the pegrail (K101-II-7) seem to have consistent early chronologies. The first layer is a thin uneven layer of plaster, suggesting that the first white coat was accidentally applied over these wooden elements. There is a fragment of the Period II yellow limewash on the pegrail, followed by a unpigmented limewash on both elements which can be aligned with generation 2 in the limewash chronology. There is a dark gray wash on top of the unpigmented limewash on the wide board, suggesting that a dark gray-painted wainscot which extended on top of the wide board was created in generation 2. The third generation in both samples is an orange-pink pigmented limewash. The later washes cleaved off the pegrail, but the sequence of coatings on the wide board suggests there may have been a dark gray wainscot in generation 2. This means that the faux wainscot extended quite high on the wall at this point. The comparative cross-sections suggest that the first layer on the Period II north wall was an unpigmented limewash, followed by a deep orange-pink wash that was also found on the Period I south wall.

Sample K101-II-6. North wall, pegrail, 3' from northeast corner.

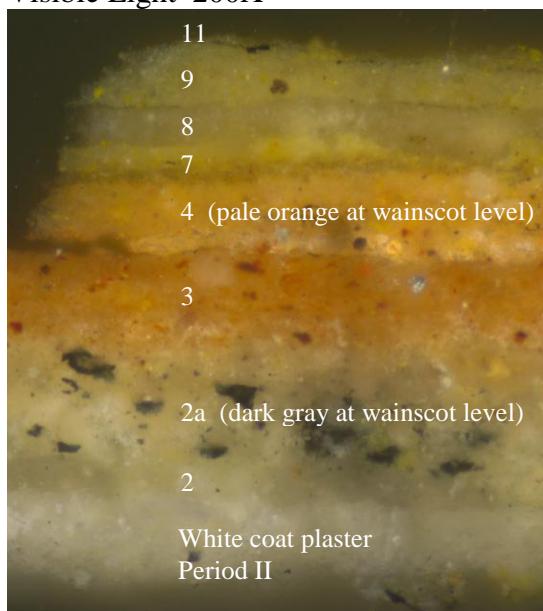
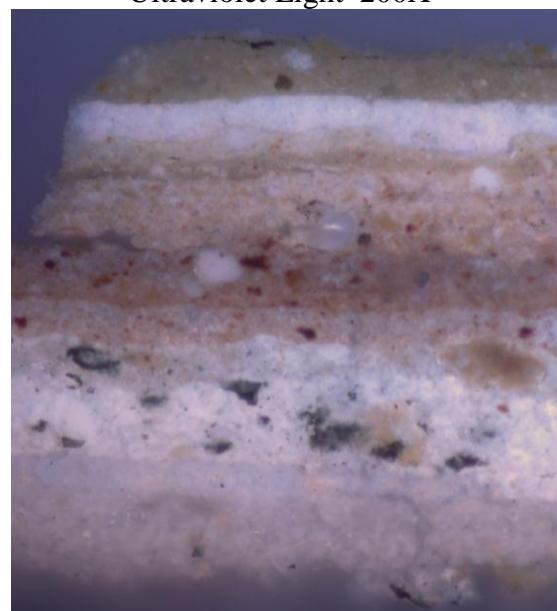
Sample K101-II-7. North wall, wide board about 3' from northeast corner.

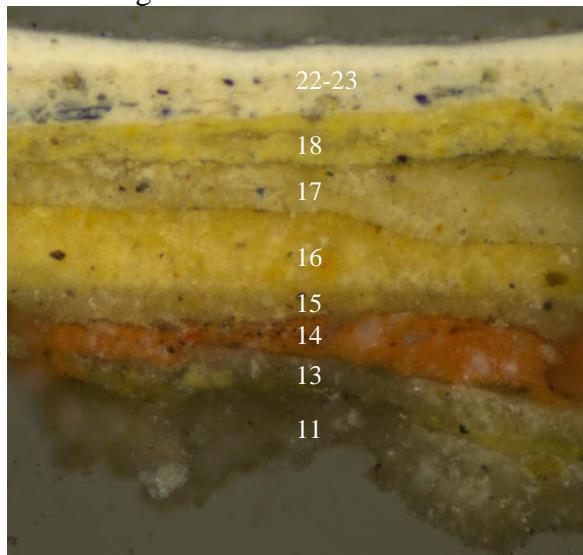
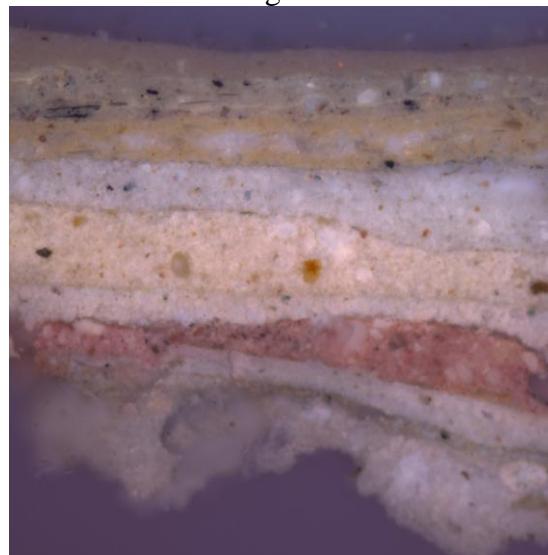
The coatings on the elements associated with the gas pipe are somewhat difficult to interpret because of the corrosion on the gas pipe (K101-II-17) and the paint loss on the support board for the pipe (K101-II-16). However, the evidence does suggest that the gas pipe was installed as early as generation 9 (a degraded unpigmented limewash) as that is the first layer in the cross-section from the gas pipe. The first layer on the board supporting the gas pipe is generation 11, so it is possible that several early washes are missing on this board as most likely the board and the gas pipe were painted simultaneously.

Sample K101-II-16. Board just above pegrail used to support gas pipe and later to support water pipe, on south wall just above door.

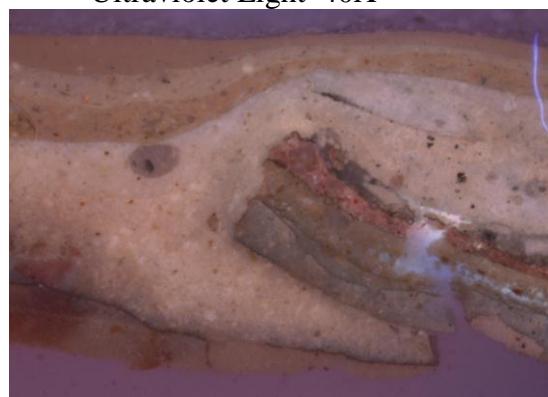
Sample K101-II-17. Paint on gas pipe, south wall, above door (surface is corroded).

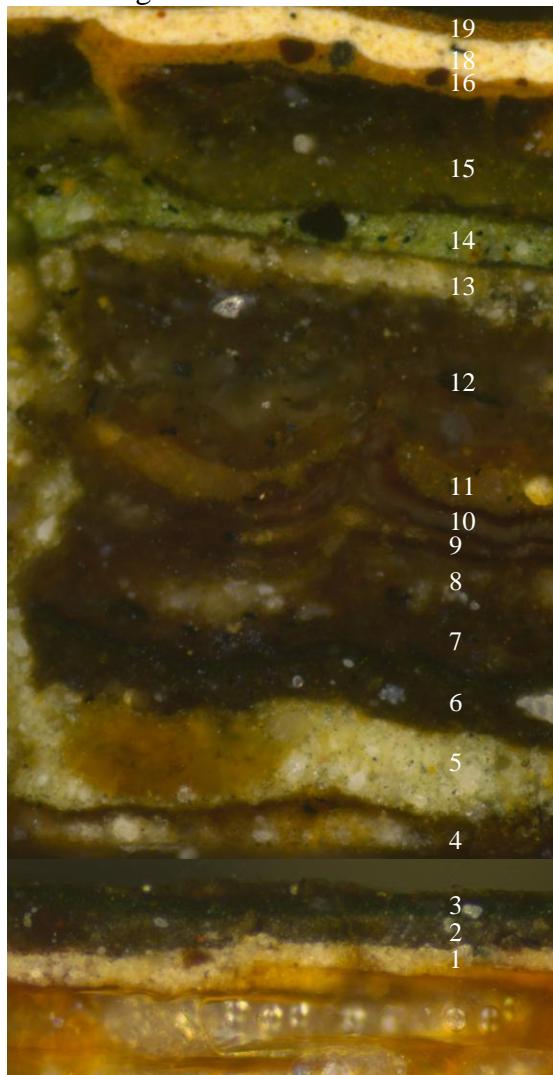
A comparison of the paints found in cross-sections K101-II-11 from the center window bar and K102-II-8 from the north wall baseboard shows how the paints line up. It is important to note that the earliest paints in K102-II-8 and K102-II-7 from a section of Period II baseboard are the same. The combined evidence suggests that the north wall baseboard was not installed and painted until Period II.

Sample K101-II-11. Center window,
lower bar across.

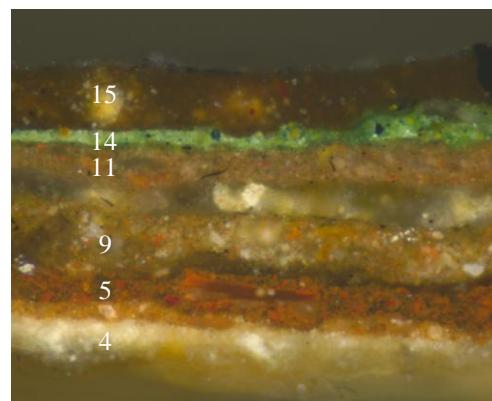
Sample K102-II-8. North wall baseboard.

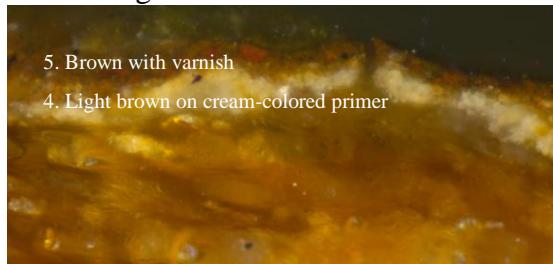
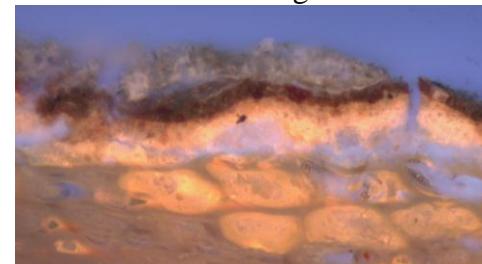
Sample K102-II-7. South wall, Period II baseboard, just left of door, for comparison with baseboard believed to be Period I on north wall.

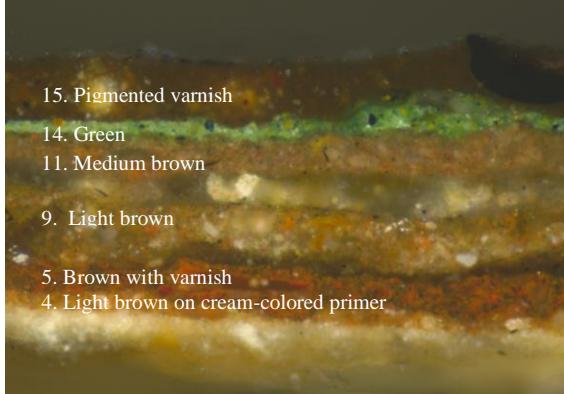
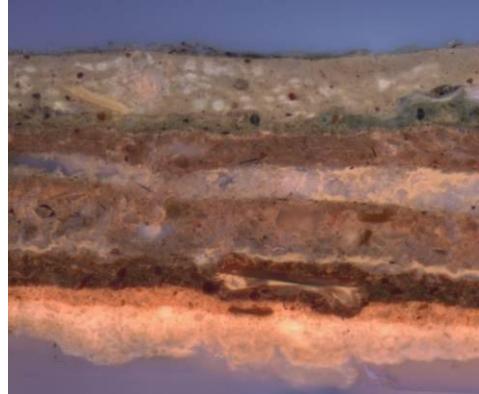
K102 Baseboards. Because many of the sampled areas of woodwork have distinctly different paint histories, the stratigraphy on each type of element will be described separately, beginning with the Period I and II baseboards. The most complete sample is K102-II-8 from a section of baseboard from the north wall believed to be Period I. This cross-section has only seven generations of paint, compared with 23 generations found on the woodwork in K101, indicating this room was repainted with far less frequency. The first paint layer is a cream-colored base coat with a darker tan resinous finish layer that can be aligned with generation 4 in K101-II-8. This is followed by a red-brown paint that corresponds to generation 5 on the K101 woodwork.

Sample K102-II-8. North wall, Period I baseboard, just right of door opening, to identify original paint and for comparison with Period II baseboard.

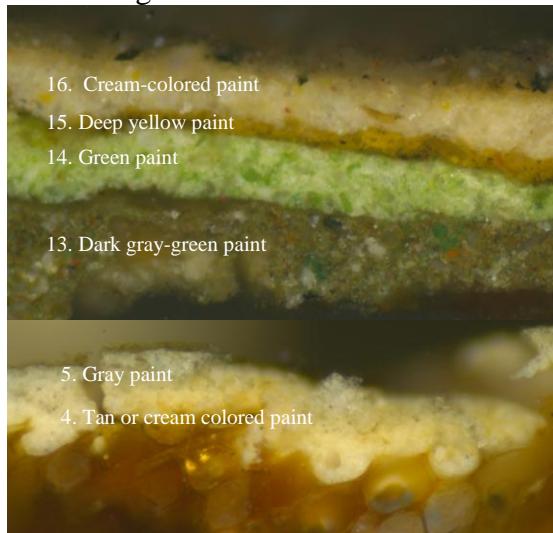
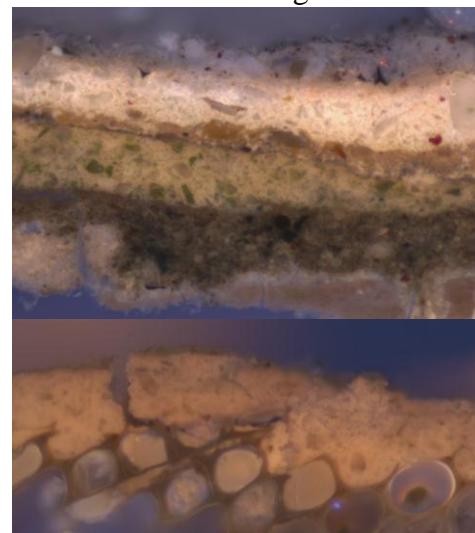
In sample K102-II-5 from the south wall pegrail, the first layer is a tan or cream-colored paint, like the first paint layer observed in the K102 baseboard samples. The second generation is light gray that may line up with generation 5 in room K101. This is followed by a dark green paint that may be generation 13, and a green paint that is generation 14 in the K101 woodwork chronology. The two subsequent layers, a dark yellow and a cream color were not found on K102 baseboards, or on the woodwork in room K101.

Sample K102-II-5. South wall pegrail, just left of door opening, at lower bead molding. For comparative chronology on pegrails in this building.

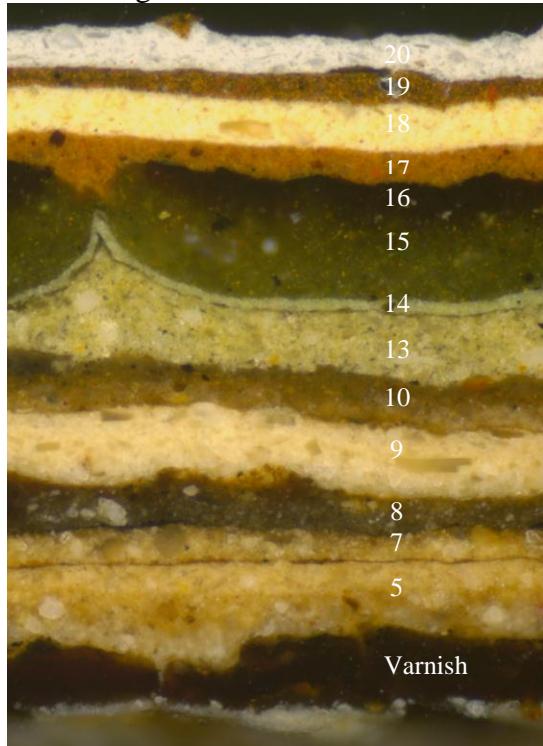
Sample K101-II-2. North wall,
later door in Period II partition wall, left side.
Visible Light 200X

K102 Period II Door Architrave. The paints on the Period II door opening on the north wall in sample K102-II-10 begin with generation 5, when compared to the K101 woodwork stratigraphy. This is just one generation later than the tan paint found as the Period II coating on the central window bar. The paint history on the north wall door opening confirms that this room was repainted less frequently than K101 as the early paints consist of generations 5, 7, 10, 11 and 14. This architrave may have originally been left unpainted. A comparison of K101-II-2 and K102-II-10 is shown below.

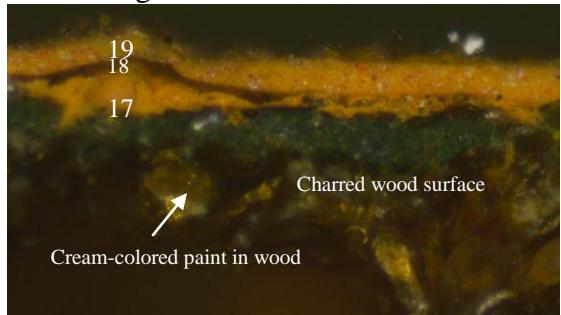
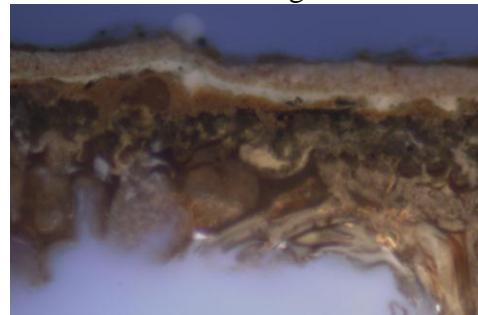
Sample K102-II-6 from the south wall door architrave contains very little evidence. The wood substrate is blackened, as if from charring, although there seem to be remnants of cream-colored paint trapped in the wood. The paints can only confidently be lined up with generations 15 through 19 on the woodwork in room K101. The paint evidence cannot help to date this door opening.

Sample K102-II-6. South wall door architrave, left side, about 5' up, (has blackened charred surface) at existing hole.

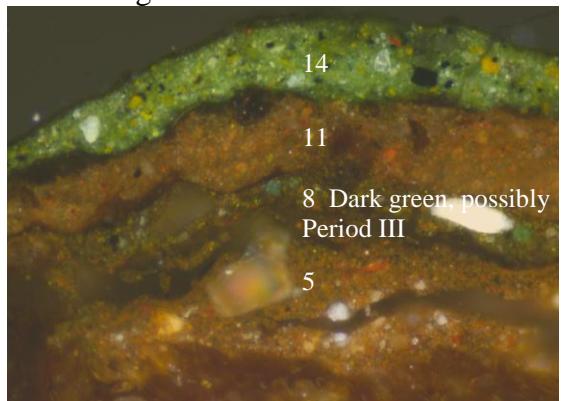
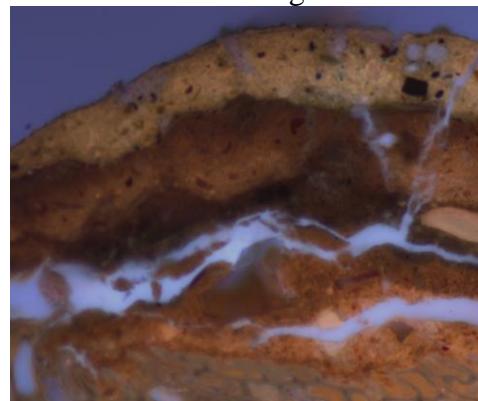
Sample K102-II-11. South wall, upper door of two-part board door, on batten.

K102 Period II South Wall Door. The two-part door is secured with a later batten on the bottom section, and Graham was interested in whether the comparative paint histories could help identify when the solid door was cut apart and the later batten added to the lower section. The first layer in sample K102-II-11 from the original upper door batten begins with the brown paint with a varnish coating that aligns with generation 5 in the woodwork chronology from K101. The paint on the later lower batten (K102-II-12) begins at generation 8. This change could have occurred before Period III as Period II was found to be generation 4.

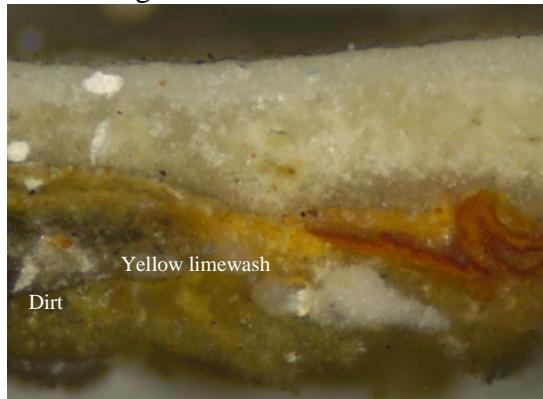
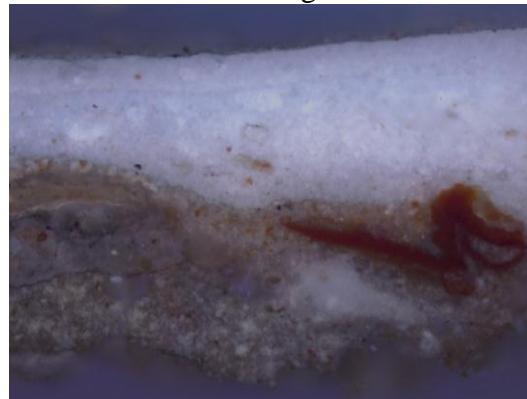
Sample K102-II-1. East wall, SE corner, wooden surround for closet in northeast corner.
Period II installation. Sampled to establish chronology for Period II woodwork.

K102 Plaster and Closet Enclosure. Comparative paint analysis suggests that the closet was originally limewashed, beginning with a yellow-pigmented limewash which can be aligned with generation 6 on the Period II partition wall (K102-II-3), although the evidence is quite fragmentary. The most recent coatings are relatively clean unpigmented limewashes. The closet may have been installed soon after the expansion of the building in Period II.

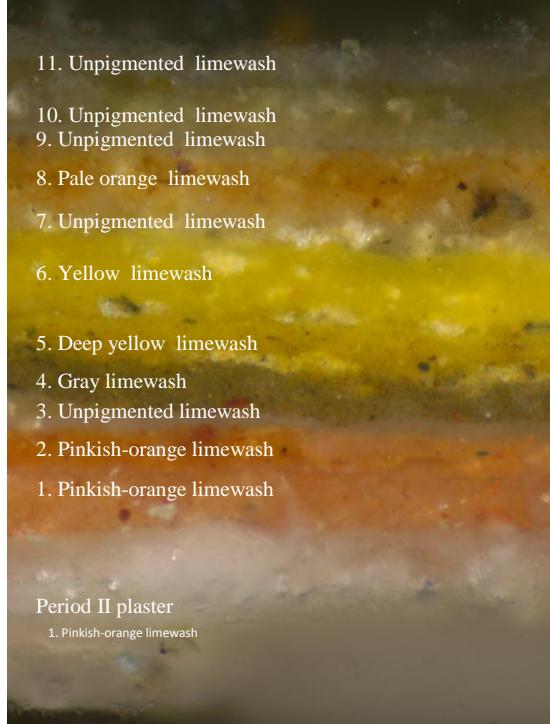
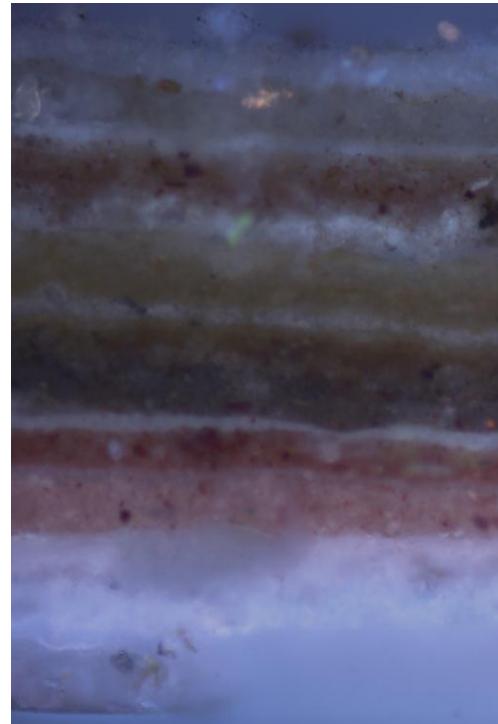
Sample K102-II-3. South wall, SE corner, just right of enclosed shelving unit, plaster should have full Period II chronology.

The limewashes on the walls in this room are similar in terms of colors, but the coatings do not line up with wall paint stratigraphy in room K101. This suggests that the two rooms were repainted at different times, or were often different colors during a given period of repainting. Sample K102-II-3 from the south wall has the best representative paint chronology with at least 11 generations of paint. The sequence begins with two generations of pinkish-orange pigmented limewash, followed by an unpigmented limewash and then two yellow limewashes. The coating chronologies in sample K102-II-3 from adjacent to the shelving in the southeast corner, and sample K102-II-4 from the plaster within and below the shelving, are the same from generation 1 through 11. This indicates the wall inside the shelving was treated in the same manner as the Period II wall, at least until the eleventh wall paint coating.

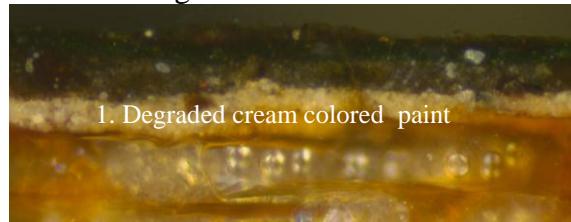
K101-II-11. West wall center window bar.
Visible Light 200X

When the first coarse cream-colored paint on the stair is compared to the original, but degraded, cream-colored paint on the bar for the central window in K101 they seem to be the same. This suggests the newel post and the upper run of this staircase were part of the Period I kitchen building. A comparison of the two cross-sections follows.

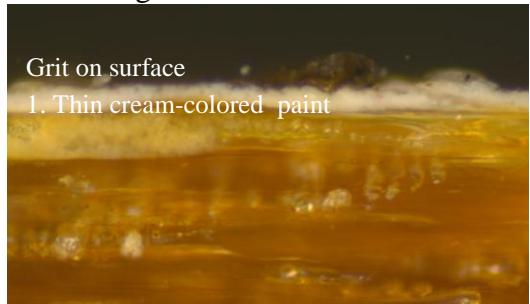
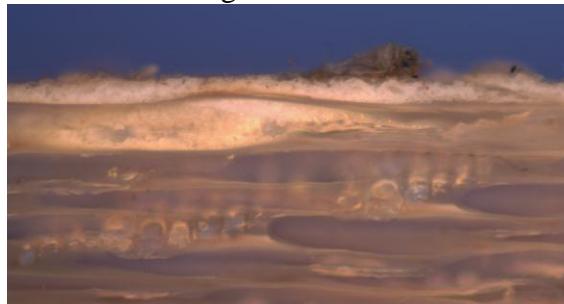
Sample K103-II-1. Staircase, exposed light-colored paint on south side, Period I paint?,
where vertical support had been secured.

The comparative evidence shows there is only one thin layer of cream-colored paint on top of the wood in sample in K103-II-1 from the “ghost” for a former vertical support on the south side of the stair. By comparison, there are three generations of paint adjacent to the ghost, beginning with a thicker layer of coarse cream-colored paint, followed by a dull translucent gray paint, and then the current red-brown (K103-II-2). Perhaps the staircase was painted once with a primer of cream-colored paint before the now missing vertical support was installed, then after the vertical support was installed another layer of the same cream-colored paint was applied. When the staircase was moved in Period II the vertical support was removed, and the stair carriage and newel post were repainted with translucent gray paint. Considerably later, all the stair elements were coated with the current red-brown paint (which lines up with generation 19 in K101).

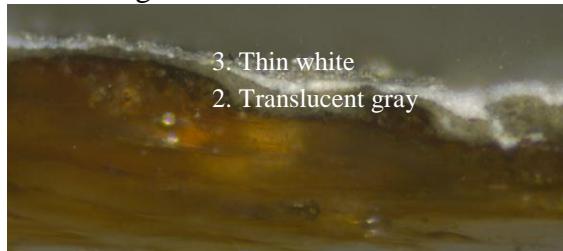
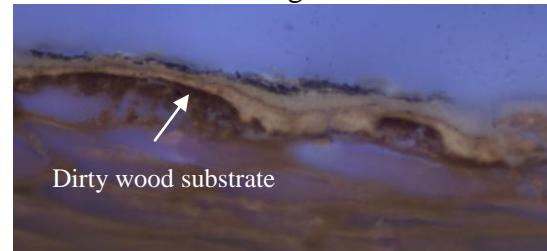
Sample K103-II-4. Staircase, added wide board in the middle used in place of former balusters, about 5' up. For comparative chronology.

When the paints on the later wide board that replaced the balusters on the upper run of the staircase are compared to the full paint chronology in K103-II-2, it is apparent that it was not initially painted as the wood substrate is quite dirty. The first layer on top of the dirty wood is the translucent gray paint that was found as the second generation on the staircase.

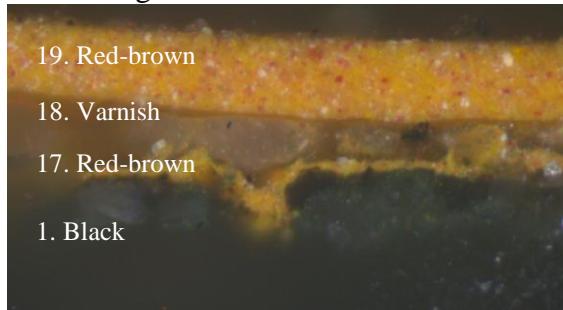
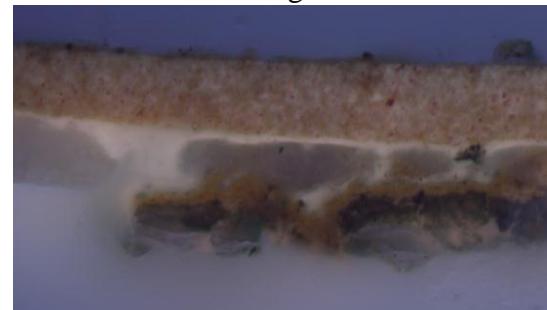
Sample K103-II-6. East wall, riser just below stair landing.

The paint evidence on the risers shows that they were originally painted black. The first black paint is very degraded and fragmentary. This black paint is followed by a red-brown paint that lines up with generation 17 in K101, then a varnish coating, and then the most recent red-brown paint. The first black paint on the risers was not found elsewhere on the staircase or on other areas of woodwork, so it is not possible to comparatively date the installation of the lower run of the stairs using the paint histories.

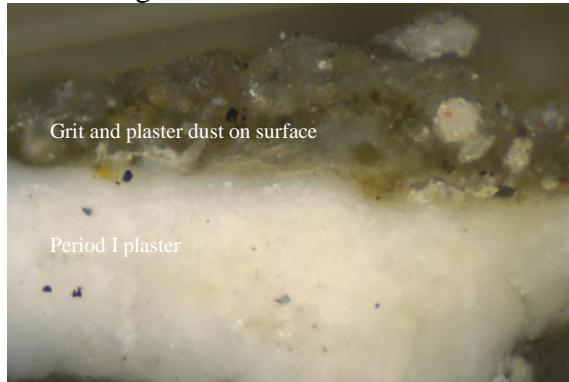
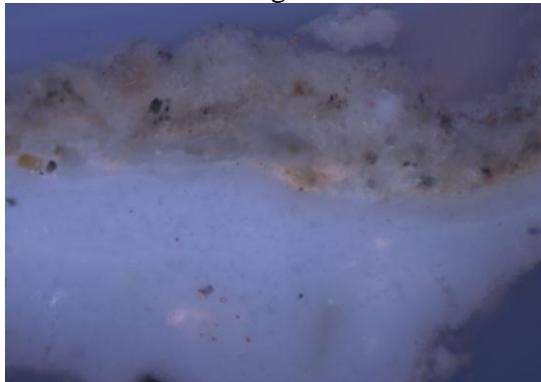
Sample K103-II-5. South wall, area of Period I plaster trapped below level of landing, which must have been from original privy.

Three samples were taken from different areas of plaster in the stairhall, and they all represent different periods and materials. One sample was taken from the trapped Period I plaster below the stair landing, believed to have been part of the wall of the original privy. The cross-section K103-II-1 consists only of a white coat of plaster and a thick layer of attached grit and plaster dust. There are no limewashes on this plaster in this area, so it appears this privy interior was never painted or limewashed.

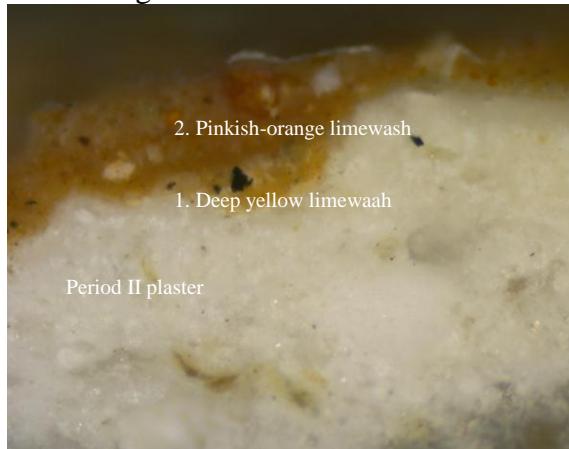
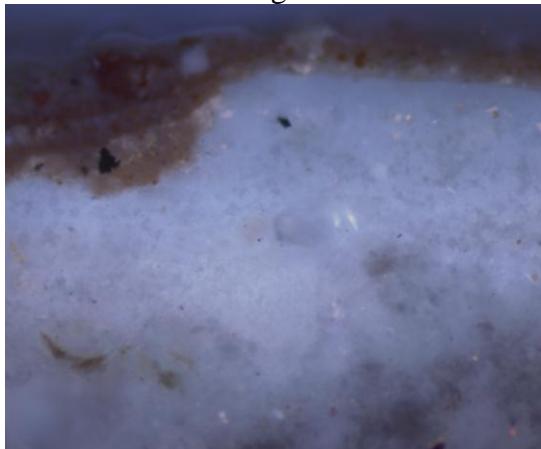
Sample K103-II-7. North wall, at stair landing, coarse early plaster, at wainscot level.

One plaster sample was taken at wainscot level at the stair landing to determine whether it might be early. The first coating on the sandy white coat is a deep yellow limewash, followed by a pinkish-orange limewash. These early pigmented limewashes closely resemble the initial two generations of pigmented limewashes on the Period II plaster in K101, helping to confirm that this is Period II plaster.

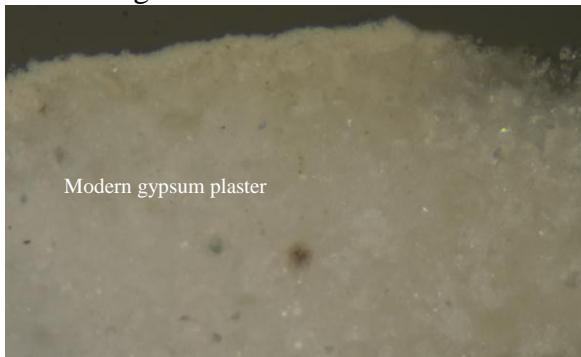
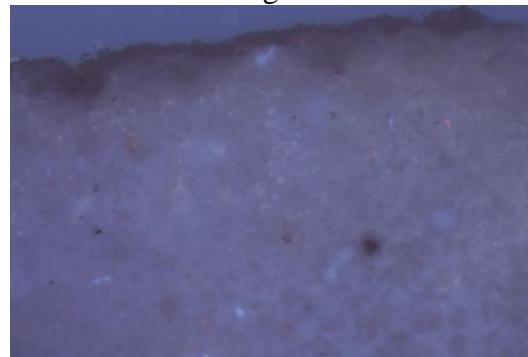
Sample K103-II-8. North wall, smoother, later plaster, just left of K103-II-7.

One sample was taken to the left of sample K103-II-7, on an area of smoother plaster on the north wall marked by Graham for analysis. The plaster substrate in this sample is a modern gypsum plaster with one thin layer on nonfluorescent, opaque, off-white paint. This area of plaster likely represents repairs done by The Charleston Museum or Historic Charleston Foundation.

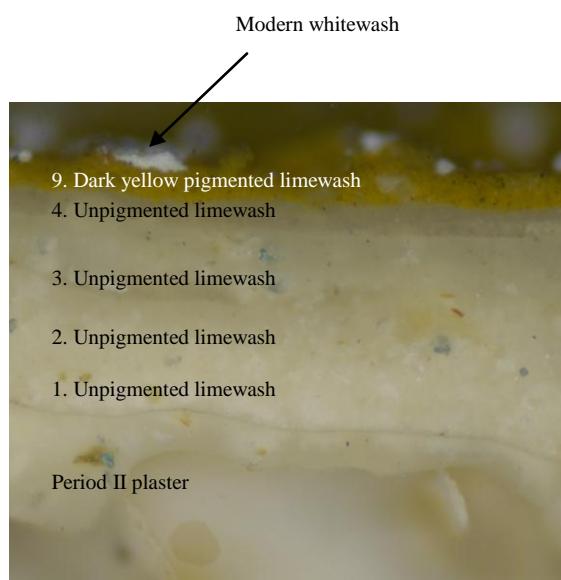
The most complete sample of washes on the Period II plaster was found in sample K104-II-3 from the south wall. There are ten generations of coatings on the plaster, beginning with four generations of unpigmented limewash. These unpigmented washes are followed by two generations of distinctive yellow-pigmented limewashes, then alternating unpigmented limewashes and pigmented orange and dark yellow-pigmented limewashes. When the sample taken from near the west wall where a yellow wash has overlapped the ghost of the former support board (K104-II-5) is compared to K104-II-3, it is apparent that the coating sequence consists of generations 1 through 4, plus generation 9. A sample taken from the narrow white band at the very top of the west wall where the water pipe support board was located consists of only generations 1 through 4. A comparison of samples K104-II-3 and K104-II-5 is shown below.

K104-II-5. Yellow wash on wall over former position of water pipe support board.
Visible Light 100X

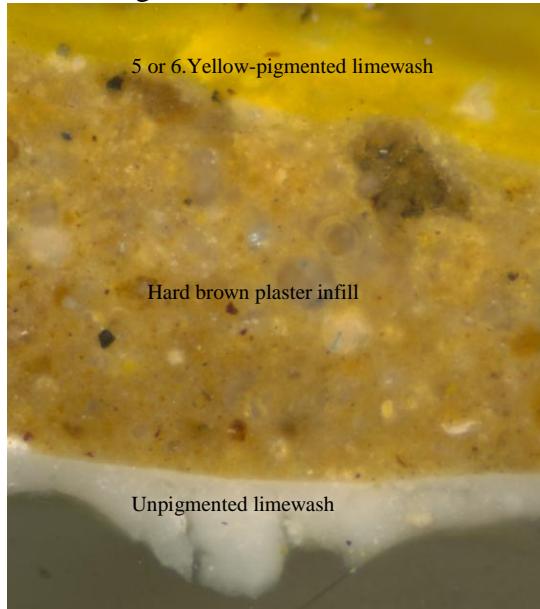
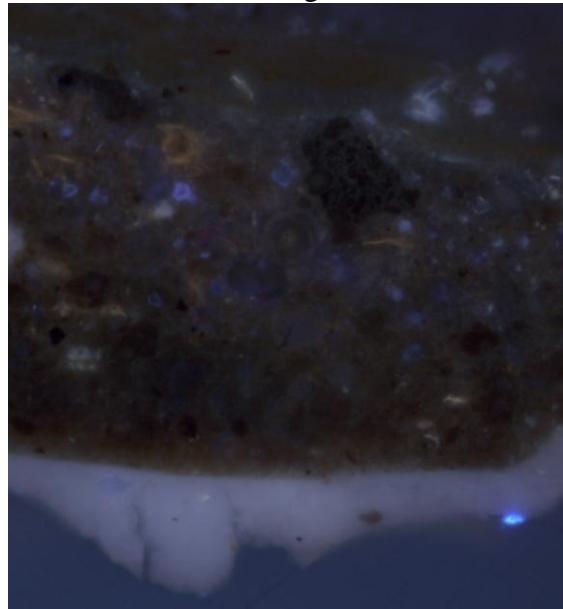
Sample K104-II-1. North wall, plaster infill possibly from 1858, just left of door which was cut in later, much harder plaster.

The other samples also have helpful comparative coating sequences. Sample K104-II-1 was taken from the edge of the hard plaster infill to the left of the north wall door opening. There are remnants of an unpigmented limewash layer below the hard brown plaster, and there is a layer of deep yellow-pigmented limewash on its surface. This suggests that the door opening was altered sometime after the first limewash was applied to the wall plaster, and it was coated over with a deep yellow limewash in either generation 9 or 10.

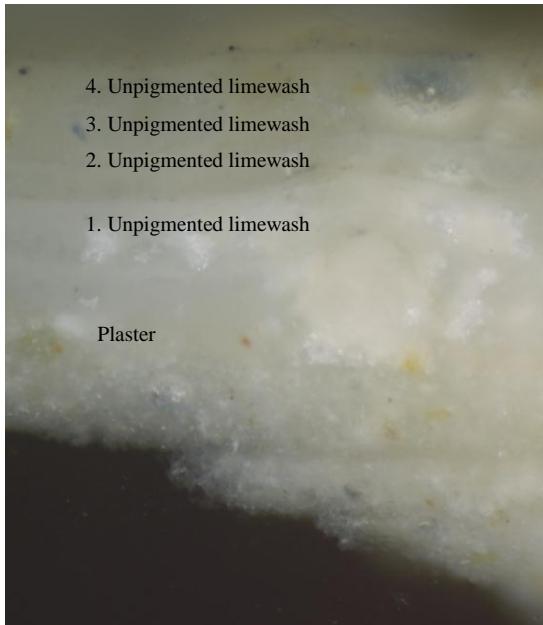
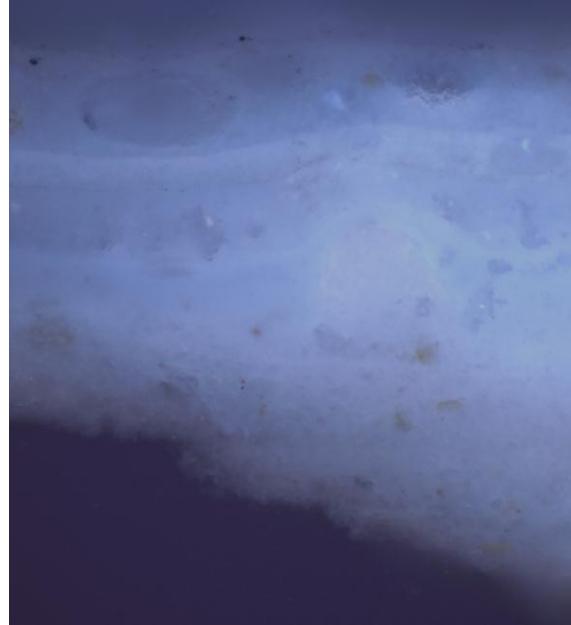
K104-II-4. West wall, left of window, narrow white band at top of wall where water pipe support board was positioned.

The narrow white band at the top of the west wall was sampled to see when the water pipe support board was installed in the coating chronology. The evidence in sample K104-II-4 shows that four generations of unpigmented limewash were applied to the plaster before the support board was installed. Sample K104-II-5 was taken just below the white band where K104-II-4 taken, in an area where a layer of yellow has overlapped. This chronology consists of generations 1 through 4, ending with one layer of dark yellow-pigmented limewash. The comparative limewash chronologies are shown in the chart below.

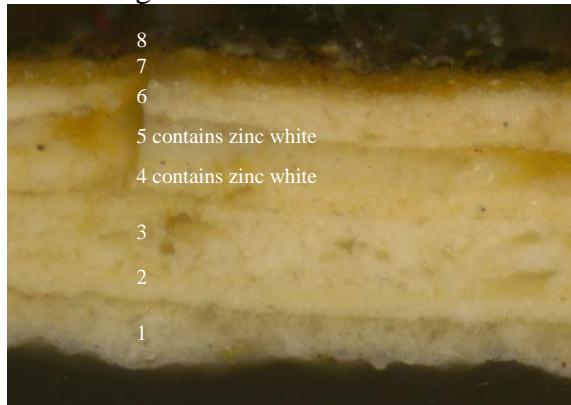
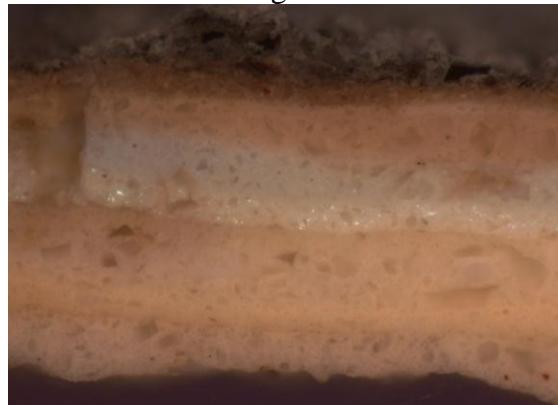
Sample K201-II-6. West wall, south window, rail between transom and glazed window, is this an earlier element?

When sample K201-II-6, from the Period I fixed window on the west wall, is compared to K102-6 (from the first round of analysis) the sequence is the same, with six generations of cream-colored oil-bound paint, followed by a light brown paint and then the most recent dark brown layer on the surface. Sample K201-II-5 from the top rail of the later glazed window shows that the paint history starts at generation 5 (trapped in the wood). The cream-colored layer in generation 5 has a characteristic sparkly appearance in reflected ultraviolet light, indicative of the presence of zinc white, which was commercially available after about 1845.¹⁰ This evidence shows that the window trim was cream-colored, like the main house, in Period I, and continued to be painted with cream-colored paints into the late nineteenth or early twentieth century.

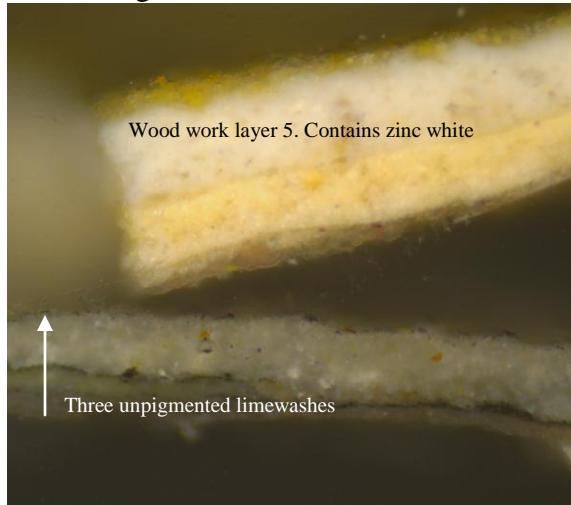
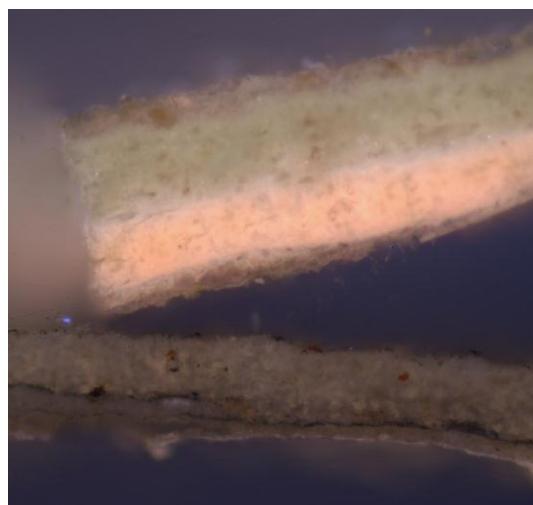
Examination of the wooden curtain support showed that the blue-pigmented limewash on the walls was brushed over earlier limewashes, as well as over oil-bound paints. In cross-section K201-II-2 the initial coatings consist of a sequence of unpigmented limewashes with dirt trapped between each layer. The samples fractured apart, but a separate flake suggests that these initial limewashes are followed by a cream-colored woodwork paint and then an off-white woodwork paint that contains zinc white which can be aligned with generation 5 in the woodwork paint sequence.

Sample K201-II-2. West wall, north window, wooden support for curtain hanger, northwest corner. Paints separated apart.

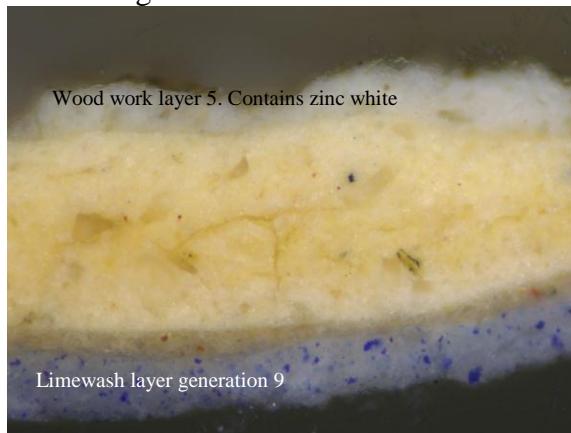
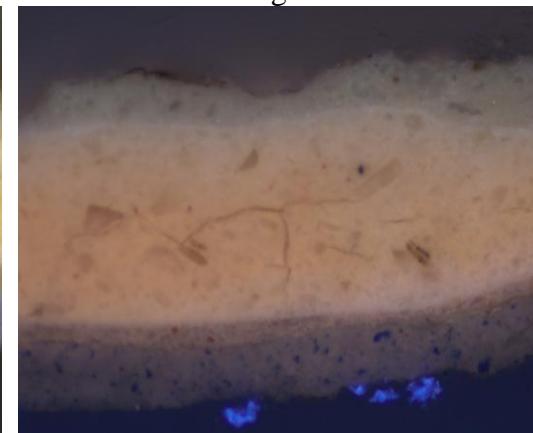
The wooden curtain support was re-sampled during the November 2012 site visit to clarify the paint history. Because of its position directly above the door architrave this curtain hanger has been coated with wall paints and woodwork paints. Several cross-sections were examined to confirm the paint sequence on this element. In one cross-section the first layer is the blue-pigmented limewash found as generation 9 on the walls. This is the layer pigmented with synthetic ultramarine that was found to be related to the 1858 redecoration of the double drawing. This blue limewash is followed by the same cream-colored and off-white woodwork paints found in the other plaster samples. In the second cross-section the blue limewash seems to have been applied on top of the three initial unpigmented limewashes. This blue-pigmented limewash above the unpigmented limewashes confirms the curtain hanger was likely installed between Period II and III.

Sample K201-II-2. Curtain support in northwest corner re-sampled.
