**Paint Investigation
Aiken-Rhett House
Charleston, South Carolina
REVISED DRAFT
Kitchen/Laundry and Stable
Interior Paints**

For: Winslow W. Hastie
Director of Preservation and Museums
Historic Charleston Foundation
40 East Bay Street
Charleston, South Carolina 29401

Conservator: Susan L. Buck, Ph.D.
303 Griffin Avenue
Williamsburg, VA 23185

Date: January 2, 2013

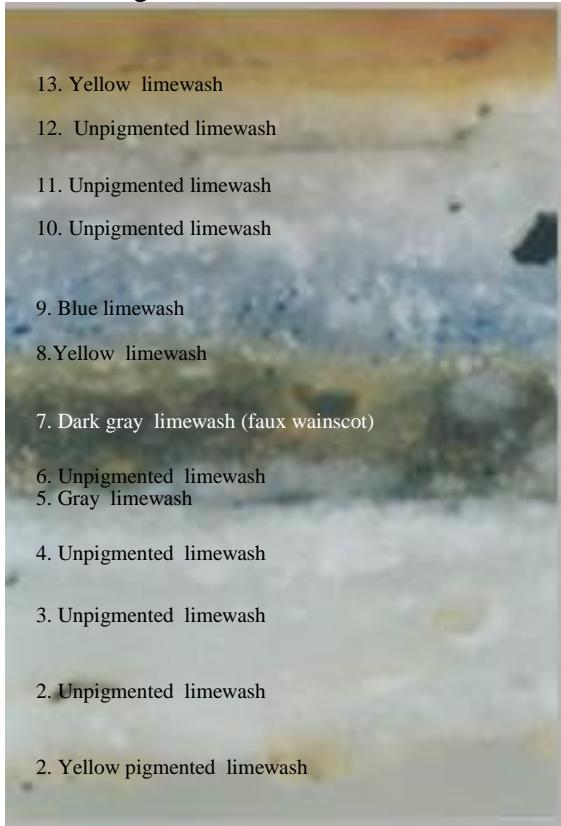
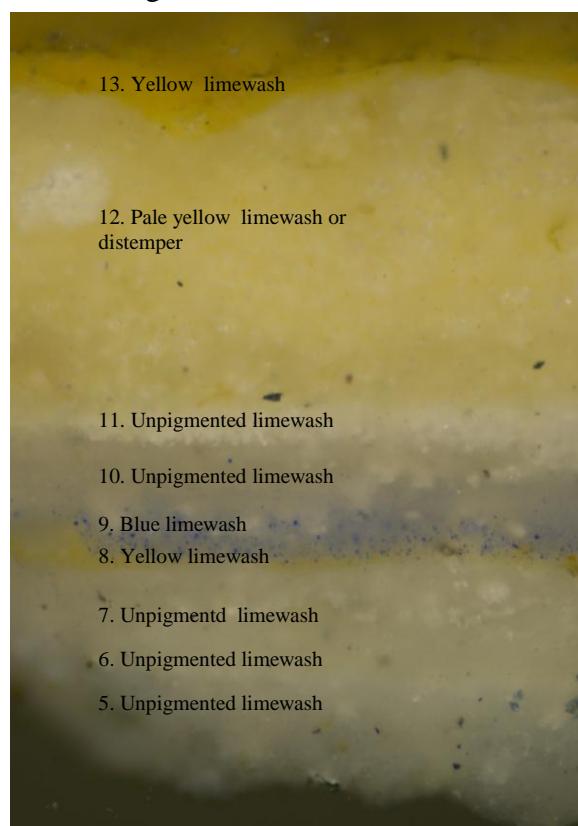
K201-2. South wall, below chairboard level. K201-II-3. East wall, left of fireplace
Visible Light 100X Visible Light 100X

The dissertation analysis identified 13 generations of limewash on the Period I plaster on the south wall below chair board level (sample K201-2) in the kitchen chamber, with the blue-pigmented limewash in generation 9.¹¹ In this cross-section there are two dark gray limewashes in generations 5 and 7, suggesting that these were times when there was a dark faux-painted wainscot on the walls. The walls above the painted wainscot in generations 5 and 7 were unpigmented limewashes (see samples K201-2 and K201-II-3 below). The color differences in the photomicrographs relate to slight differences in illumination, color printing, and color capture.

painted mantel in the third generation as there is a thick, dark gray-pigmented limewash or distemper paint layer here that was not found on other areas of Period I wall plaster. This dark gray paint is followed by a thick, cream-colored, oil-bound paint found on the woodwork as generation 6.

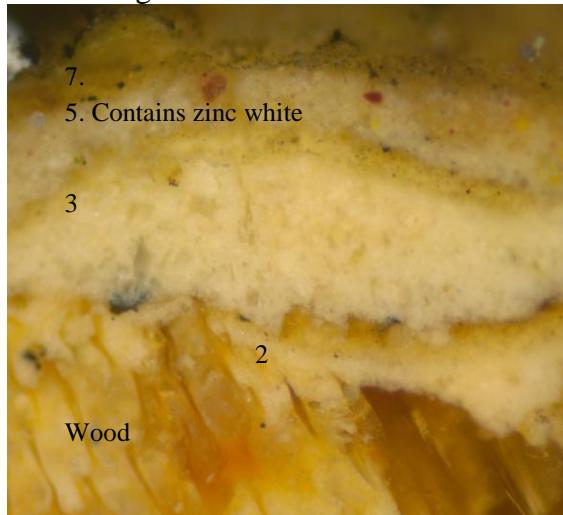
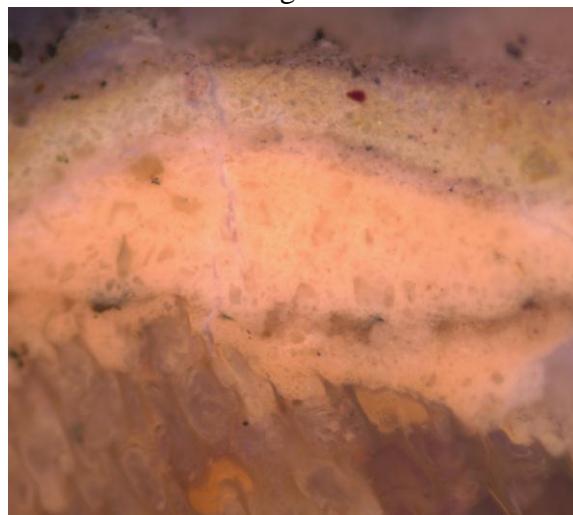
Sample K202-II-2. West partition wall, window left of door, window frame, right side, about 4' up to establish chronology.

The two samples from the window frame and upper sash have related paint chronologies (K201-II-2 and K201-II-3, respectively). There are only four generations of paint on the window trim and sash, beginning with a cream-colored paint and associated varnish that line up with generation 2 on the Period I fixed window in room K201. The balance of the paints on the window relates to generations 3, 5 and 7 on the K201 woodwork.

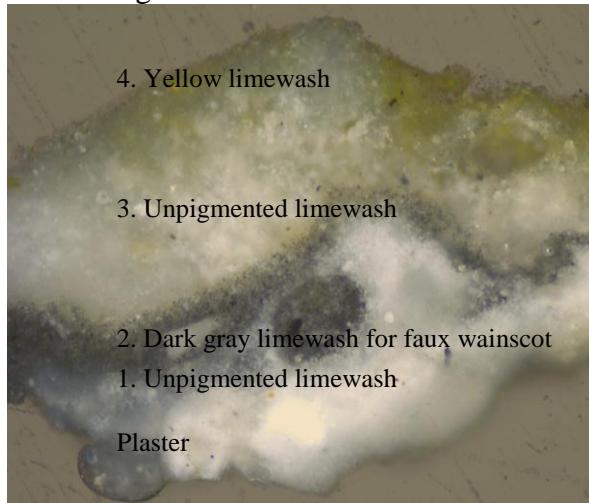
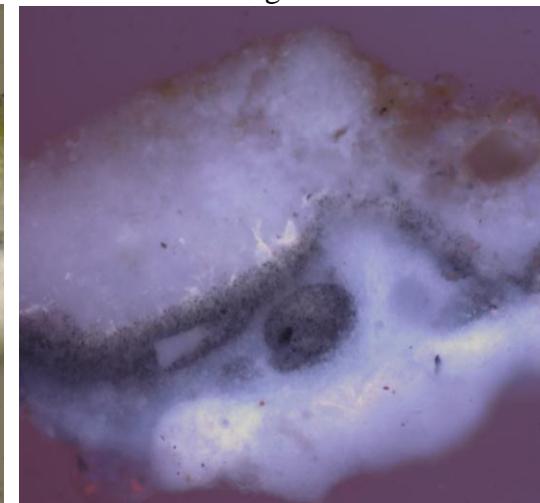
Sample K202-II-1. Plaster with yellow wash on Period II west partition wall, about 4 ½' up. Yellow paint on top of black-painted wainscot.

The layers in sample K202-II-1 from the plaster are somewhat disrupted, but they confirm that there is one layer of unpigmented limewash on top of the Period II plaster, followed by the dark gray limewash used to create the faux-painted wainscot. There is one more unpigmented limewash on top of the dark gray limewash. The uppermost yellow-pigmented limewash is the current yellow color on the walls. It is likely that the walls in this room have not been repainted since the Period III or just slightly later, given the paucity of wall coatings.

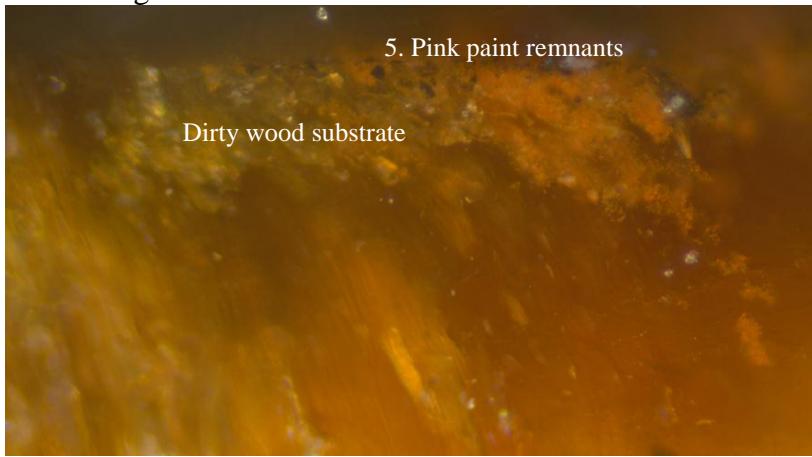
Sample K203-II-2. North wall, pink paint on crude curtain support structure, stile on right side, one piece is circular sawn.

The paint evidence suggests the curtain support on the north wall was initially left unpainted as there wood substrate in sample K203-II-2 is quite dirty, while the paint directly on top of the wood is the most recent dark pink paint. The paint history on the peg rail (K203-II-4) does not resemble the coatings found on any of the other pegrails. The first paint layer is a dark red brown oil-based paint, and this layer became quite weathered and fragmentary before a shellac coating was applied. The peg rail was later coated over with a brown paint that is the same as that identified as generation 11 on the woodwork in K101. After substantial dirt accumulated, the peg rail was painted black, and then finally the current pink. The original red-brown paint on the peg rail may have matched the first red-brown paint which was found on the door during the dissertation phase of research.¹³

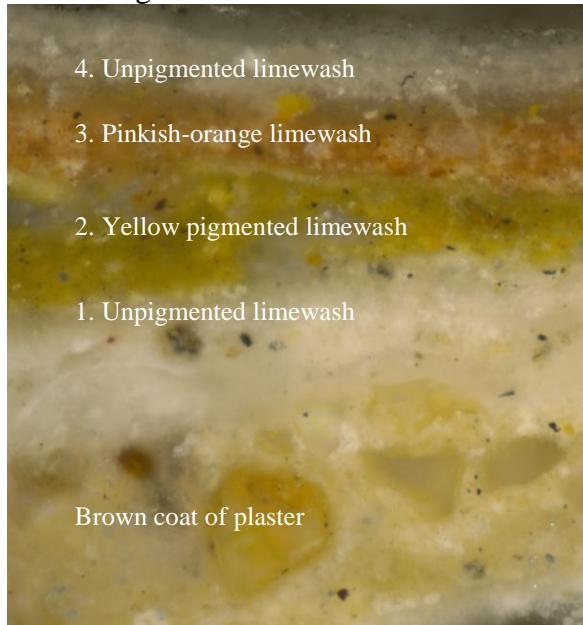
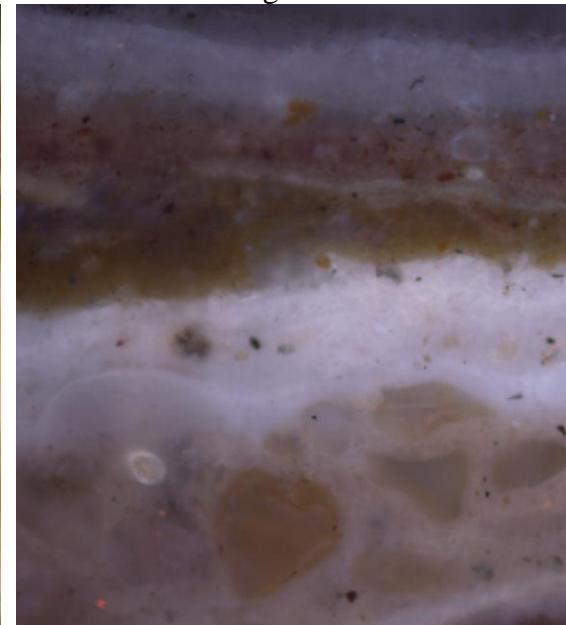
Sample K203-II-3. West wall, on grayish ghost behind position for former curtain support for comparison.

When the wall plaster was analyzed during the first phase of research, eight generations of coatings were found on the walls, beginning with an unpigmented limewash, followed by a yellow-pigmented wash, and then an orange-pigmented limewash. This same sequence of coatings was found on the ghost for the missing curtain support on the west wall of the room (sample K203-II-3). The most recent coating in this cross-section is a now-degraded unpigmented limewash layer in generation 4. This suggests that the curtain support was installed before the fifth generation of limewash was applied. This is perhaps an indication that the curtain support is a nineteenth-century element, but was initially left unpainted, as shown in sample K203-II-1.

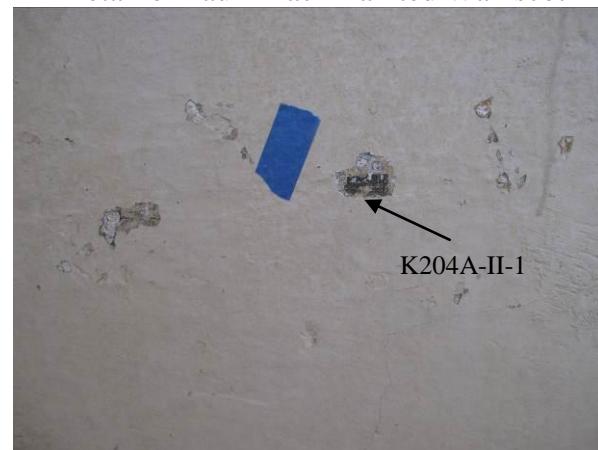
Detail of Faux Black-Painted Wainscot

K204A-II-1. East wall, near join of Period II building, faux black wainscot can be seen below peeling paint. There are at least two generations of gray/black wainscoting on the wall. (See K204A-10.)

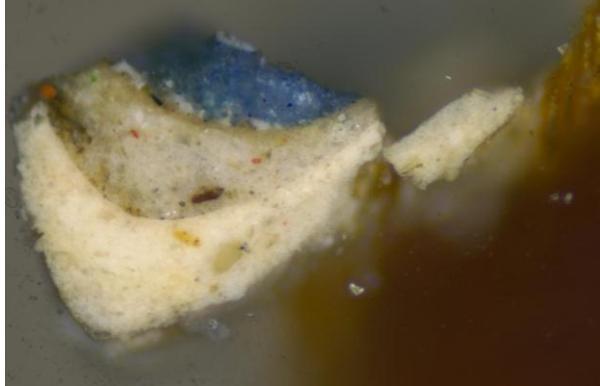
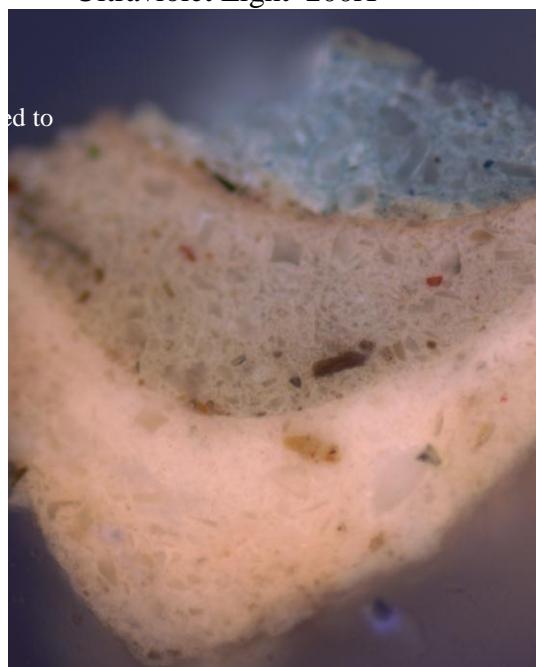
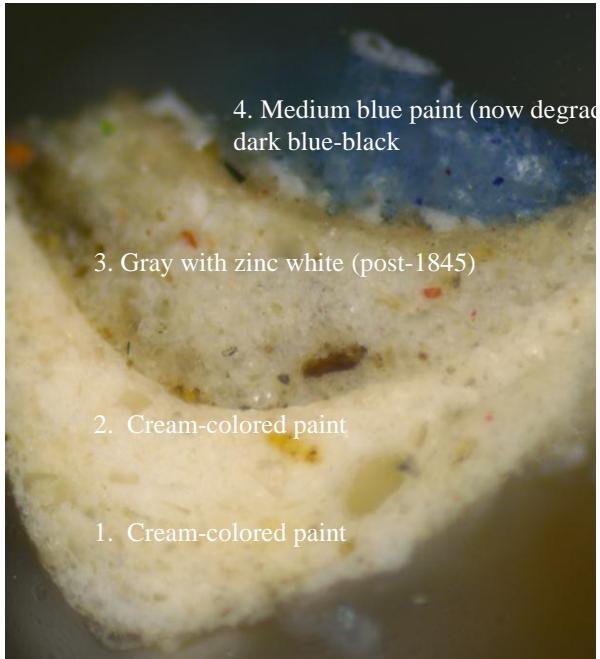
Sample K204B-II-4 East wall rob window, upper left corner of window frame (early blue paint is present).

The sole woodwork sample in this hall was taken from the rob window at the north end. There are only three generations of darkened paints in sample K204B-II-4, but the evidence clearly shows that the window was originally painted with the same type of cream-colored, oil-bound paint found as the first layer on the Period II rob window in room K202 (see sample K202-II-2). This is followed by another cream-colored paint, and then a grayish-white paint that contains zinc white in generation 3. The most recent woodwork paint is a medium blue paint that has now darkened to almost black.

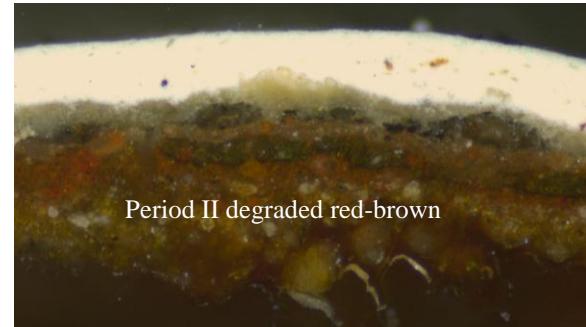
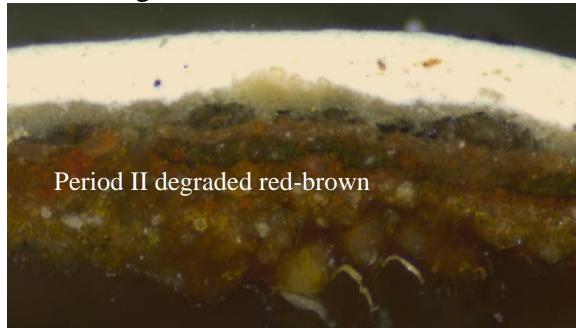
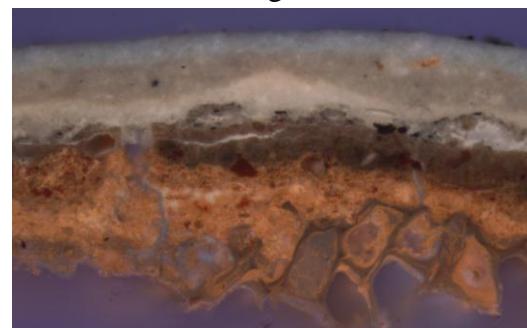
Sample K205-II-3. West wall, board door, left side, at edge of middle left board, about 5' up.

The first paint on the board door is a thick resinous red-brown coating that is now very degraded. It resembles the first (Period II) red-brown with varnish identified on the board door separating rooms K101 and K102 (see below). This door was then repainted dark green, followed by brown and then black. These two board doors seem to have been painted in the same manner until the most recent coatings, suggesting they were both installed in Period II.

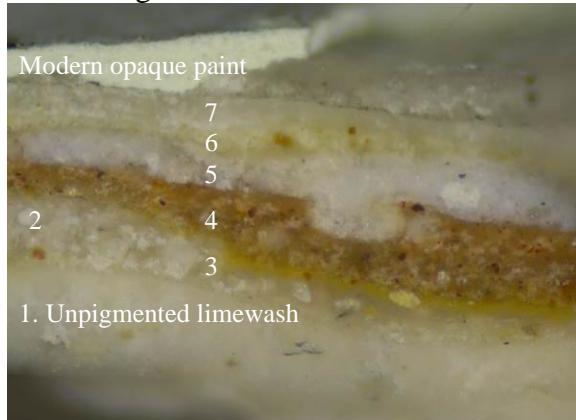
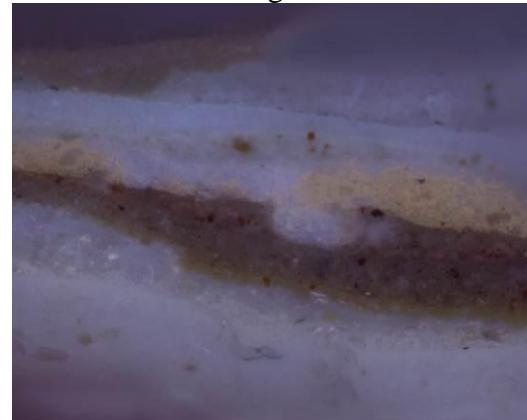
Sample K205-II-1. East wall, centered between chimneybreast and south wall, plaster about 5' up. (Compare to K205-2).

Samples taken from the upper and lower portions of the east wall confirm that this room did not have a faux-painted wainscot. The walls were initially limewashed white, then were re-limewashed yellow in generation 3 and orange in generation 4 in this room. All subsequent coatings were whites, and the evidence shows that these walls were repainted with far less frequency than the passage or the north chamber K206.

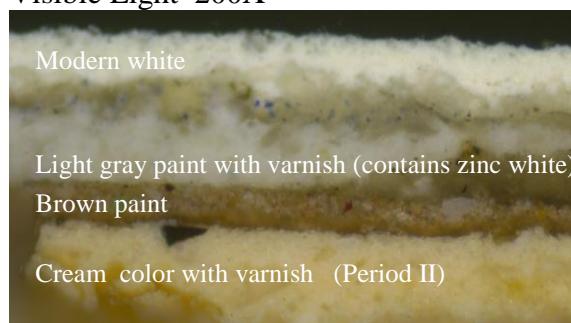
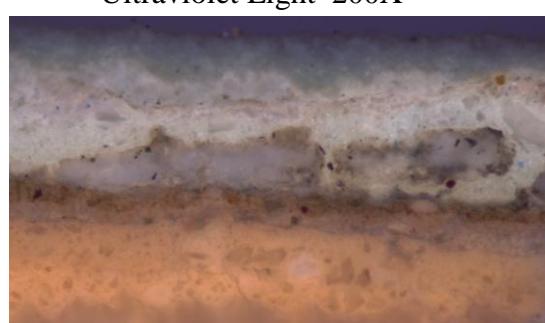
Sample K206-II-1. South wall pegrail.

South Wall Pegrail. Sample K206-II-1 from the pegrail begins with an oil-bound cream-colored paint which has a varnish coating. This coating can be aligned with the first paint layer found on the frame for the rob window in K202, and it seems to be the Period II window paint. The same paint was also found as generation 2 on the Period I window in room K201. This is followed by a medium brown paint, and then a light gray paint which contains zinc white, dating it to after 1845. The most recent paint is a twentieth-century nonfluorescent white. The paints on this pegrail do not resemble any of the other pegrail coating sequences in this building.

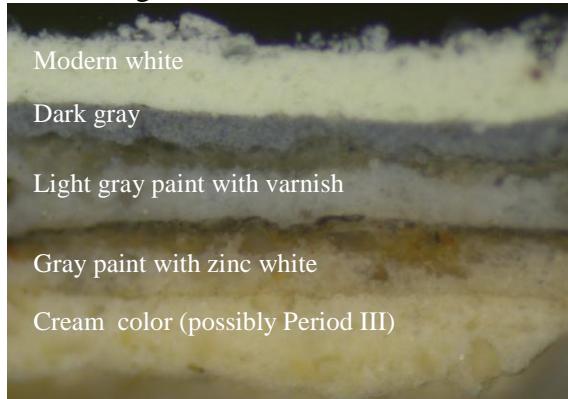
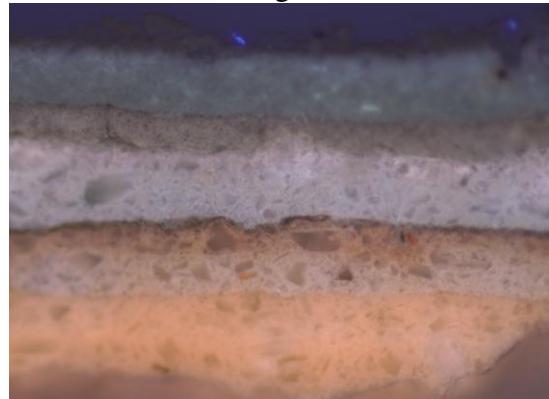
Sample K206-II-2. North wall, inserted window, likely in Period III, reveal on left side, to establish the later paint sequence.

North Wall Window Reveal. The paint sequence in the cross-section from the reveal of the window also begins with a cream-colored paint layer that may line up with generation 3 in the woodwork paint chronology for room K201. It appears to be one generation later than the first paint identified on the pegrail, and may well be the Period III coating on the second-floor windows in this building. It is followed by the same light gray paint which contains zinc white that was used on the pegrail.

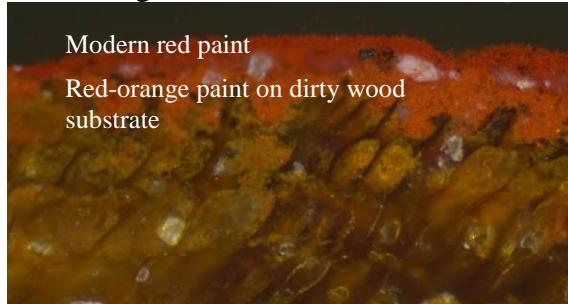
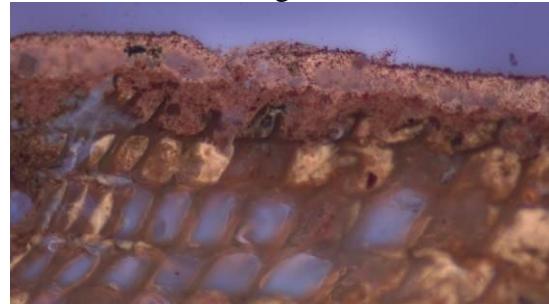
Sample K206-II-3. North wall, inserted window, likely in Period III, red paint on exterior of window frame.

North Wall Exterior Window Frame. The evidence in this sample suggests that the exterior paints were allowed to completely weather away as the wood substrate is fibrous and dirty. There is only one layer of finely ground red-orange, followed by red paint, in this cross-section. Both paints likely applied by Jim Crow (HCF) as they are on top of a new thin board nailed to the front of the window frame.

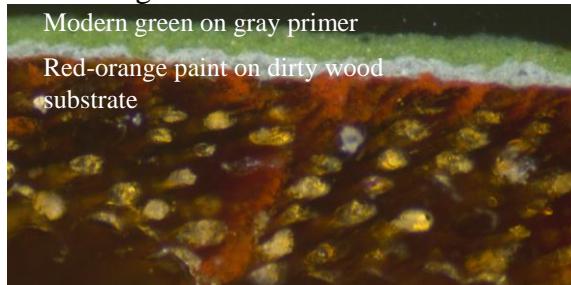
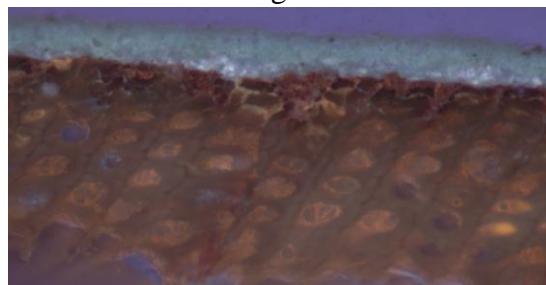
Sample K206-II-4. North wall, inserted window, likely in Period III, green on exterior of underside of Gothic arch, left side.

North Window Exterior Gothic Arch. No early paint remains on the underside of the arch as the wood substrate is darkened and weathered. Only the most recent two generations of modern, finely ground paint are on top of the wood.

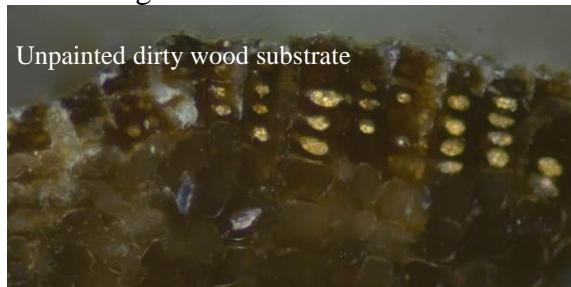
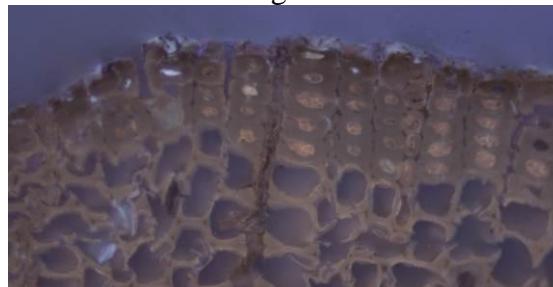
Sample K206-II-5. North wall, inserted window, likely in Period III, back side of louvers for Gothic window.

North Window Louvers. This cross-section K206-II-5 suggests that no early paint remains on the louvers, or the back sides of the louvers for the arched Gothic windows were never painted.
