AN ARCHITECTURAL INVESTIGATION OF  
**79 ANSON STREET**  
CHARLESTON, SOUTH CAROLINA

Willie Graham, Carl Lounsbury and Orlando Ridout V  
for the HISTORIC CHARLESTON FOUNDATION  
10 March 2005

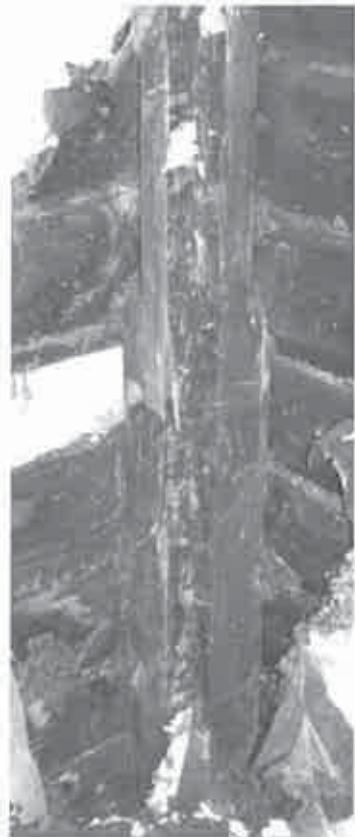
The piazza originally was constructed with six-by-six-inch support posts that were square in section up to plinth level, and then tapered into octagonal columns above lamb's-tongue chamfer stops. Many of these posts and the original balustrade survive on the western face of what was the second-story piazza, buried in the later exterior walls that were added when the upper piazza was enclosed about 1827. The balustrade is composed of molded cap rails, square-section balusters, and a plain bottom rail.

As part of the ca. 1827 work, the original posts and railings were removed entirely at first-story level and replaced with wood columns and a new balustrade. At second-story level, the old posts were retained where they could be used as structural members for the new wall, but it was necessary to chop the interior faces back to accommodate the depth required for the new wall. The balustrade became extraneous, but was left in place, and new

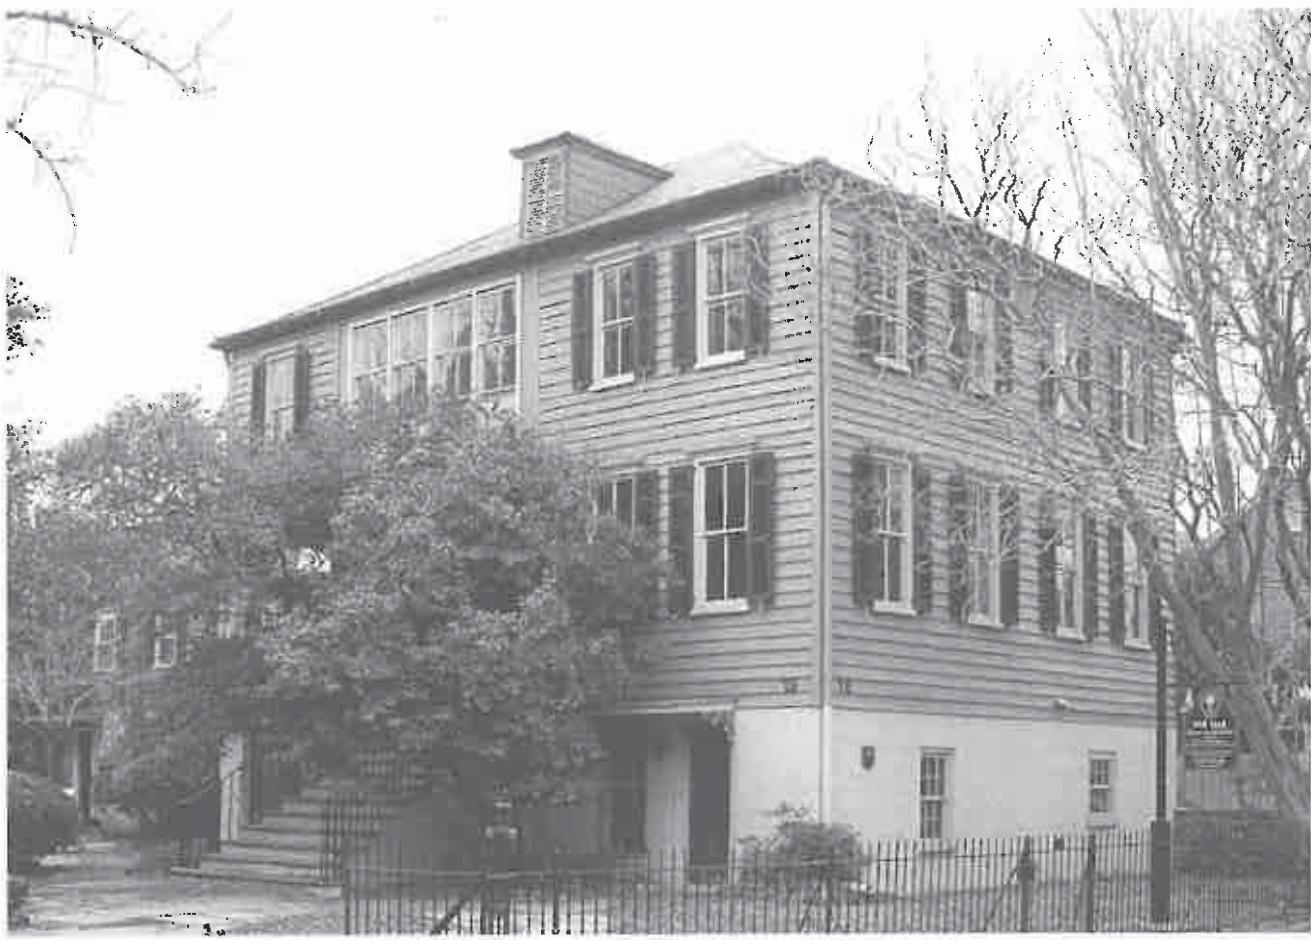
The brick foundation on the east elevation has been rendered with a thin coating of stucco. Original scored imitation ashlar coursing is evident, including splayed arches above both cellar window openings. The first and second stories are sheathed with beaded weatherboards trimmed with beaded corner boards; the cornice matches the south elevation. A large chimney originally pierced this plane of the roof, serving back-to-back fireplaces in the two east rooms of the first and second floors. In 1956 this chimney was demolished down to the

level of the first floor and the roof was reframed and covered with slate. This change occurred because of a desire to add bathrooms and modern utilities between the east chambers. It is curious to note that the infill rafter and sheathing visible from the attic appear to date earlier than the mid-twentieth century, but is probably material salvaged from the west wing that was demolished as part of the 1956 work.

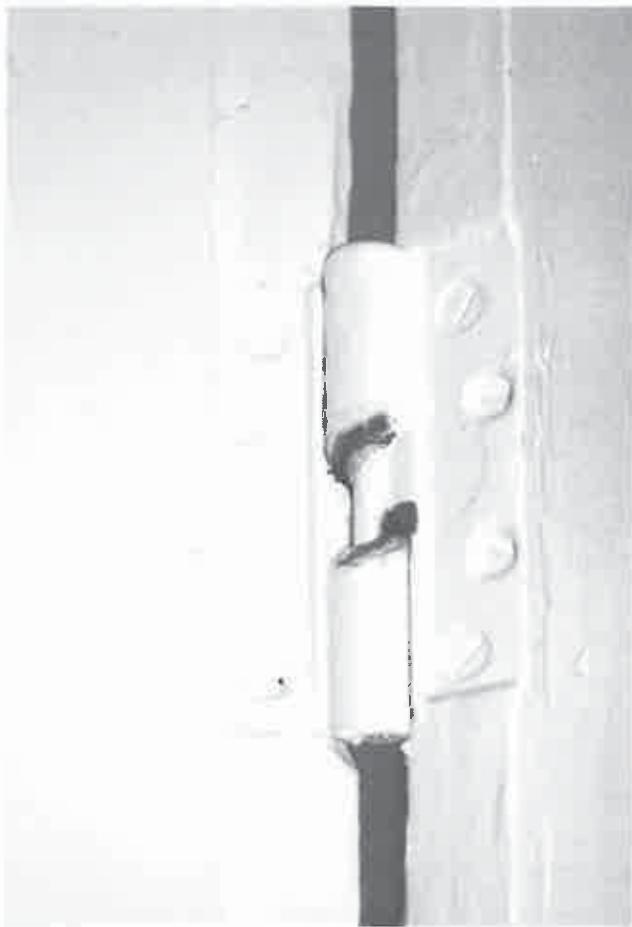
As noted previously, originally this room was only accessible from the piazza and possibly through the partition shared with the northeast room. In 1956, the piazza door was blocked and a new opening was cut through from the central room to create a more conventional circulation plan. Creating that new door required cutting through a structural down brace, leaving no doubt that a door opening was not initially intended in this location. The new opening was trimmed with an early single architrave with ovolu backband and bead and was fitted with a six-panel door hung on cast-iron raising butt hinges. The

trim, door and hinges were probably reused from a closet that was eliminated when the chimney was demolished in 1956—perhaps taken from the second floor.
