CROSS-SECTION MICROSCOPY ANALYSIS RESULTS

Client: Glenn Keyes Architects
12 Vanderhorst Street, Charleston, SC 29403

Date: November 29, 2006

Object: Interior Surface of Front Door
Aiken-Rhett House, Charleston, South Carolina

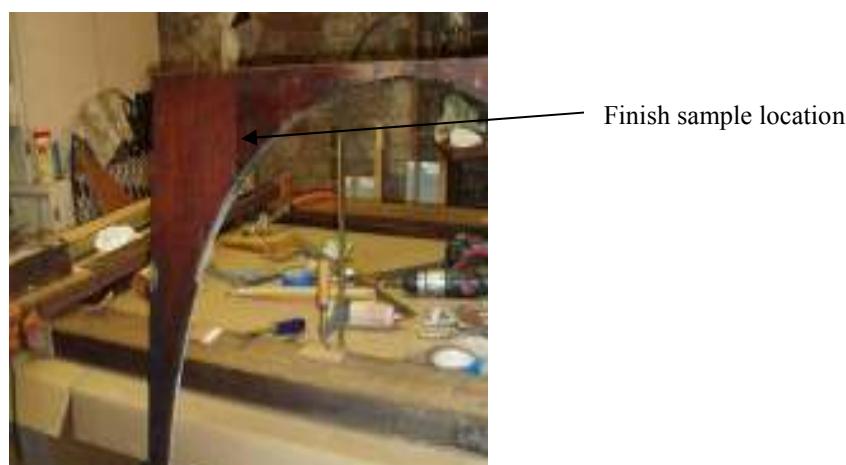
DCF: Positive for the presence of oils in the wood and in the first and third pigmented oil-resin varnish coatings.

Comments: The cross-section analysis results show that the finish history in this sample begins with a pigmented plant resin varnish with an oil component. There are brown and red pigments widely distributed and suspended in this layer, which confirms that the surface was not originally stained, rather the mahogany color was enhanced by using a pigmented varnish. The second generation is a clear plant resin varnish and the uppermost layer appears to be a degraded, grimy layer of pigmented plant resin varnish. The first layer has penetrated into the wood fibers and also remains as a legible layer on top of the wood. This suggests that this may be the first layer of varnish applied to the door and that the interior surfaces were not stripped. It is likely that the exterior surface of the door was originally finished in the same manner, although this type of natural resin coating would not have been a durable exterior coating. No evidence of any early coatings was found on the exterior of the door during earlier investigations.
