COE HALL INVENTORY WORKSHEET

PLANTING FIELDS FOUNDATION

Introduction

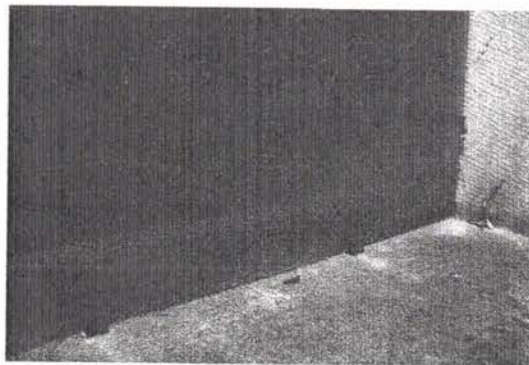
Detail showing how the Plexiglas was attached

Next we removed the stained glass window. The window was set into the stonewall. A channel had been cut to accommodate the upper panels and glazing putty held the leaded window in this channel. The putty was chipped out to release the leaded upper window sections. The main sections of stained glass were installed into hinged steel frames. The glass was sealed with glazing compound and attached with removable steel moldings. After removal, the panels were placed in padded crates to be transported back to the studio. The Plexiglas was then re-installed temporarily to cover the openings.

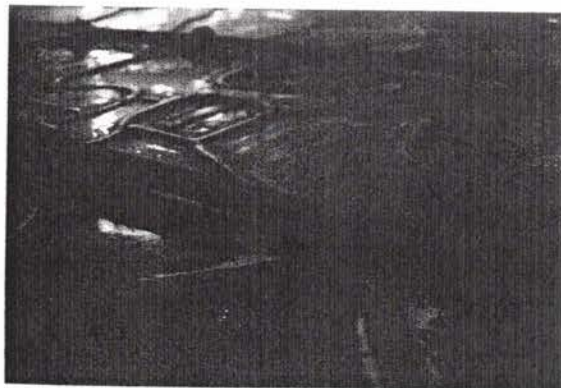
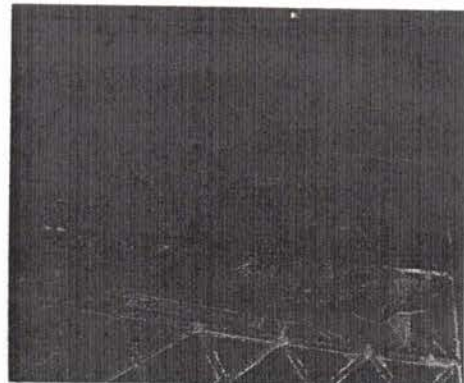
Detail showing the rebars, one crossing Queen Elizabeth's head

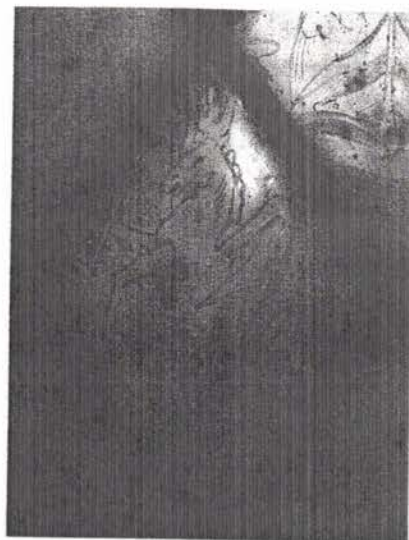
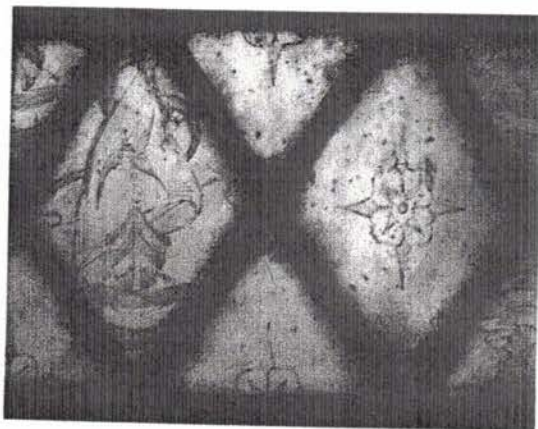
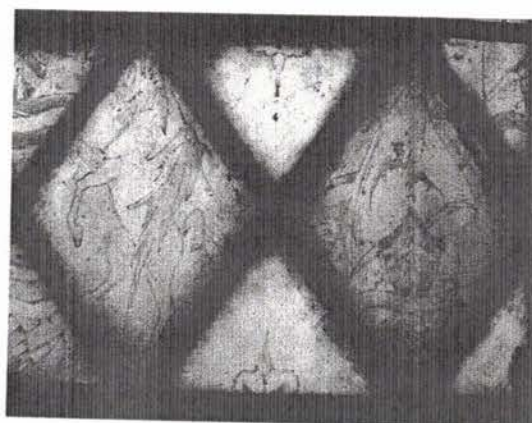
The diamonds were well fired and were not exhibiting paint loss. The paint style (ornaments with silver stain) is reminiscent of other patterns produced during this period by firms such as Cottier and Co.

Details of the painted diamonds

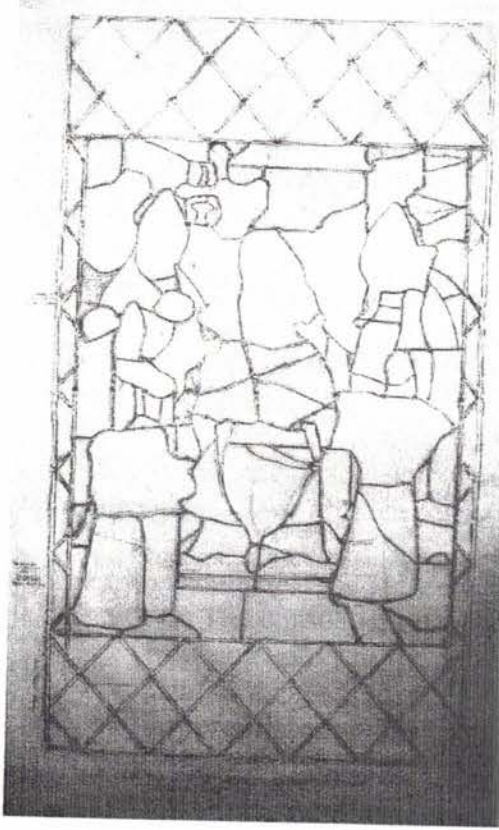
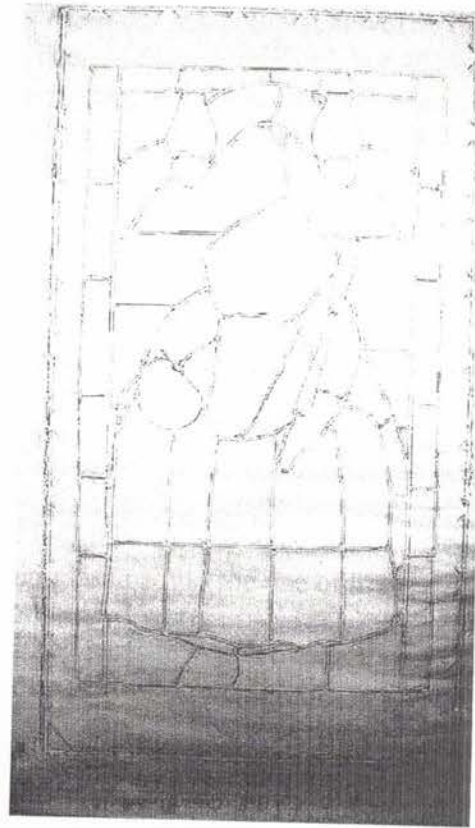
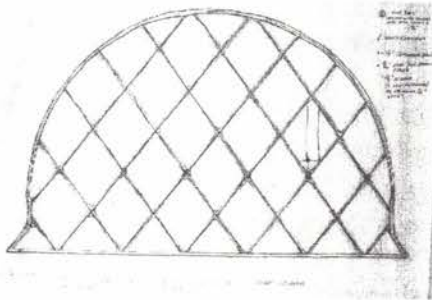
At this point we identified and documented replacement pieces of glass on St. Nicholas's gown, his staff and some surrounding decorative pieces. There were also some stopgaps. The diamond panel at the bottom of the St. Nicholas window was bulging. We also identified and documented stopgaps in the Queen Elizabeth figural panel and 3 replacement diamond pieces. (See pictures of rubbings.) A brown rubbing was made and used as a pattern for the re-glazing of the panel.

Vellum rubbings for the St. Nicholas stained glass window

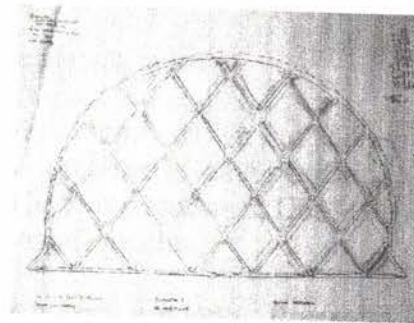
Vellum rubbings for the Queen Elizabeth stained glass window

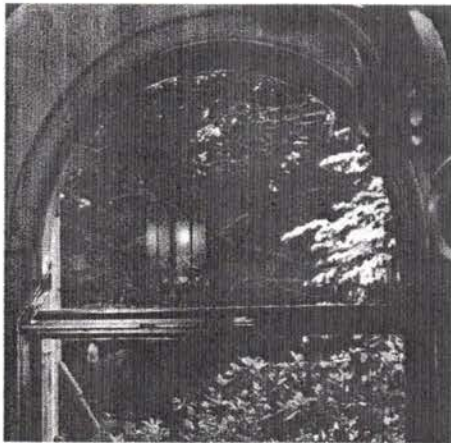
*Detail showing the precise fit of
the frame into the stonewall*

Metalworker John McDevitt fabricated new steel frames for the (2) stained glass windows. Very precise templates of cardboard were made particularly of the top opening (housing the diamonds), which was not a regular semi-circle. From these templates the dimensions for the frame were documented and used for fabrication in the workshop.

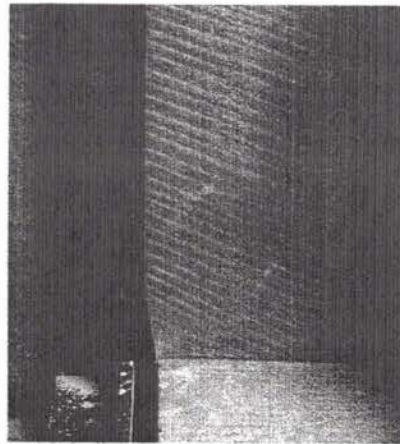
*Detail showing the frame
attached to the stonewall*

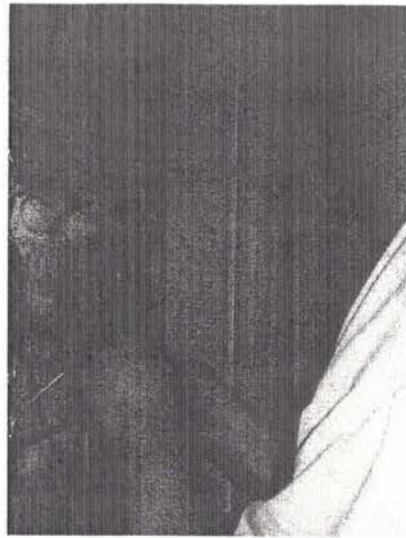
*The rebars being
tied to the window
with the wire ties*
