REPORT ON ACCIDENT TO  
AVRO ARROW 1 - 25201  
PART 2

June 11, 1958

71/ENG PUB/10

This Report is in two parts. Part 1 contains details of the accident and the investigation into the cause. Part 2 contains details of damage to the aircraft resulting from the accident, and details of the necessary repairs.

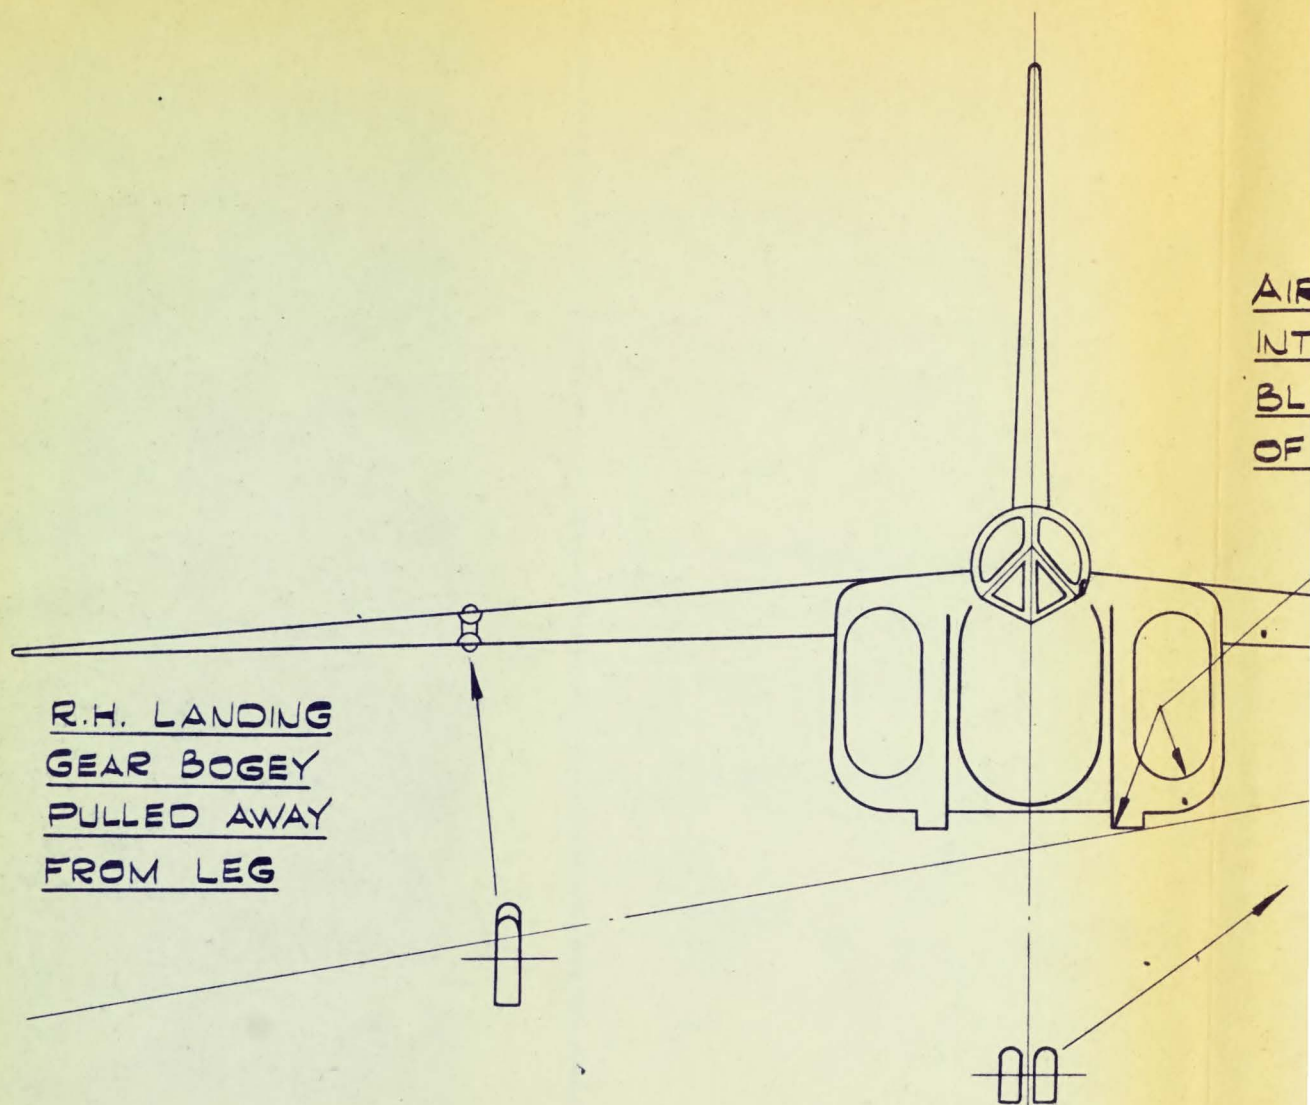
AIRCRAFT POSITION

R.H. LANDING  
GEAR BOGEY  
PULLED AWAY  
FROM LEG

NOSE LA  
PULLED  
ATTACHM  
ON NAVIC  
BULKHEAD  
NOSE WH

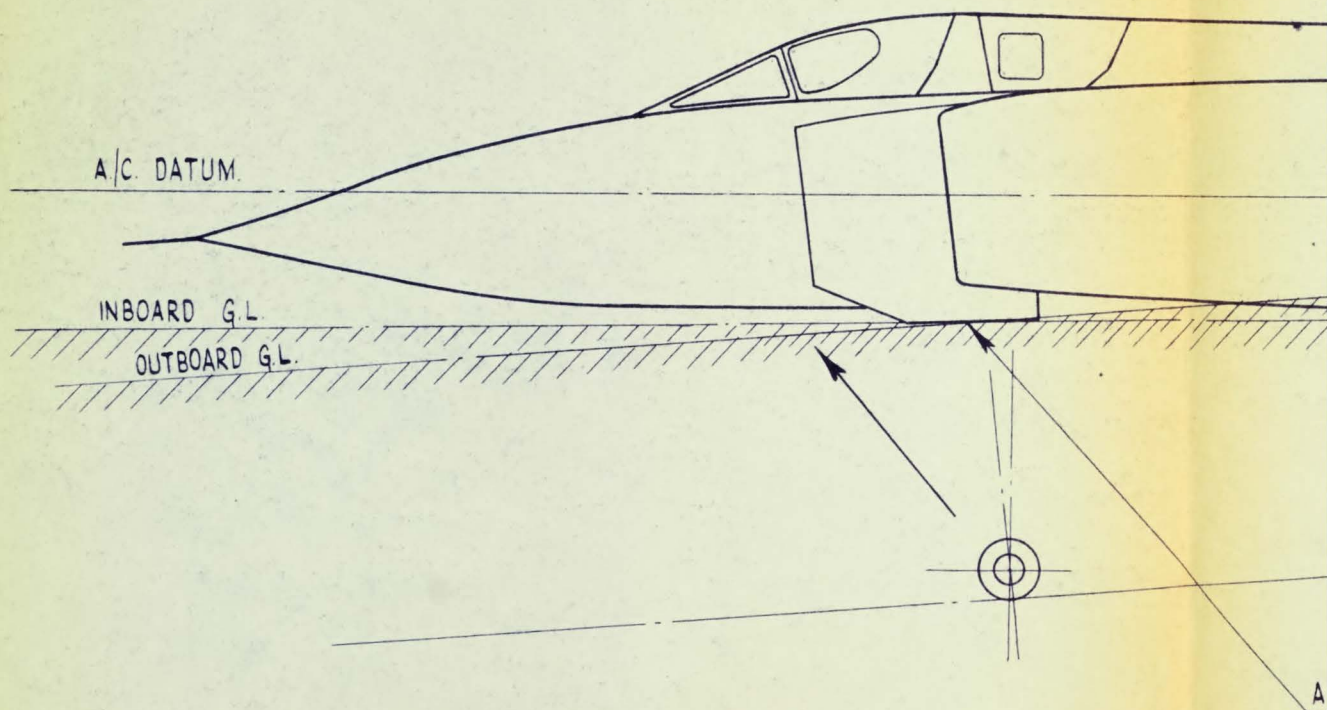
AIRCRAFT POSITION - SIDE VIEW.

OUTER WING DAMAGED  
BY MAIN LANDING GEAR.

SLIGHT DAMAGE TO  
AILERON & WING TIP.

AIR INTAKE RAMP.

ENGINE BAY FORMERS  
LOWER SURFACE BUCKLED.

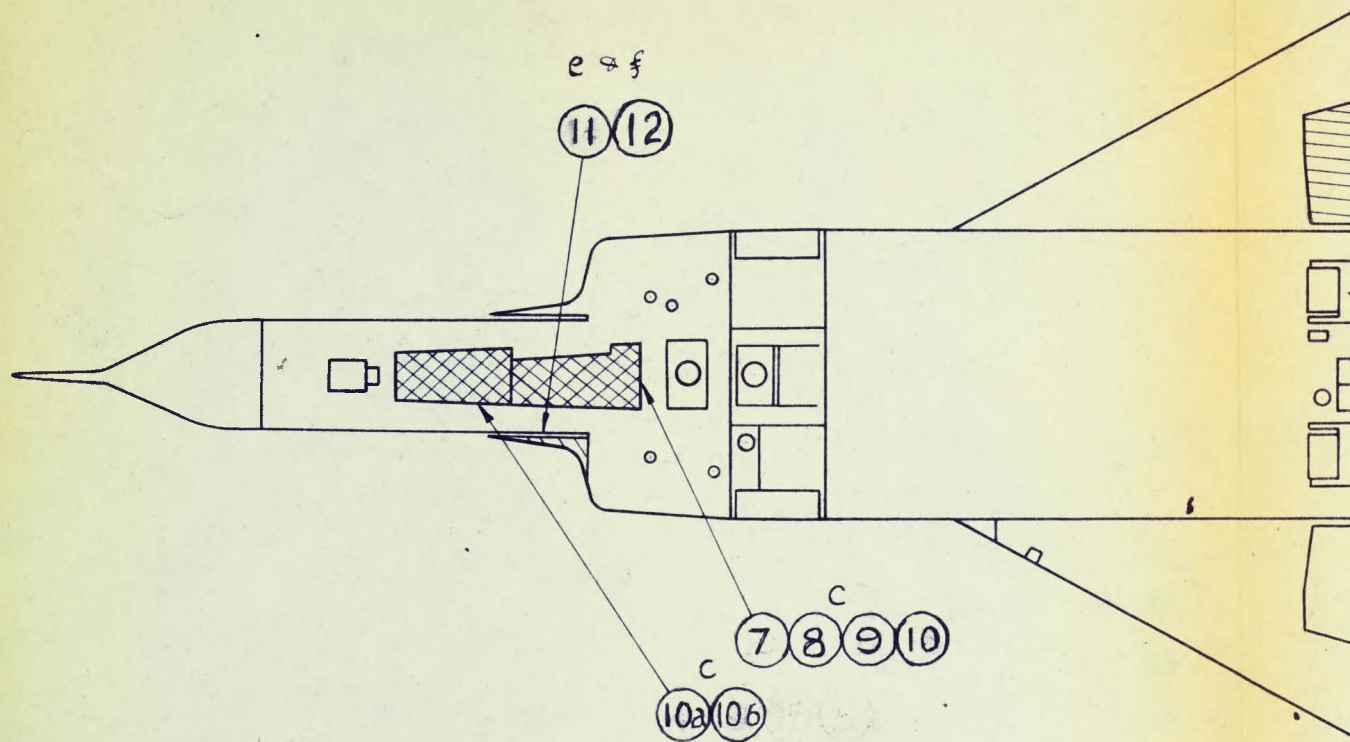
FIGURE 24

BEARING BROKEN  
L.H. & R.H. SIDES

BROKEN  
H. SIDES

BOTH OF THESE FITTINGS REMOVED FROM L.H. AND  
X-RAY AND CRACK DETECTION CARRIED OUT  
AND STRUCTURE

REPAIR L.H. SIDE  
L.H. SLEEVE REMOVED  
PIVOT FITTING REBOR  
NEW D/S SLEEVE FIT
