UNCLASSIFIED
REPORT ON ACCIDENT TO
AVRO APERCH 1 25201
AT WILTON
UNCLASSIFIED
June 11, 1958

71/ENG PUB/9

This Report is in two parts. Part I, contains details of the accident and the investigation into the cause. Part II will detail the damage to the aircraft resulting from the accident, and will be issued when the aircraft has been fully stripped and examined.

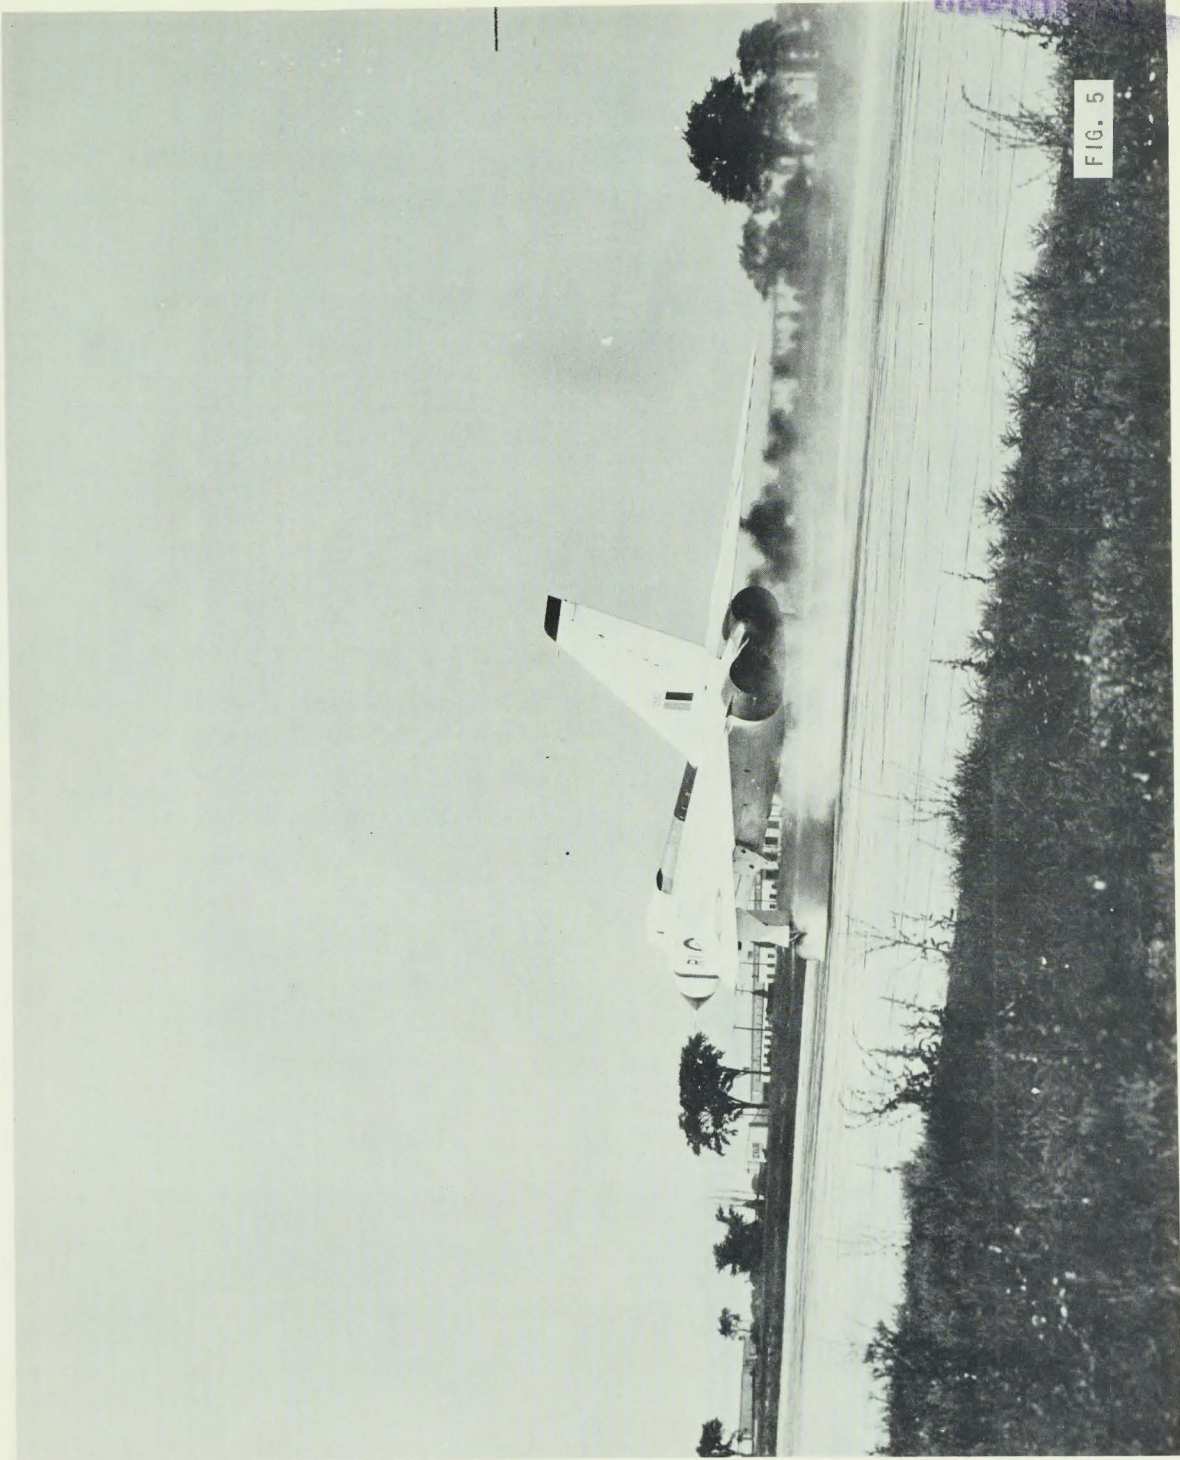
FIG. 5

5. Photograph of Aircraft Landing Run
6. Photograph of Aircraft with Chute Deployed
7. Photograph of Aircraft with Chute Deployed
8. Photograph of Aircraft with Parachute Jettisoned Leaving Runway
