REPORT ON ACCIDENT

AVRO ARROW I 25201

June 11, 1958

MALTON

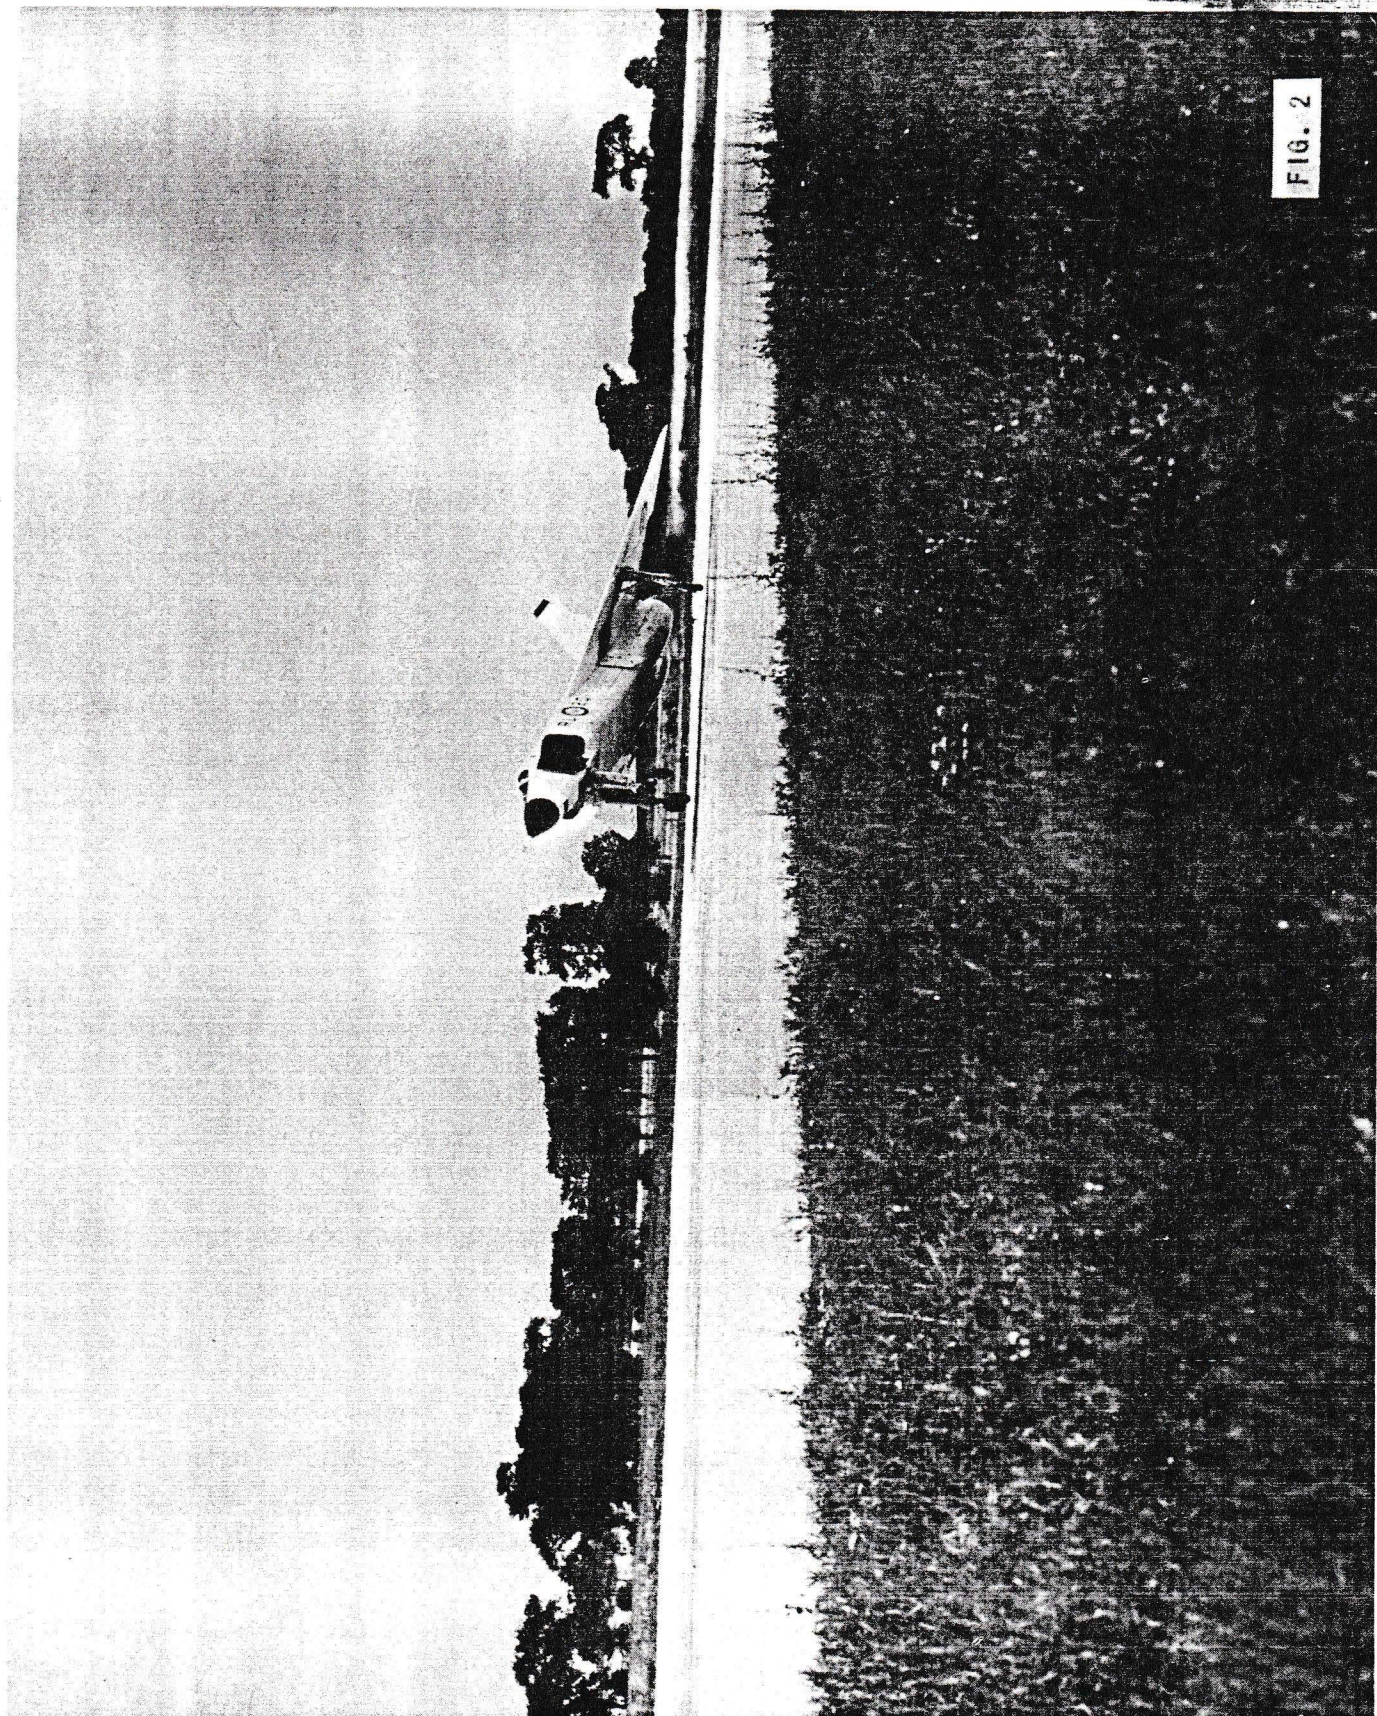
FIG. 2

The pilot selected landing gear when in the circuit for landing and as stated in section 3.2, the cockpit indicators showed DOWN and LOCKED. The aircraft touched down on the end of runway 32. (Ref. Fig. 1.) Figure 2 shows that the L.H. leg extension and turning had not been completed prior to touchdown. The partial extension can be seen and that the wheels were not in line with the aircraft's longitudinal axis.

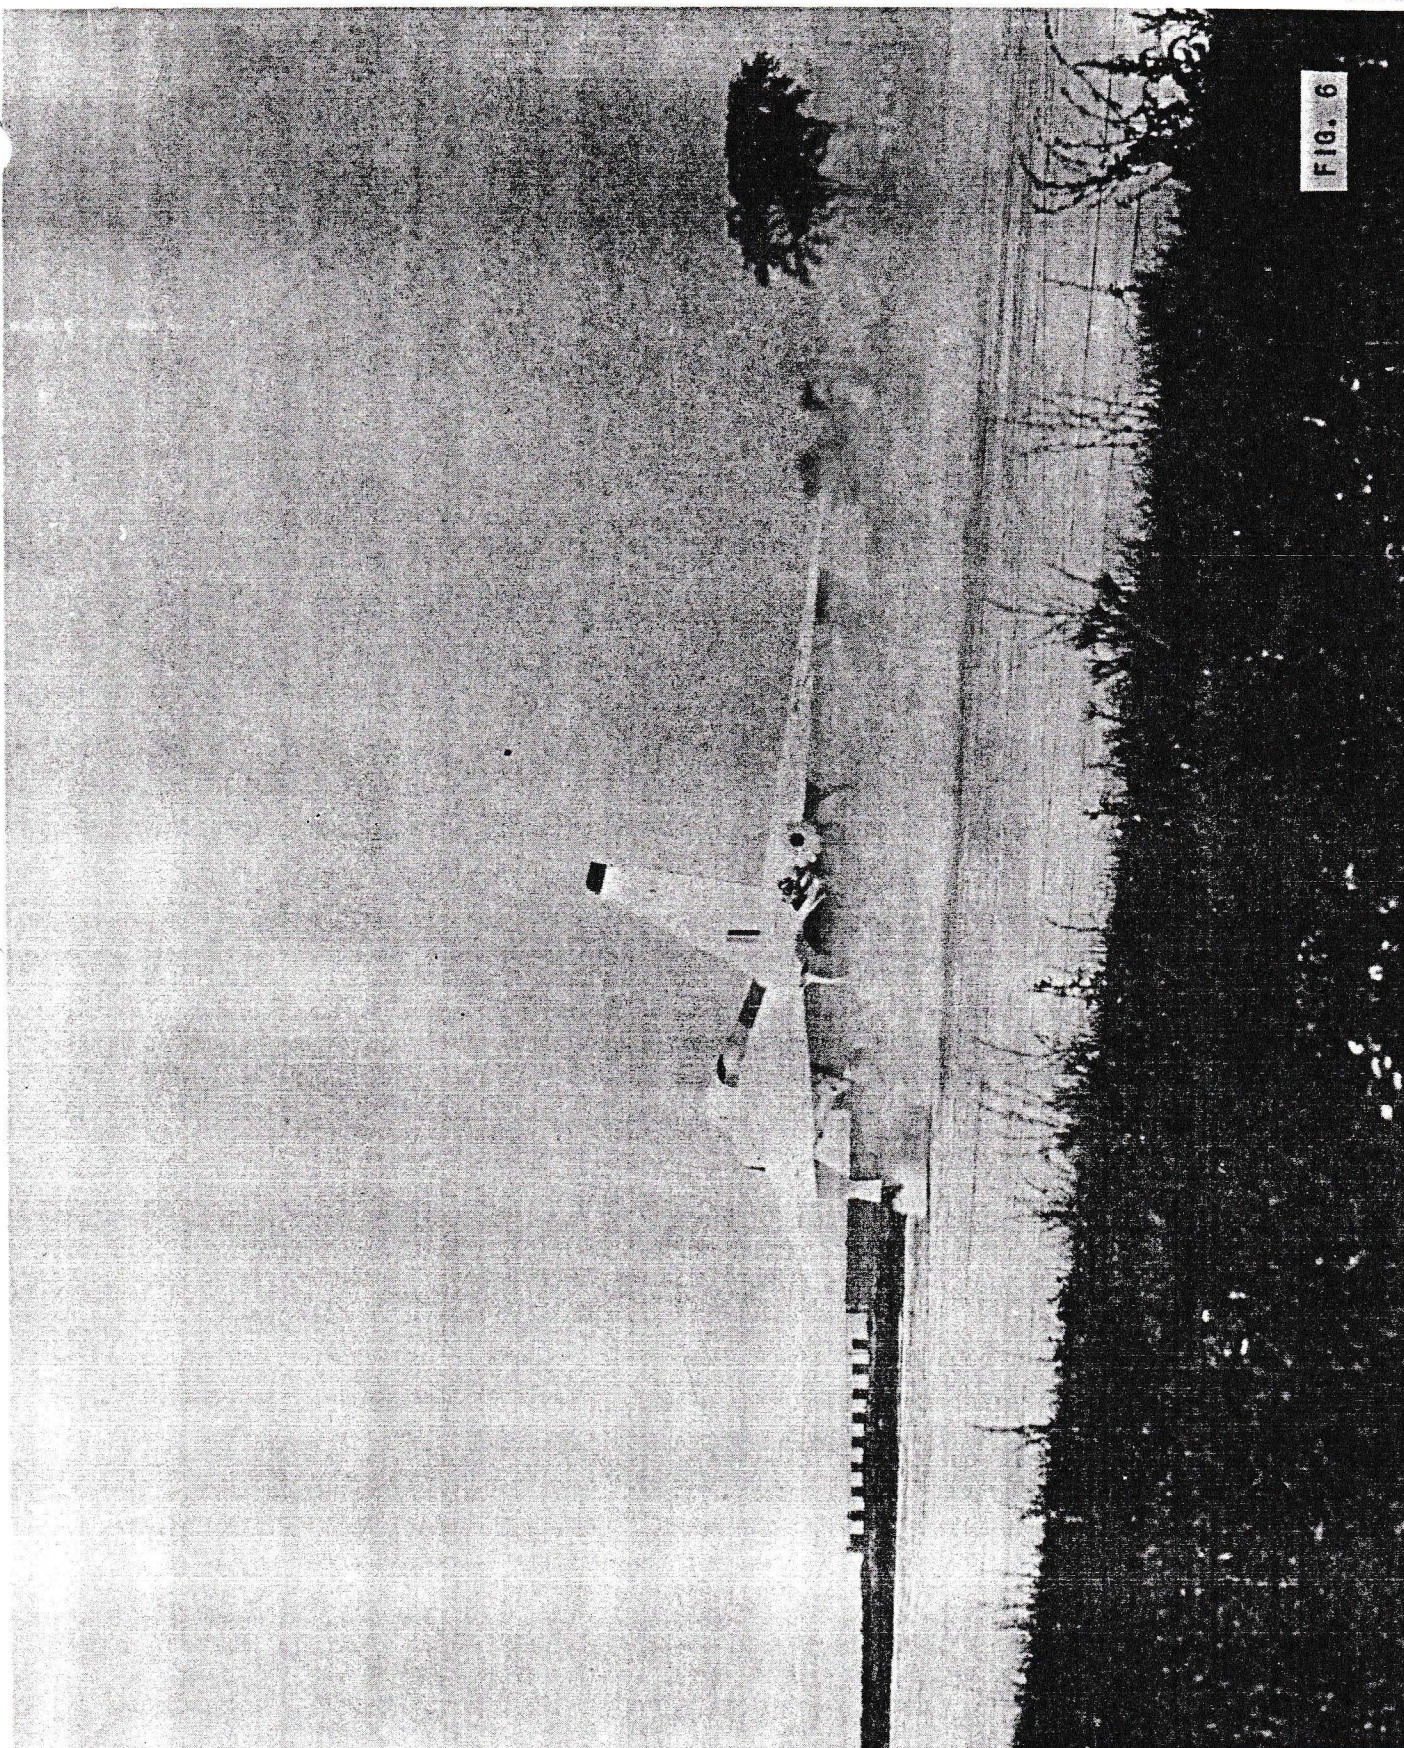
FIG. 6

Immediately after touch down (Fig. 3), the aircraft's weight caused the left-hand landing gear to turn further and assume the position which it would normally occupy when stowed in the landing gear bay (Ref. para. 3.3). The drag chute was then deployed. Figure 6 shows smoke coming from the left-hand tires, due to their misalignment with the aircraft's path. The aircraft continued to swing towards the left-hand side and corrective brake action had no effect in arresting the swing. The pilot then considered that the drag chute may be causing the swing and jettisoned the chute. Figure 7 shows the aircraft in various positions until it left the runway. When the left-hand wheel struck the soft ground, the aircraft swung violently to the left, causing the landing gear to collapse due to the excessive loads imposed on it. Figures 12 and 13 are aerial photographs taken shortly after the accident. The skid marks shown on Figure 14 are those made by the left-hand landing gear at the touchdown point, and indicates the increase in the spread of the tires, as the bogie is twisted further out of line, due to the increasing weight on the landing gear. Figure 15 indicates the point at which the left-hand tires burst. This occurred at approximately 3/5 of the total distance which the aircraft travelled (approximately 4,000 ft.).

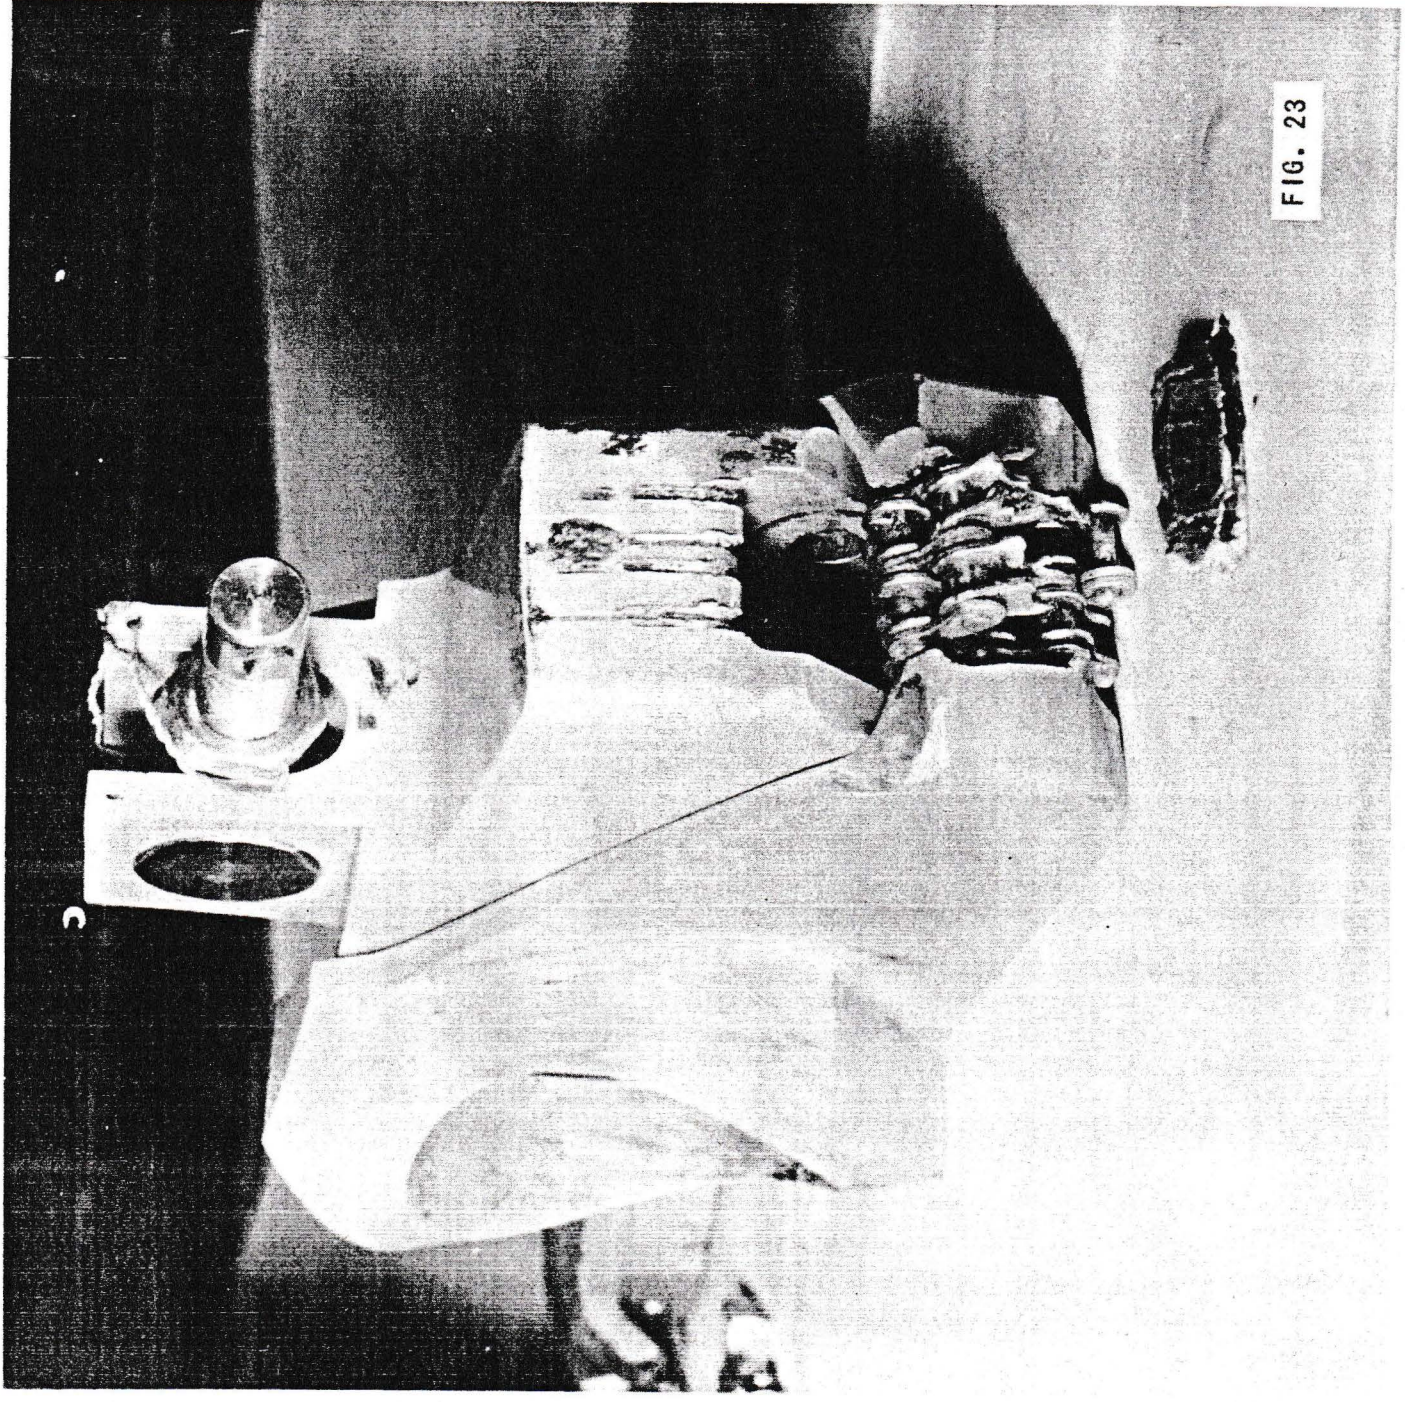
FIG. 23

Turning is accomplished by means of two cam tracks on the main leg barrel and two rollers on the extending unit. The main oleo is attached to the shortening gear, therefore, the oleo is active whether the extension is up or down. Figure 21 shows the main leg details and Figure 22 shows the shortening mechanism details lock. The dust cover is shown on Figure 23.
