REPORT ON ACCIDENT

AVRO ARROW 1 (25201)

PART 2

Report No. 71/ENG PUB/10

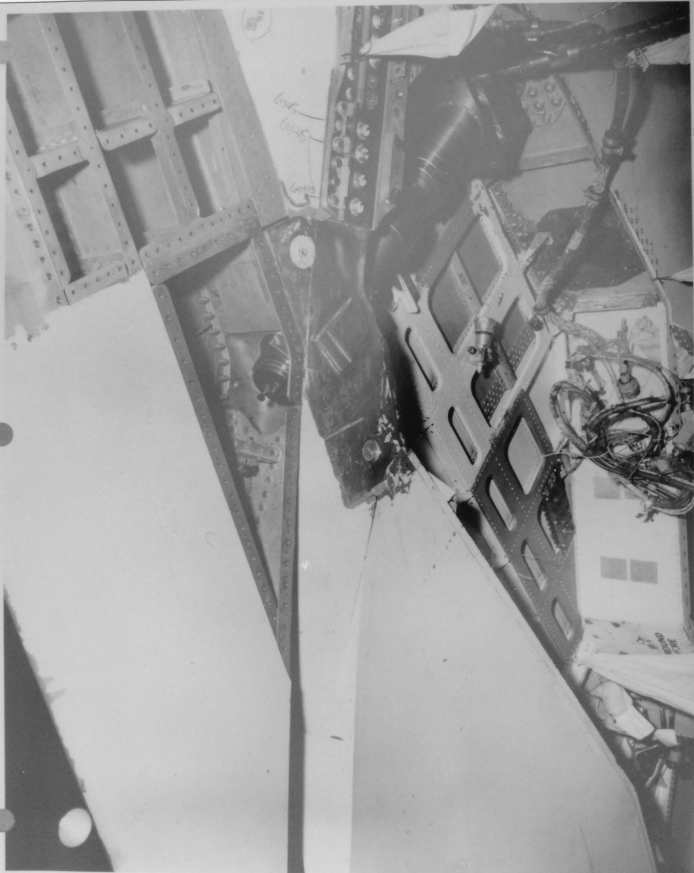
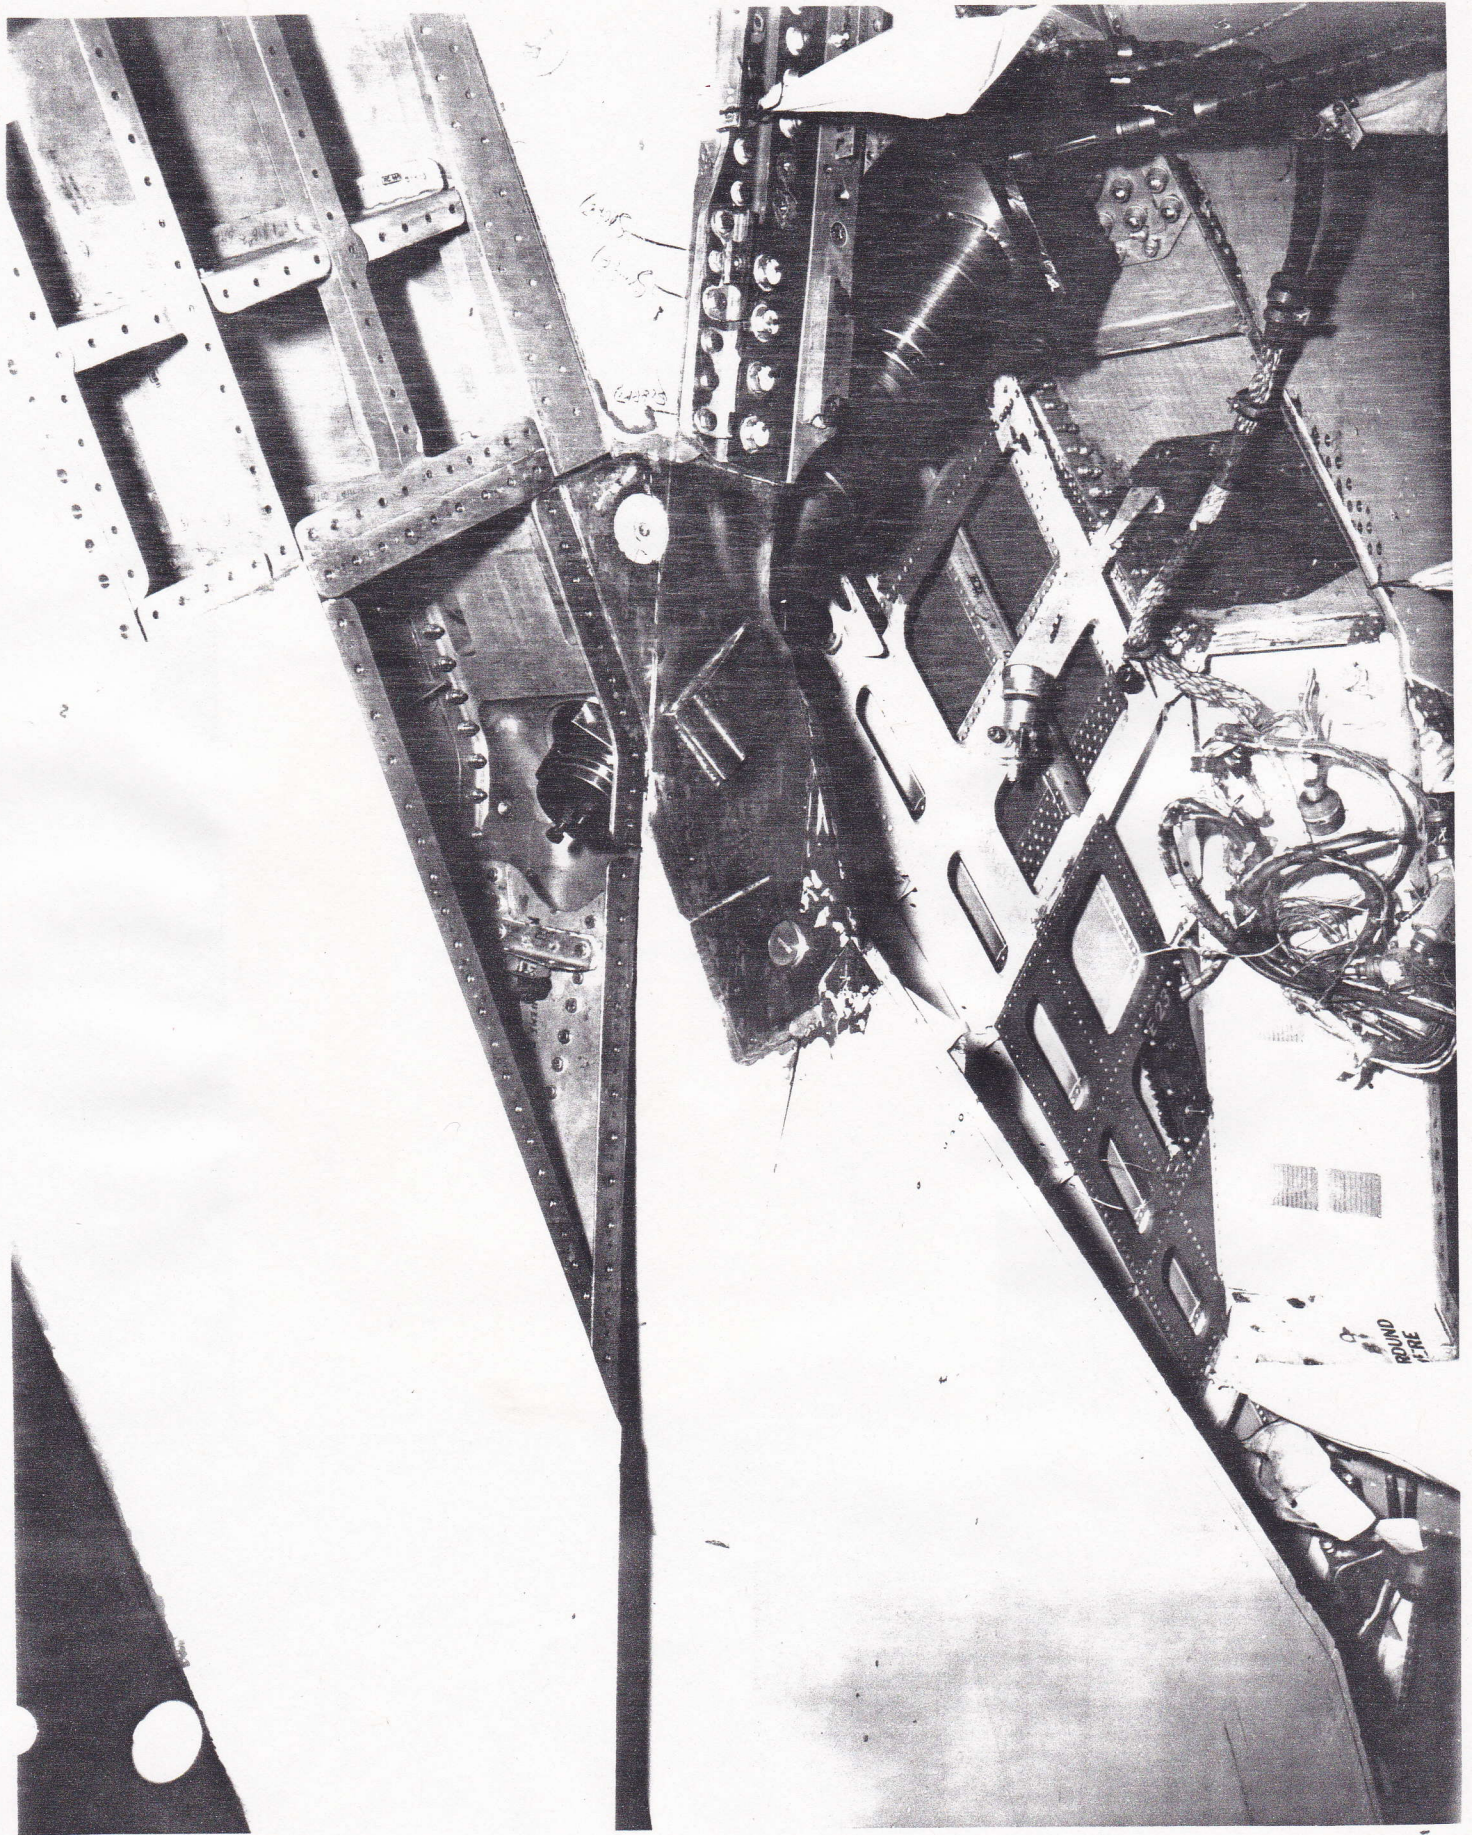
FIG. 3

The accident caused elongation of the sleeve insert which carries the main leg pivot forward fitting. The sleeve was removed using heat lamps and dry ice. Examination showed that the bore of the pivot fitting had elongated with the sleeve. The fitting was rebored in situ using a special boring bar. (Ref. Figures 3,4,5 and 6). A modified sleeve was made to fit the rebores, and the internal bore of the sleeve was honed out to suit the pivot shaft.
