HAYES MARINE & CONSULTING SERVICES POWER BOAT VESSEL SURVEY

1929 Chris Craft Sedan Limousine, Runabout (28ft)

Date of Survey: **March 31, 2023**

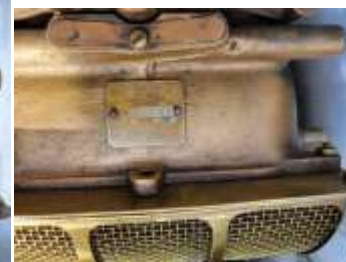
ENGINE(S): 1929 CHRIS CRAFT "A 120-L-H" , 8 CYLINDER, 824 CU IN, 13.5L (250HP) **SERIAL#: 436**
(ORIGINAL TO VESSEL)

ENGINE REPORTED TO HAVE BEEN RESTORED BY KNOWN, REPUTABLE BUILDER AND HAS FEW HOURS SINCE REBUILD. HOURS UNKNOWN.

MANIFOLDS SOUND. ALL HOSES, BELTS AND CLAMPS AND WIRING WERE INSPECTED AND FOUND TO BE NICELY AND PROPERLY ROUTED AND APPEARED TO BE IN PROPER WORKING ORDER.
