Buchanan Marine Appraisal Services Limited

REPORT OF MARINE SURVEY

**Insurance Underwriting Condition & Value
of the vessel**

Chris Craft 27' Custom Runabout, model 936

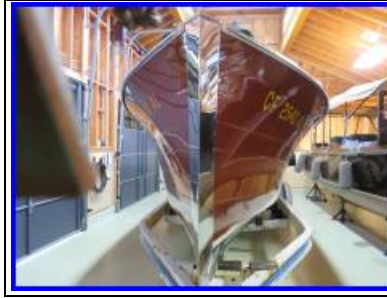
Stem: The timber stem was found to be in sound condition with no indication of deterioration evident at the time of the inspection. A bronze plated cutwater is

installed, well secured.

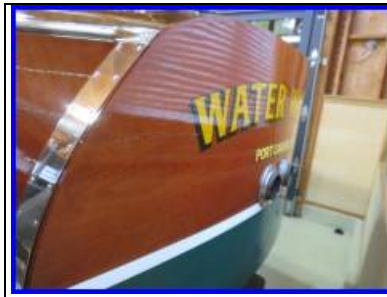
The transom is carvel planked in sawn timber. The exterior transom planking checked sound, drawn tight with surfaces smooth and fare.

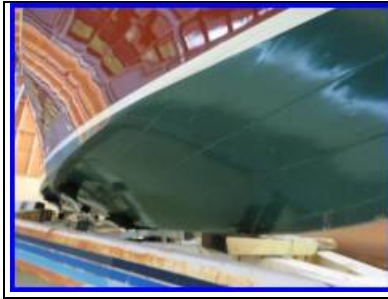
The bottom is double planked, having the inner planking laid diagonally over the timber frames, with the exterior timber planking laid longitudinally, having a layer of bedding between the layers of planking. The exterior planking was subjected to percussion soundings and visual inspection. The bottom planking was found to be in sound condition, drawn tight with surfaces smooth and fair.

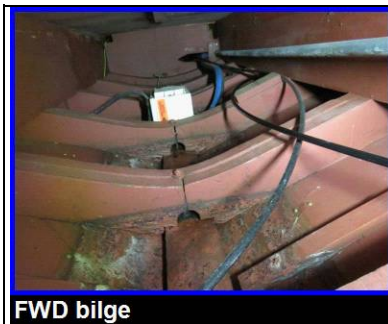
FWD bilge

Bottom Frames The bottom frames are sawn timber positioned on varying centres along the length of the hull, checking sound in areas normal access allowed inspection.

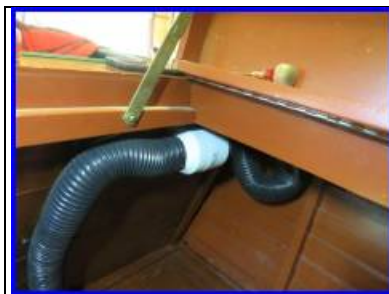
Natural and powered ventilation for engine compartment is provided as per the requirements of Transport Canada TP1332, Section 6.3.8, having a single 12 volt marine bilge blower installed, its operation not verified. ***The owner is to verify the operation of the bilge blower at the time of launch and start-up.***

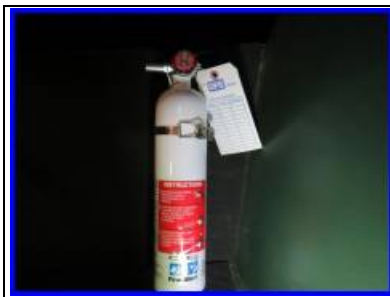
Dry Chemical Extinguishers: 2.5 lb BC, located in the forward cockpit, gauge indicates that the unit is operational, no recent tag attached,
NOTE: Periodically shake dry chemical extinguishers to ensure the dry chemical powder is loose and is not compacted. If in doubt, replace the extinguisher.

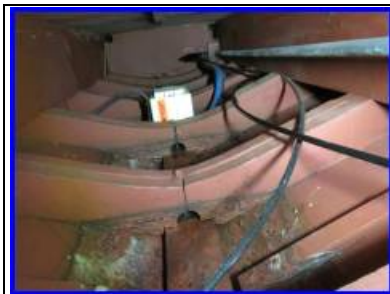
FORWARD BILGE : Lovette 900 GPH automatic pump at the bow, upgraded.

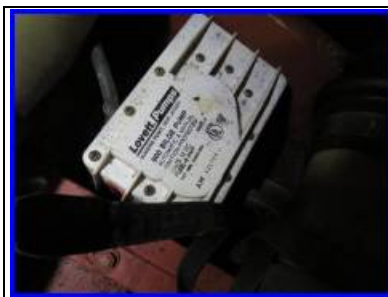
Lovette 900 GPH automatic pump at the transom, upgraded.

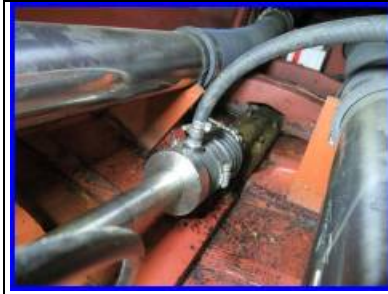
A bronze port is installed in the bottom, hose connected to a dripless shaft seal, with the hose in serviceable condition, properly secured.

Inspect shaft seal upon launch and start-up and periodically thereafter for any leakage and replace as warranted.

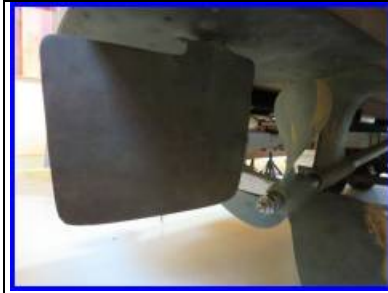
Bronze, suspended spade style, well secured with no abnormal horizontal or fore/aft movement in the rudder.

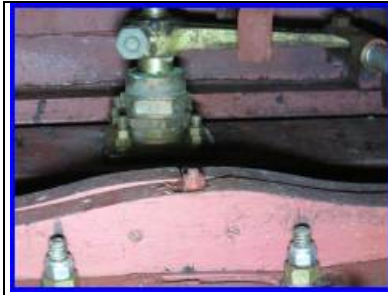
Bronze rudder port, secure in its mounting.

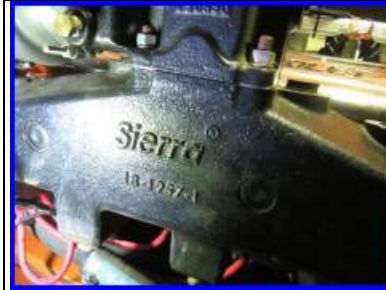
Siera brand cast manifolds with risers are installed on the engine, with the riser / manifold connection showing no indication of leakage.

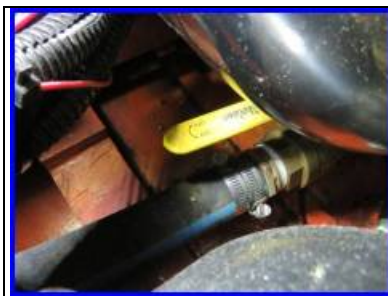
Sea Connections:	Bronze seacock ball valve installed.
-------------------------	--------------------------------------

Sea valves used for:	Engine raw water intake.
Sea valve condition:	Sea valve is functional.
Sea valves piping:	Marine rated, reinforced water hose, double clamped at the respective valve connection.
Recommendations:	<i>Inspect all thru-hull fittings and valves periodically to ensure their efficient operation and ongoing condition as part of routine preventative maintenance and service on an annual basis. Where allowed by adequate space on the hose spigot, all connections to sea connection valves are to be double clamped for safety.</i>

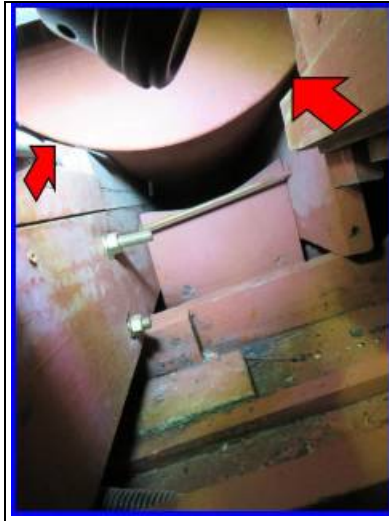
No & Location:	One tank located below the aft deck, not accessed for close inspection.
---------------------------	---

Tank Material:	Steel with paint finish.
Tank Capacity	Capacity of 66 US gallons (per Chris Craft - The Essential Guide)
Manufacturer' s label(s):	Tank manufacturer label was not sighted on fuel tank(s). Recommend owner verify that the fuel tank meets all ABYC & TP1332 requirements.
Shut off valve(s):	Shut off valve(s) not sighted. RECOMMENDATION: Ensure existence and operational status.
Vent line/location:	Not accessible for close inspection.
Fill pipe & condition	- Two deck fuel fills, one on either side of the aft deck.
Gasoline system:

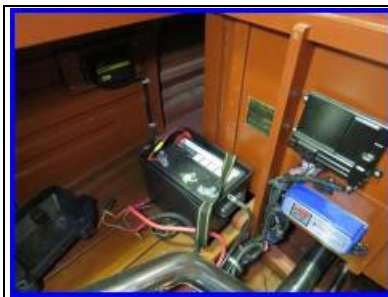
D.C. Voltage system: 12 Volt system - upgraded from the original.
Number and type of batteries: One 12 volt lead acid at aft starboard corner of the engine compartment.

Storage: Acid proof battery box with cover is provided, secured with nylon strap.
Battery cables: The battery cables are in serviceable condition, disconnected for storage.
Positive terminal covers: Positive terminal(s) are covered as per Transport Canada TP1332 which mandates that positive terminals be protected against accidental shorting by the use of insulation barriers or sleeves.
Battery selector switch: None installed or required.
Charging system: Engine alternator.
Distribution panel: Fuse block under the dash, upgraded.
