Report of Marine Survey

"Joyride"

1965 21 ft. Chris Craft Capri

TYPE OF SURVEY REQUESTED: Pre-Purchase Condition and Value
DATE AND TIME OF SURVEY: 5-29-23
FILE NUMBER: 1172
VESSEL TYPE: High speed inboard runabout with a wood hull and deck
VESSEL BUILDER: Chris Craft Corp., Pompano Beach, FL ,& Algonac, MI.
HIN (HULL IDENTIFICATION NUMBER): CP-21-005. The hull ID number of the vessel was found located on the builder's plate on the engine hatch.
YEAR BUILT: 1955
STATE REGISTRATION NUMBER: CF 3616 KA sighted on hull sides with 2023 tags.
STATE REGISTRATION DECAL NUMBER: F-158439
STATE REGISTERED VESSEL OWNER: Ken Peter 95404
VESSEL MATERIAL: Wood hull and deck.
LENGTH OVERALL (LOA): 21 ft.
LOCATION OF SURVEY INSPECTION: Santa Rosa. CA, at owner's home.
PERSONS IN ATTENDANCE DURING SURVEY: Owner and surveyor.
WEATHER CONDITIONS PRESENT: Overcast, damp.

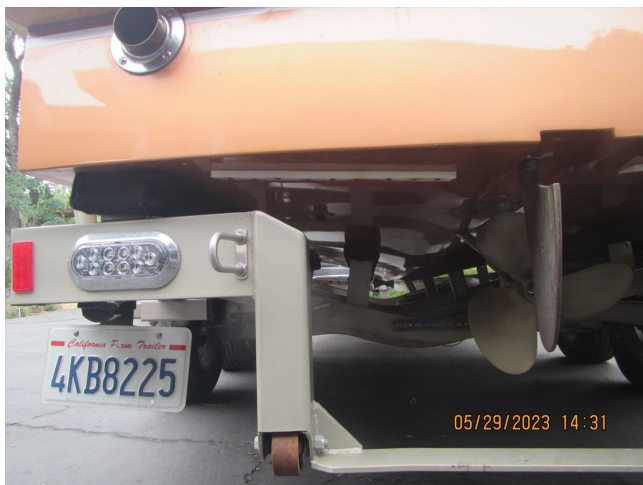
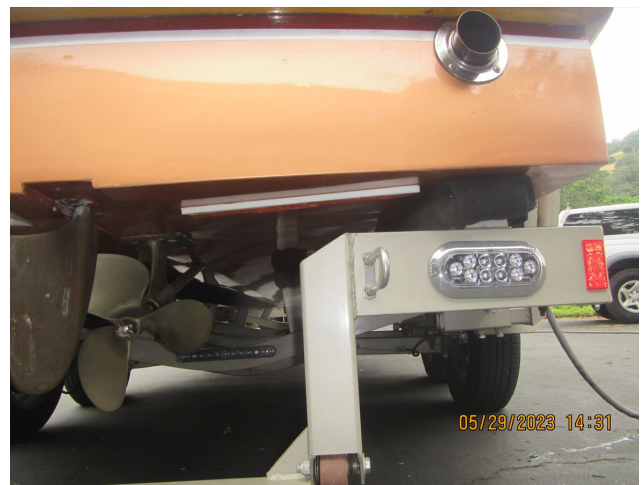
PROPELLERS

Three blade bronze propeller is in new condition.

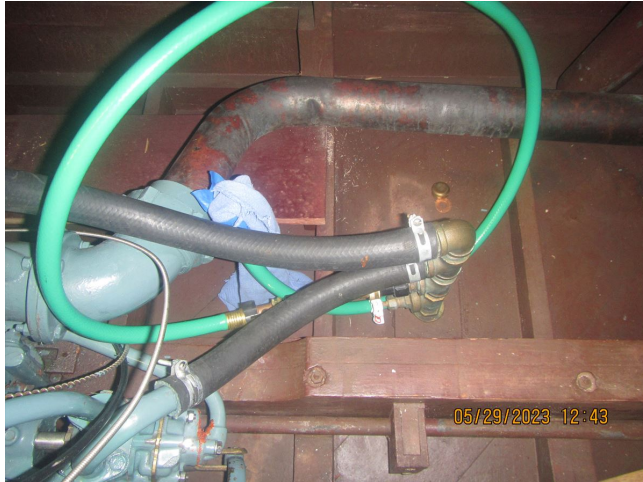
HOSES

Appeared serviceable, where sighted. Monitor frequently for dry cracking, degradation, damage or chafing. Hoses were chosen to match original type.

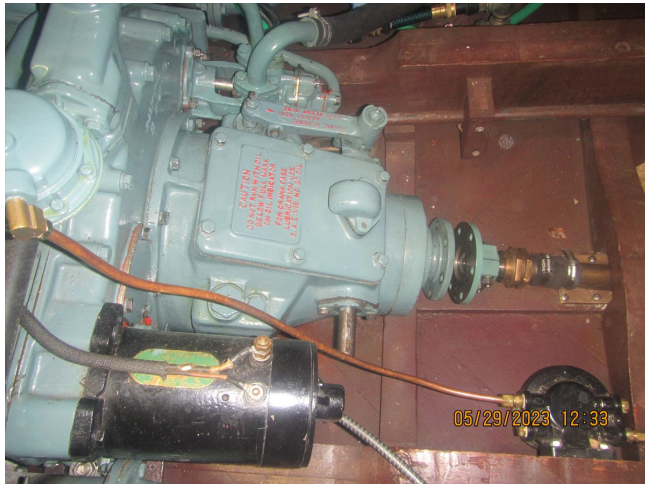
PROPELLER SHAFT SEALS

Bronze standard stuffing box. Hose and single clamps in place. Monitor frequently. Clamps were wired and hose appeared serviceable.

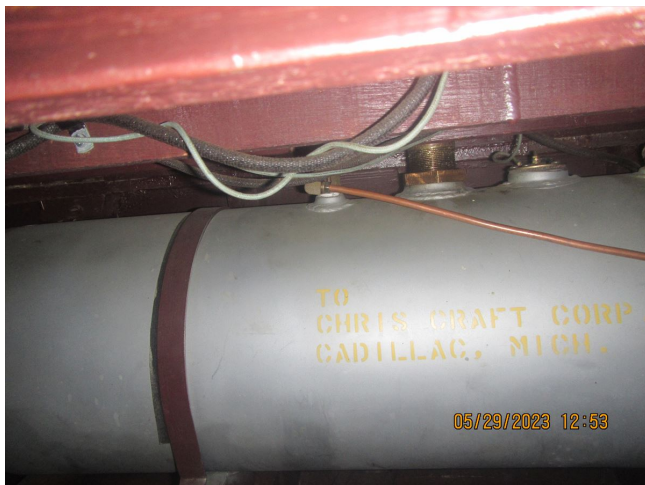
FUEL TANK MATERIAL

Round painted steel tank is secured with metal straps in wood sawn chocks. Located below aft deck.

Recommend verifying the fuel tankage capacity.

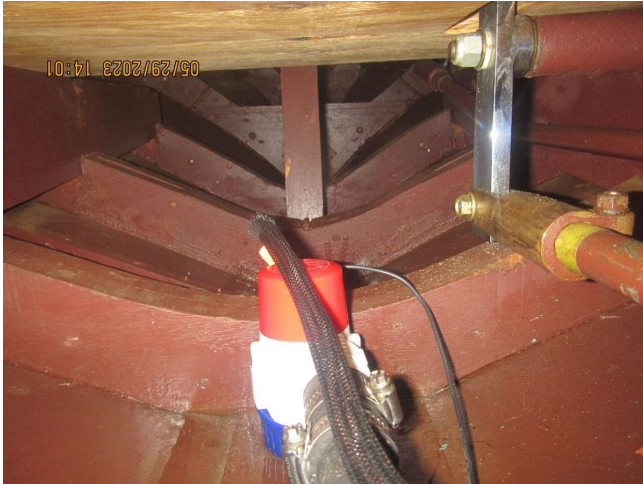
MANUAL BILGE PUMPING SYSTEMS

None sighted. Recommend a manual pump and bucket aboard in case of power failure.
