GLENWOOD CEMETERY

To: Dick Ambrus
From: Martha Peterson
Subject: Estrada Monument Restoration Work
Date: October 12, 2005

MONUMENT RESTORATION PROJECT

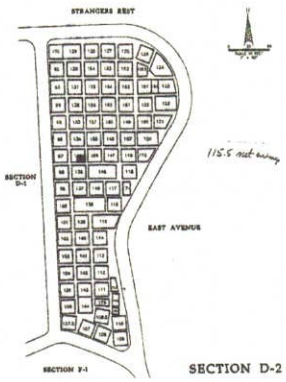
Priority Status	Low (visibility) See below	Lot Purchaser Purchase Date Deed of Perpetuity Contact Last Burial	WOODHEAD, John 1891 Yes None 1896

Section Lot No. Description	D 135 SE¼			
Work Performed	<p>The marble coping had sunk and was buried on the southwest corner. The beam of the coping was cracked behind the monument and a section approximately 2' long was missing.</p> <p>The missing piece of coping was found buried on the lot and was recovered. The four corner posts and the reassembled coping were leveled and reset on a new foundation.</p>			
Work To Be Completed	<p>A marble monument, 52" high x 20" x 10" is relatively plumb (1° north), but it is sliding on its base and overhanging it by approximately 1" on the northwest corner.</p>

D-135 SE¼: Four marble posts, 40' marble coping (24" found buried beneath surface) were leveled and reset on a dry foundation. There was no entrance threshold. 12 man hours; cost to Glenwood, \$185.40.

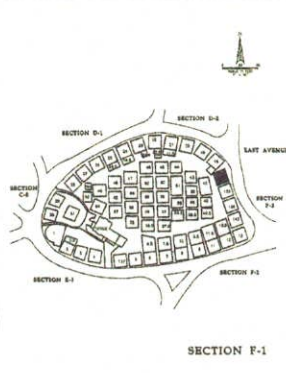
Section Lot No. Description	F 017 400 s.f.			
Work Performed	The two small marble markers were sunken and tilted. The two small markers were raised, leveled and reset on new foundations.			
Work To Be Completed	The large marble monument will be checked for stability and, when any necessary leveling work is completed, the entire lot will be cleaned.

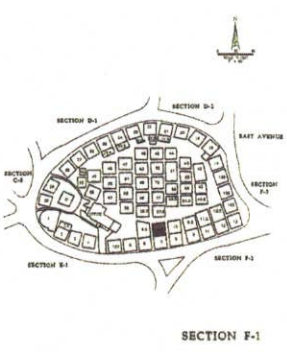
Section Lot No. Description	F 007.5 400 s.f.			
Work Performed	<p>A raised, flat granite marker for Henry Bering was sinking 4° north.</p> <p>The marker was raised level with the other marker on the lot and reset on a new foundation.</p>			
Work To Be Completed	None.			SECTION F-1

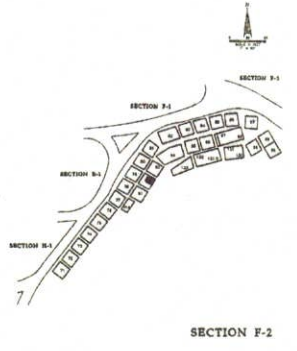
Section	F	Purchase Date	1931	
Lot No.	092	Deed of Perpetuity	Yes	
Description	NE¼	Contact	None	
		Last Burial	1937	
Work Performed	Two in-ground markers were sinking. The two markers were raised, leveled and reset on new foundations.			
Work To Be Completed	THE SECOND MARKER HAS NOT BEEN DONE. RETAKE "AFTER" PHOTO.
