GLENWOOD CEMETERY HISTORIC PRESERVATION FOUNDATION

**RODRIGUEZ MONUMENT RESTORATION PROJECTS**

(Identified, Not Scheduled)

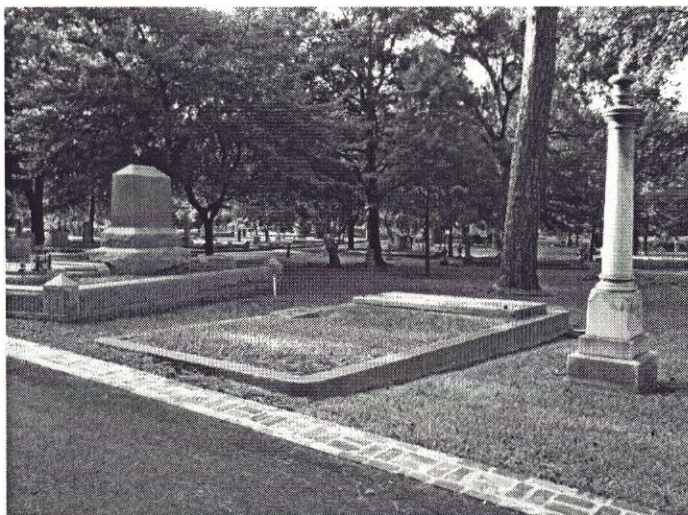
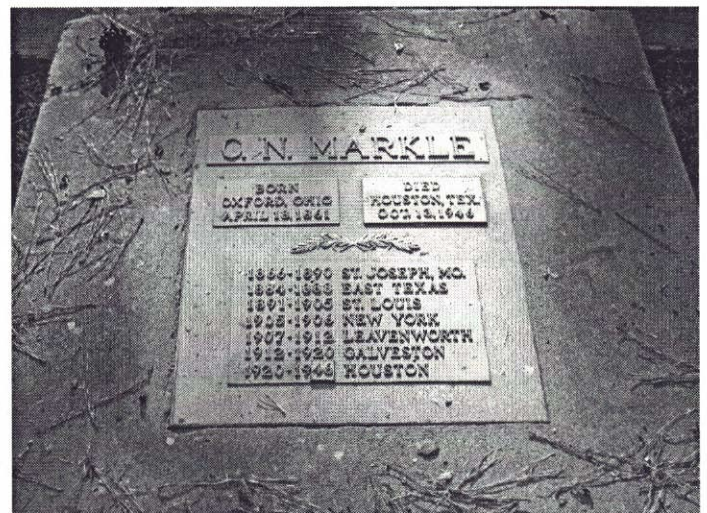
Markle, C.N.  
D-107 W 1/2  
1940  
DOP yrs  
Contact in Houston  
(since 2003)

| | Lot Name | Section | Lot No. | Lot Description | Begin Date | End Date | Actual Cost to Date |
|---|---|---|---|---|---|---|---|
| 1. | Markle, C. N. | D | 107 | W 1/2 - ACTIVE CONTACT | | Sunken coping | |

*Coping  
surk*

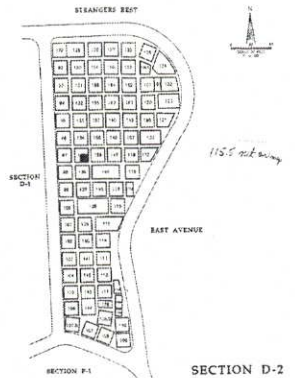
| <b>Work Performed</b> | <p>The marble coping had sunk and was buried on the southwest corner. The beam of the coping was cracked behind the monument and a section approximately 2' long was missing.</p> <p>The missing piece of coping was found buried on the lot and was recovered. The four corner posts and the reassembled coping were leveled and reset on a new foundation.</p> | | |

**BEFORE:** The marble coping has sunk and is buried on the southwest corner. The beam of the coping is cracked behind the monument and a section approximately 2' long is missing.

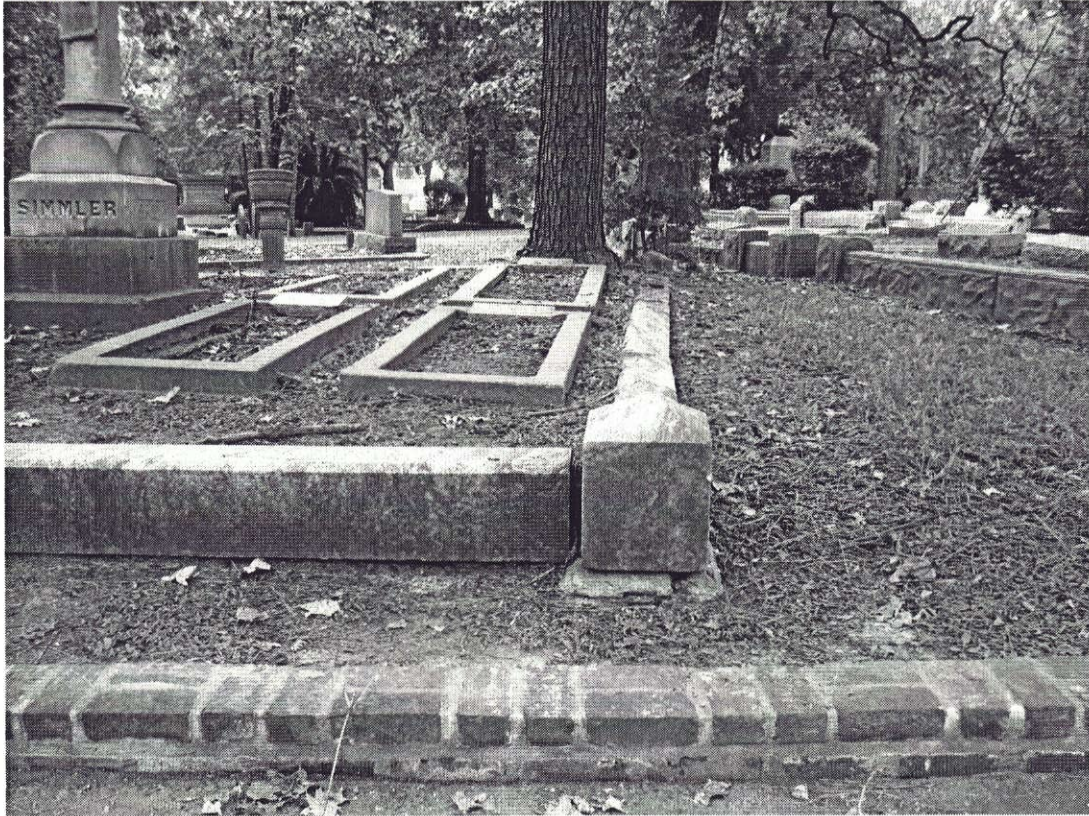
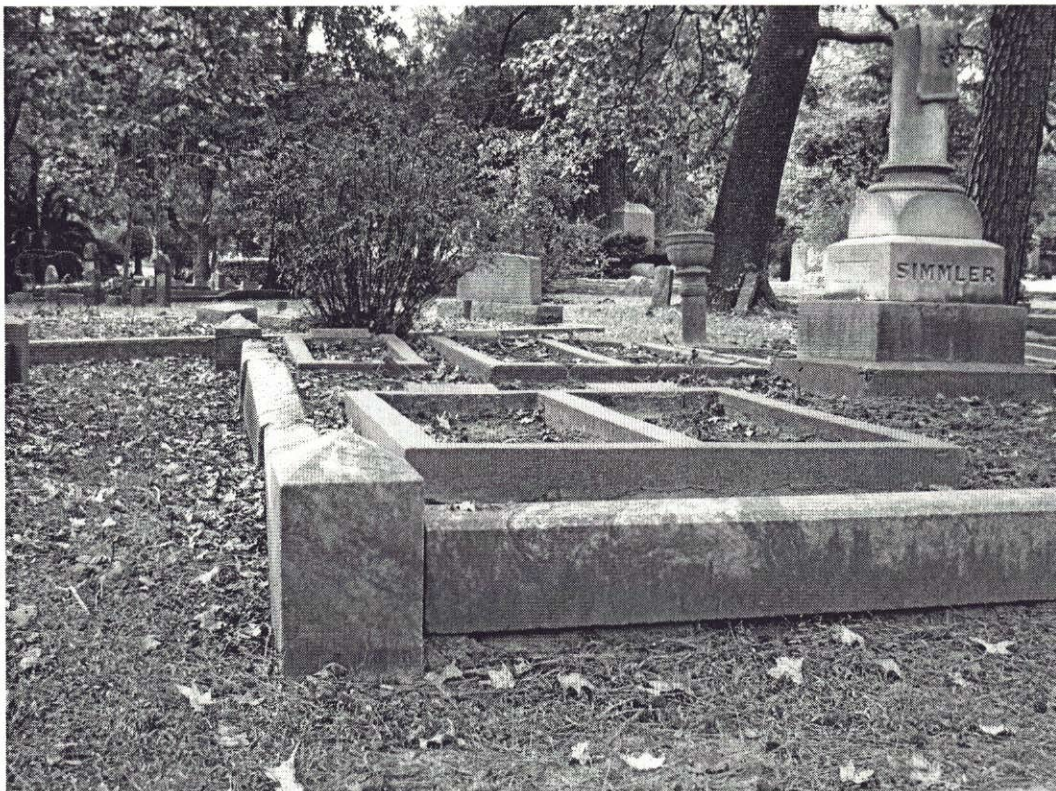
| | Lot Name | Section | Lot No. | Lot Description | Begin Date | End Date | Actual Cost to Date |
|---|---|---|---|---|---|---|---|
| 7. | Simmler, E. | F | 020 | | | Heavy coping | |

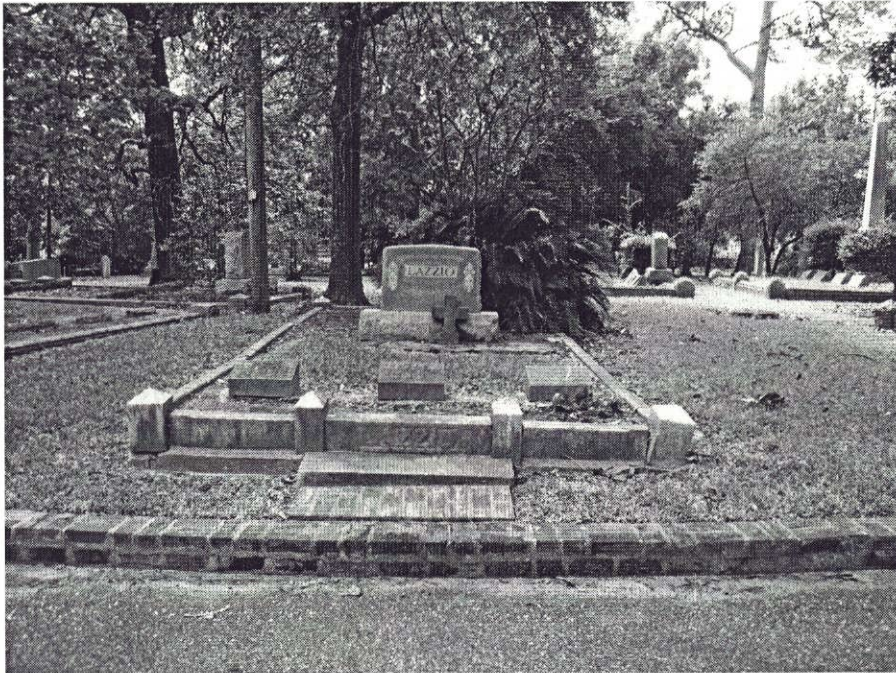
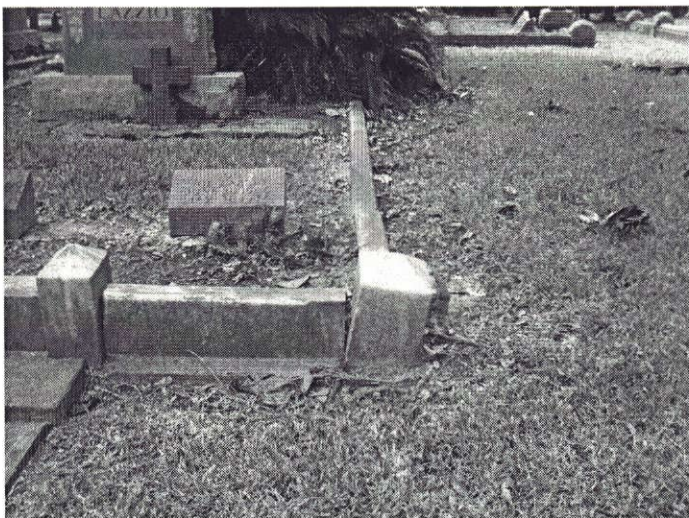
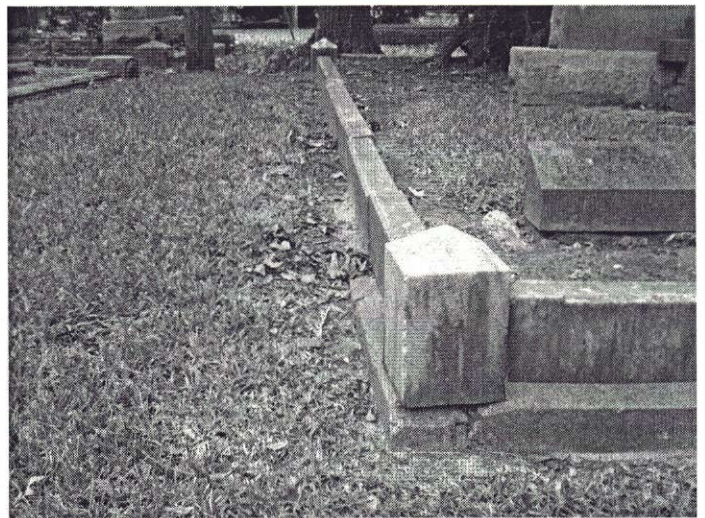
Locascio, Rosa Lanzio

| | Lot Name | Section | Lot No. | Lot Description | Begin Date | End Date | Actual Cost to Date |
|---|---|---|---|---|---|---|---|
| 8. | Locascio, Rosa | F | 022 | E 1/2 | | Heavy coping | |

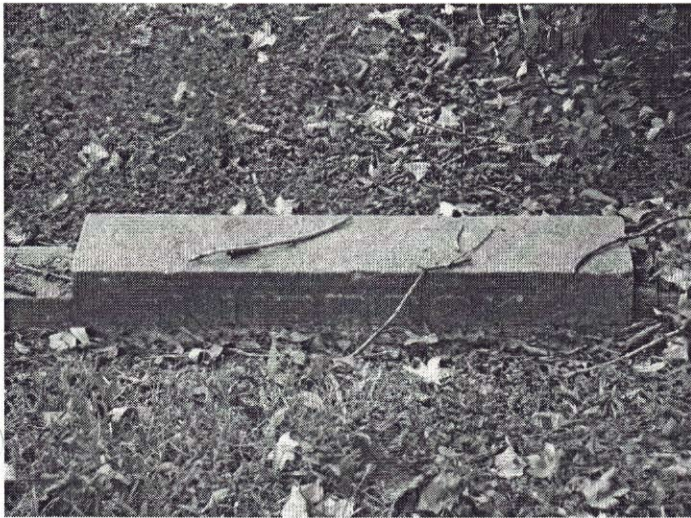
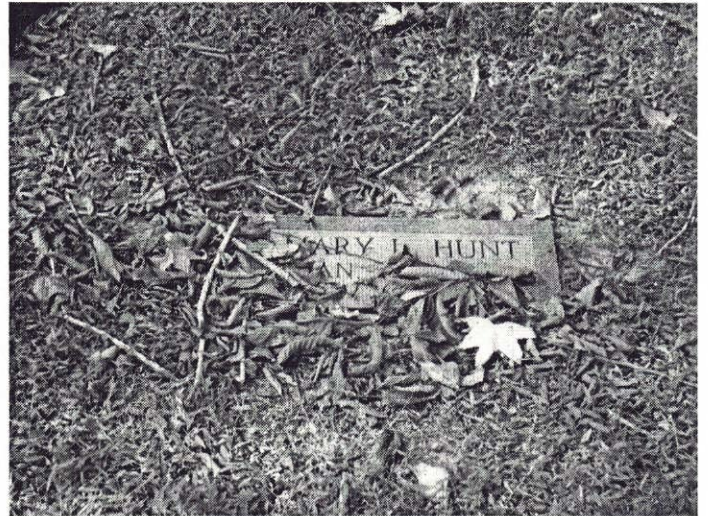
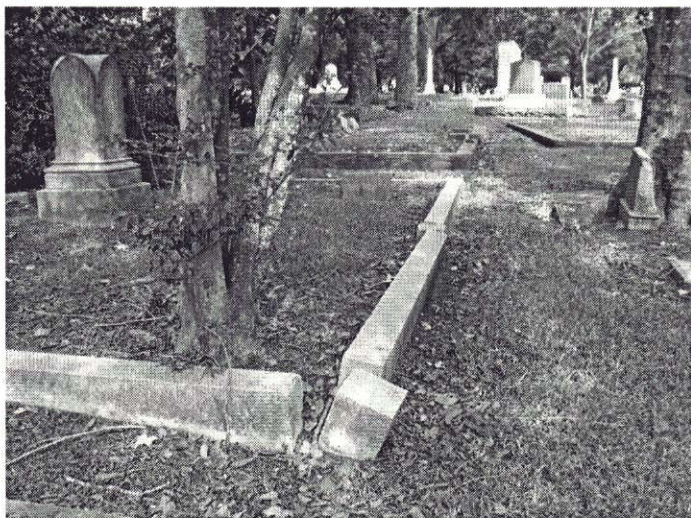
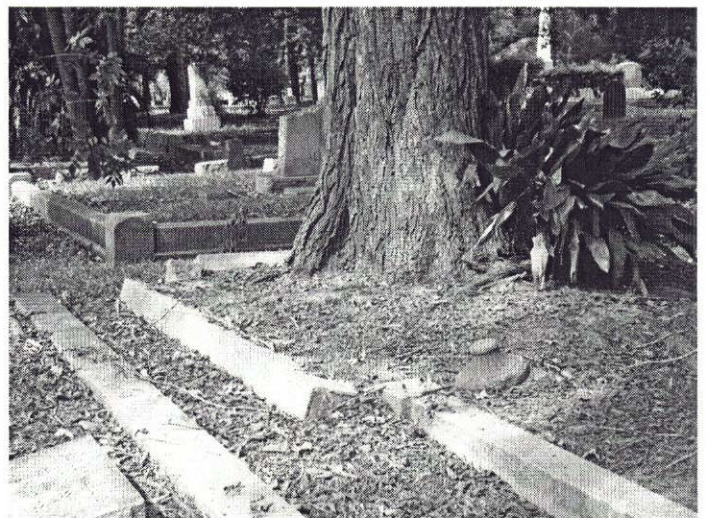
| | Lot Name | Section | Lot No. | Lot Description | Begin Date | End Date | Actual Cost to Date |
|---|---|---|---|---|---|---|---|
| 11. | Lubbock, T. U. | F | 059 | | | Coping and markers | |

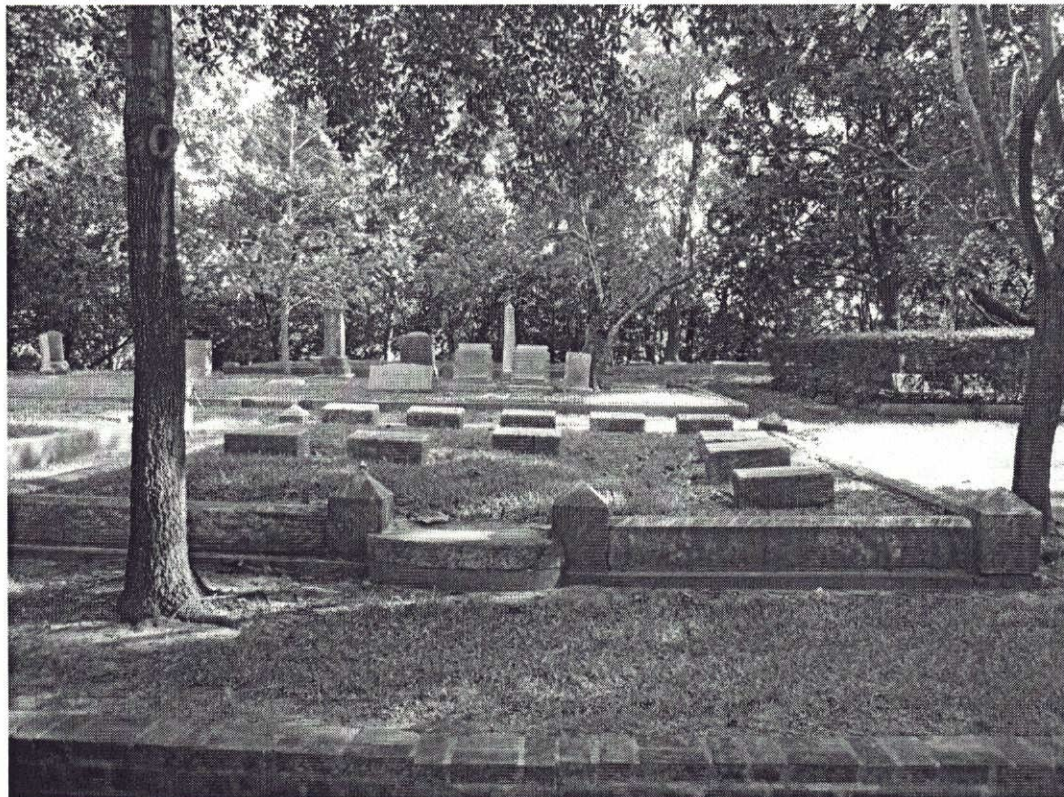
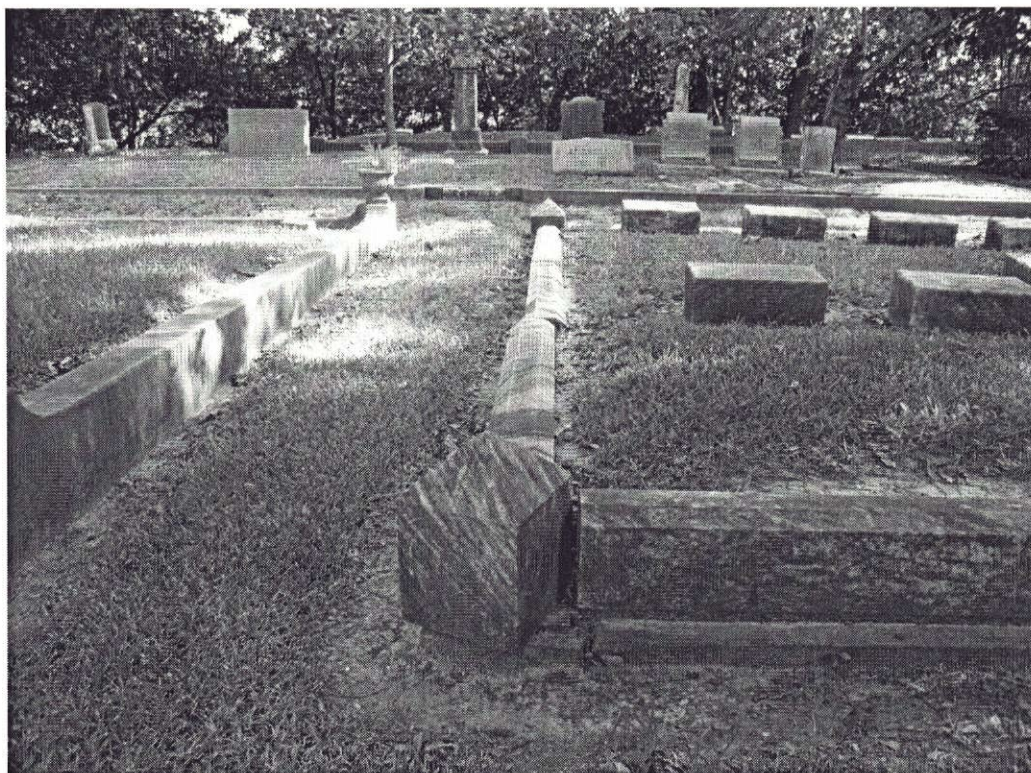
Hamblen, EP

| | Lot Name | Section | Lot No. | Lot Description | Begin Date | End Date | Actual Cost to Date |
|---|---|---|---|---|---|---|---|
| 12. | Hamblen, E. P. | F | 085 | | | Heavy coping | |

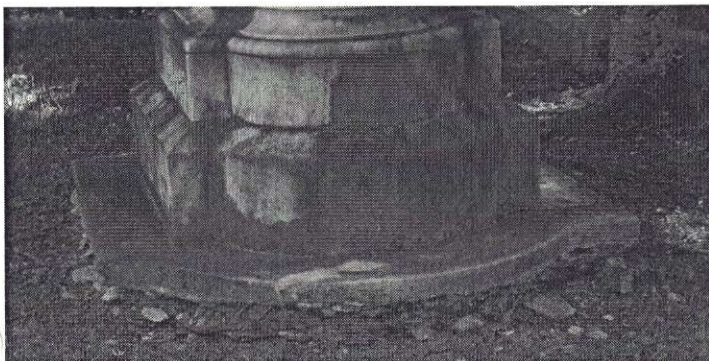
| <b>Work To Be Completed</b> | A white marble monument, approximately __' tall, is set on a rubble foundation and is tilting __° __ and __° __. One of two urns approximately ____" tall is missing from monument and may be buried on lot.<br><br>Monument will be leveled on a new foundation and cleaned. An effort will be made to find the missing urn. | | |
