The Proposed Renovation of
The Oldest House

322 Duval Street
Key West, Florida

Perpared for the
Historic Key West Preservation Board

May 1975

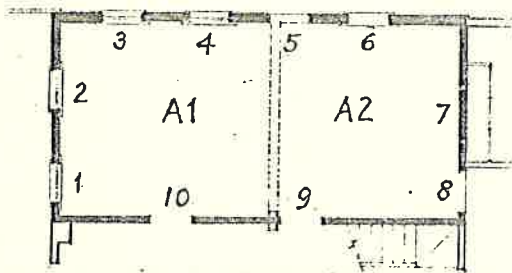
"A" appears to have been originally two rooms ("A1" and "A2"). The floors appear to be old but not original. The uniform width boards are stained dark..

The baseboards have many layers of paint on wood: white to green to black to wood. New quarter-rounds have been placed at floor juncture in some areas.

Doors: #5 is placed under the beam separating "A1" and "A2", and therefore obviously not original to construction of the house. #8 is a shuttered doorway to the old back porch area; its original interior door is missing (possibly the existing back entrance door). #9 is a shuttered doorway to stairhall "C". #10 is an open doorway to vestibule "B". Door frames #8, 9 and 10 retain cuts from removed hinges.

The walls have a white-painted plaster and lath finish. In some areas they are improperly repaired: at the lower left of door #5, around window #6, above door #8. There are holes near the ceiling at the back wall, and other small areas of deterioration.

The ceiling was originally a lath and plaster finish. In "A1", cardboard and tape (painted white) cover wallpaper, plaster and lath; new quarter-round trim has been added. A sagging box beam appears to be reinforcing the beam which was inserted at the time of removal of the wall originally dividing "A1" and "A2". The box beam shows evidence of dry rot and termites. "A2" retains its plaster ceiling, cracked and deteriorating. The ceiling is curved and slopes at the back wall in response to the original roof line. A paper and tape patch is located in the center of this ceiling.

The exterior wall of "A" seems to be damaged by water entering the hole left after the removal of the balcony on the left side of the house.

The wall originally separating "A1" and "A2" should be replaced. This will return the original order to these rooms' window placement, simultaneously making available room "A2"

The sash of window #6 should be replaced.

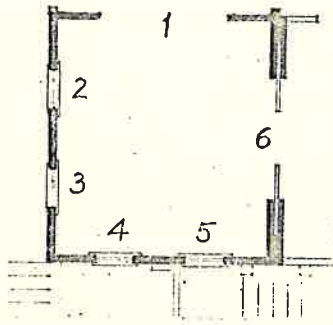
"C" is the stairhall. Floors and baseboards are the same as described for room "A". Doors: #1 is a shuttered opening to "A2", peculiarly framed behind the stair soffit. The back entrance (#2) is a white wood door whose interior mouldings and framing are in disrepair. It has a brass knob. #3 is a framed opening whose underside is improperly spackled.

The walls are plaster and lath painted white in good condition, except for the back wall which is heavily water damaged; all plaster and some lath has been removed here.

The stair soffit shows recent poor repairs to the plaster.

The ceiling of the stairhall is rotting and poorly repaired. Its deterioration appears to be the effect of earlier roof leakage and water damage.

All poor restoration should be removed. Damaged areas should be restored to plaster and lath finish.

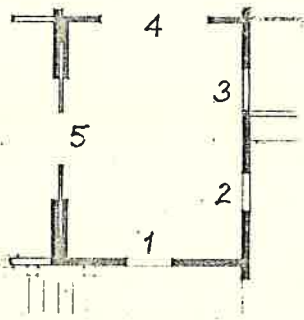
"D" is the original living room.

Floors and baseboards are the same as described for room "A". Doors:

since removed, doors. The dropped transom was probably added with the doors. #6 is the location of double doors (painted white, with porcelain knobs, and at present immovable), which slide into the wall. The track on the floor board (painted brown instead of stained like the rest of the floor) is still in good condition.

The walls of the living room are white plaster and lath, in good condition.

Remove extra moulding from windows #2, 4 and 5.

Remove hardware from doorway #1.

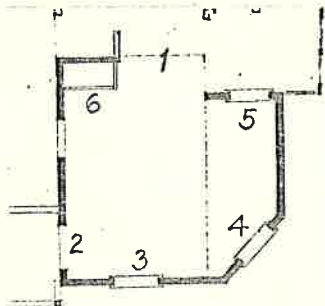
"E" was probably the original dining room. The floor consists partially of boards similar to those of rooms "A" and "C": they are old but not original.

These are spliced (at the quarter point of the room) to newer boards which have been inadequately stained.

The baseboard finish is a mixture of paint and stain.

This room has undergone a partial renovation - resulting in the removal of the plaster - which reveals the wide random boards (up to 18" in width). These are the original cladding, pre-dating the plaster and lath. The boards have been extremely abused. The remaining walls still sport their plaster and lath in good condition.

Doors: #1 is a pair of partially glazed french doors with what appears to be old glass. They have deteriorating mouldings inside and out, and porcelain knobs. (Note: this door frame moulding is the most elaborate existing in the house. This, and the difference between the side porch opening off this door and the front porch, suggest the later substitution of this door for a previously existing original window.) #3 is a sealed door; the knob hole is spackled and the other side is blocked by a closet in "H". The opening #4 into the stairhall is in good condition. The double doors (#5) are described with room "D".

The ceiling in room "E" has recently been poorly renovated, with celotex whose seams show. An incomplete light socket is centered in the ceiling. A beam bisecting the ceiling is assumed to have been added at the time of the ceiling renovation, to structurally reinforce the large dormer above. The beam is supported by a new column to the left of door #1. It appears that the wall boarding was cut and removed to insert the column, and then inconsistently replaced.

The ceiling renovation should be removed and replaced with plaster; the new beam should be retained because it is structurally necessary.

The floor should be properly re-stained.

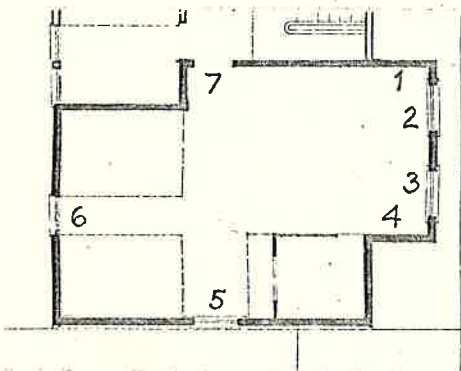
"P" is the other of the two upstairs bedrooms. Its floor is in a condition similar to that of the other bedrooms, with some dry rot in the area of the large dormer. The floor slopes at the large dormer.

Although this condition is disturbing, it is not unsafe, having been stabilized with a new beam below (see room "E").
