## Brief History of Restoring the Hendrick Martin House:

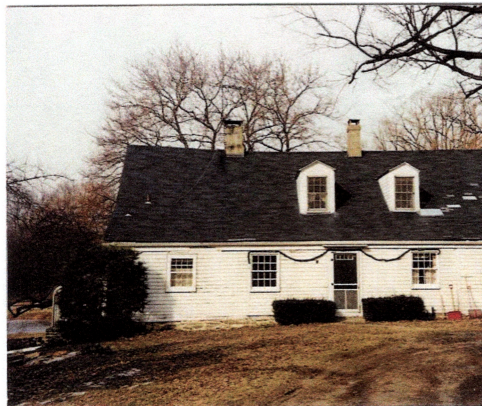
After  
2000: front is  
wood and  
mostly  
original. Third  
dormer  
added.  
Concrete

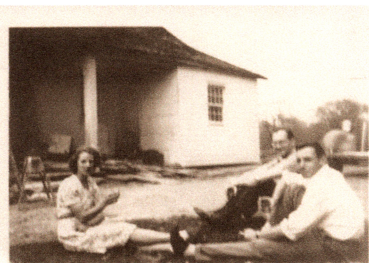
Originally an open stoep (see sloping floor). Windows at extreme ends are older than other two. They two extreme rooms were enclosed early on (hand planed partition wall at left of porch). Photos circa 1943 courtesy of Dutchess County Historical Society

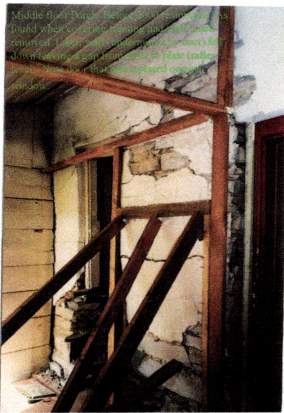
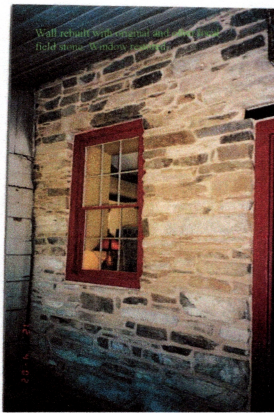
The original entry doorway is to the right. Low, wide, pegged frame, original moldings. Original pegged window frame to right was discovered behind a built-in cabinet.

Wall to left collapsed (due to 1943 duct work) and was rebuilt with original stones and some replacements.

Window to left was restored after finding remnants of the original frame.

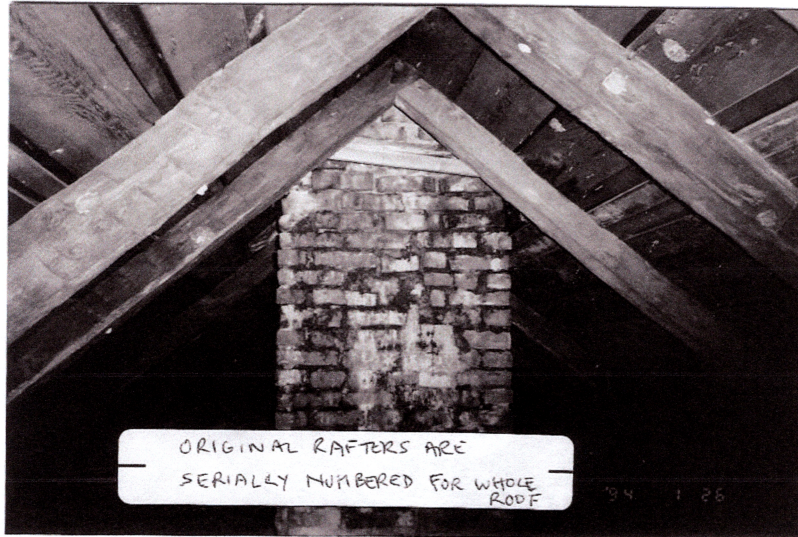
Rafters unchanged

Attic rafters are serially numbered from one end to the other indicating that the roof was built as a whole. To cope with variable sizes and shapes of hewn (by [adze](#) or [axe](#)) and sawn timbers, sockets are "tailor-made" to fit their corresponding timbers; thus each timber piece must be numbered (or "scribed").

Roof sheathing indicates use of wooden shingles.

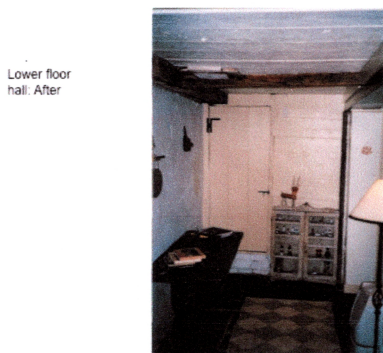
Ceiling is bottom of middle floor hall floorboards  
Covered gap in ceiling was for a stovepipe  
See original wideboard wall at inner end of hall  
Floor was dug down about 5 inches in middle of last century  
See thickness of stone walls

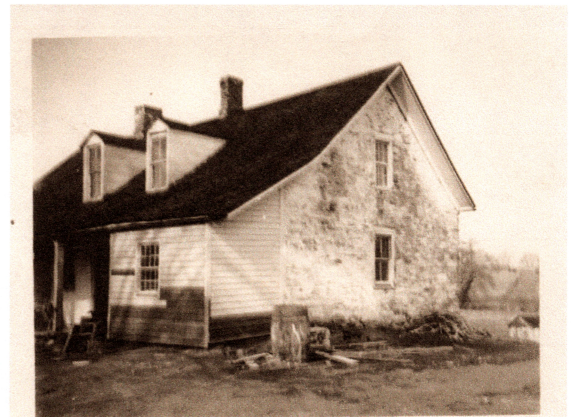
1940 North gable side. Note original and replaced clapboards. Eave overhangs.

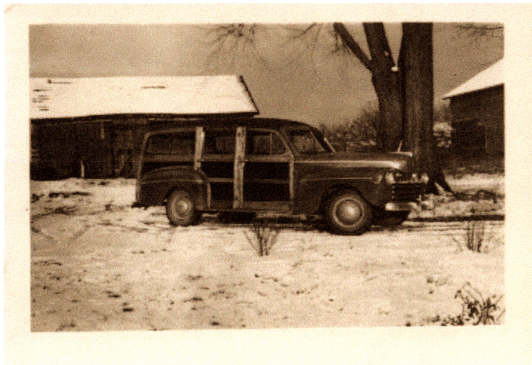
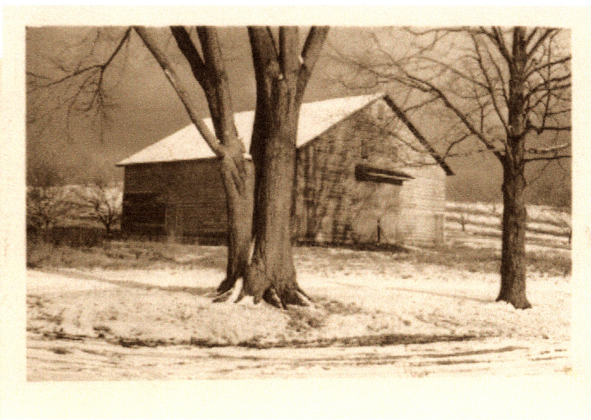
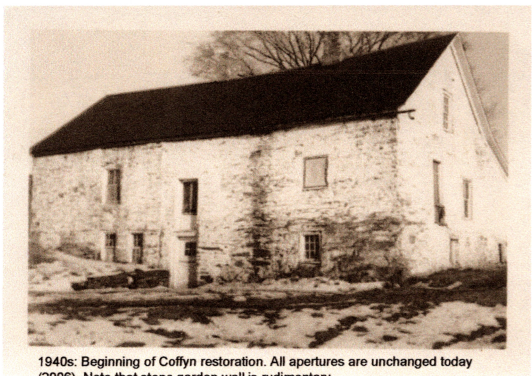
1940s: Beginning of Coffyn restoration. All apertures are unchanged today (2006). Note that stone garden wall is rudimentary.

During 2000 restoration. Note demarcation between earliest 18C house on left and later 18C addition on right.

Demarcation shown. West wall entirely re-pointed (from outside and inside) with soft mortar. Canopy, deck and balustrade added.
