**The James McBeth House**

**34 Church Street**

**c. 1847**

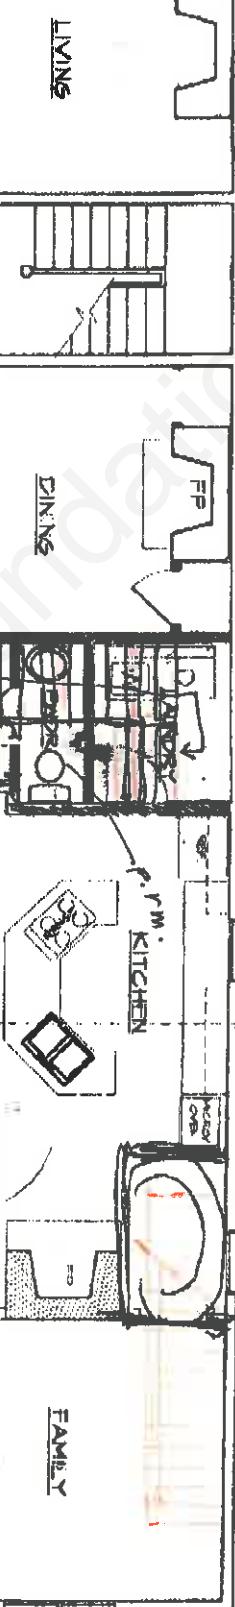
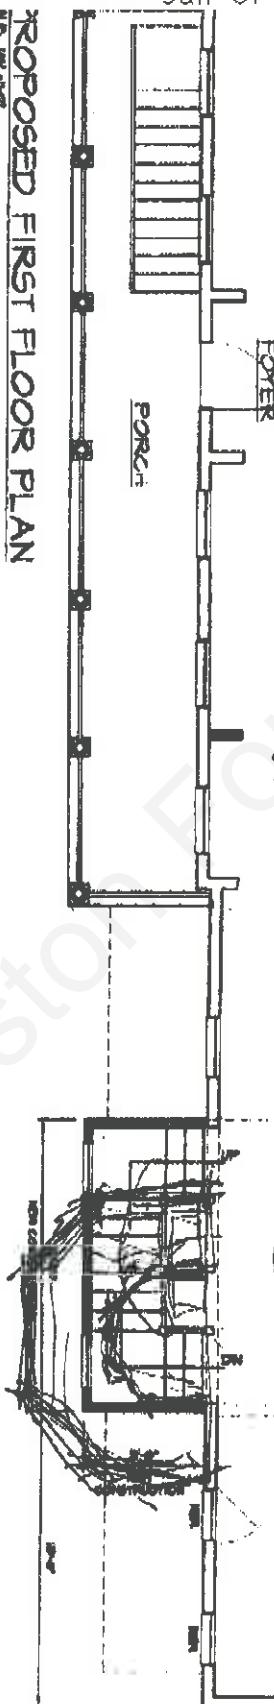
OR SEE MS. CHILD'S

KITCHEN BLDG. STAIR  
LAYOUT ON PITT ST.

PUT STAIR  
HERE &  
WIP  
IN  
BASEMENT  
KITCHEN

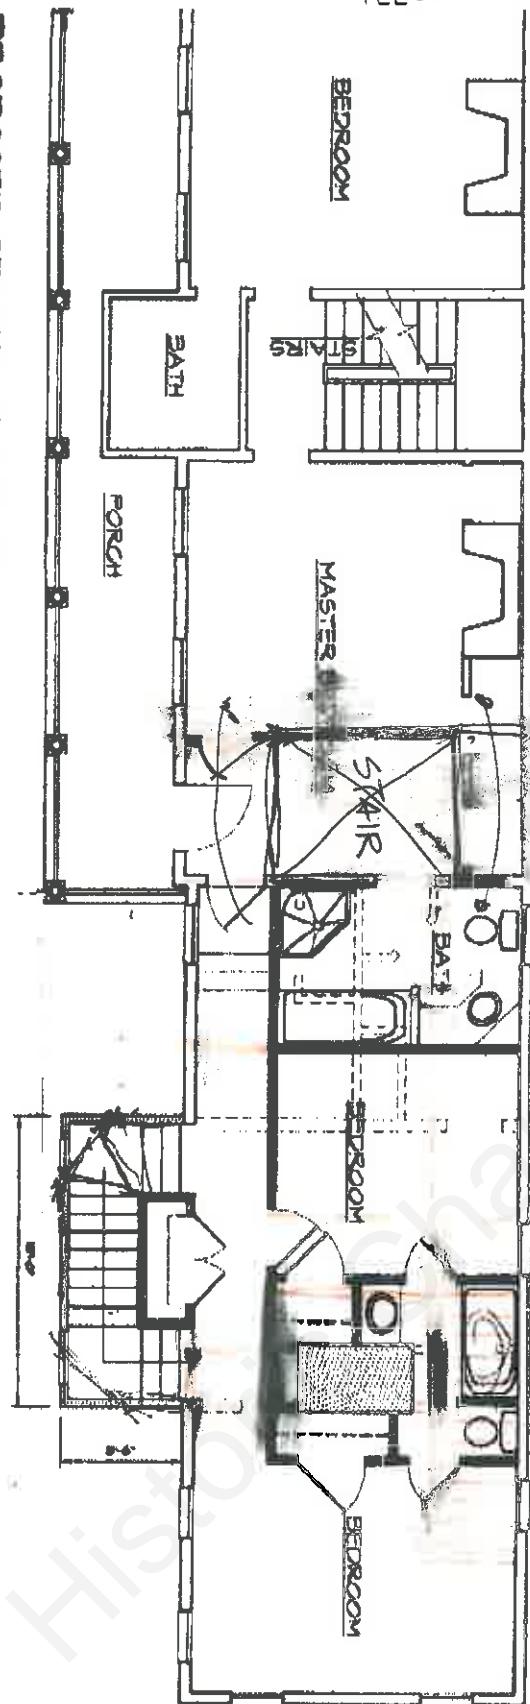
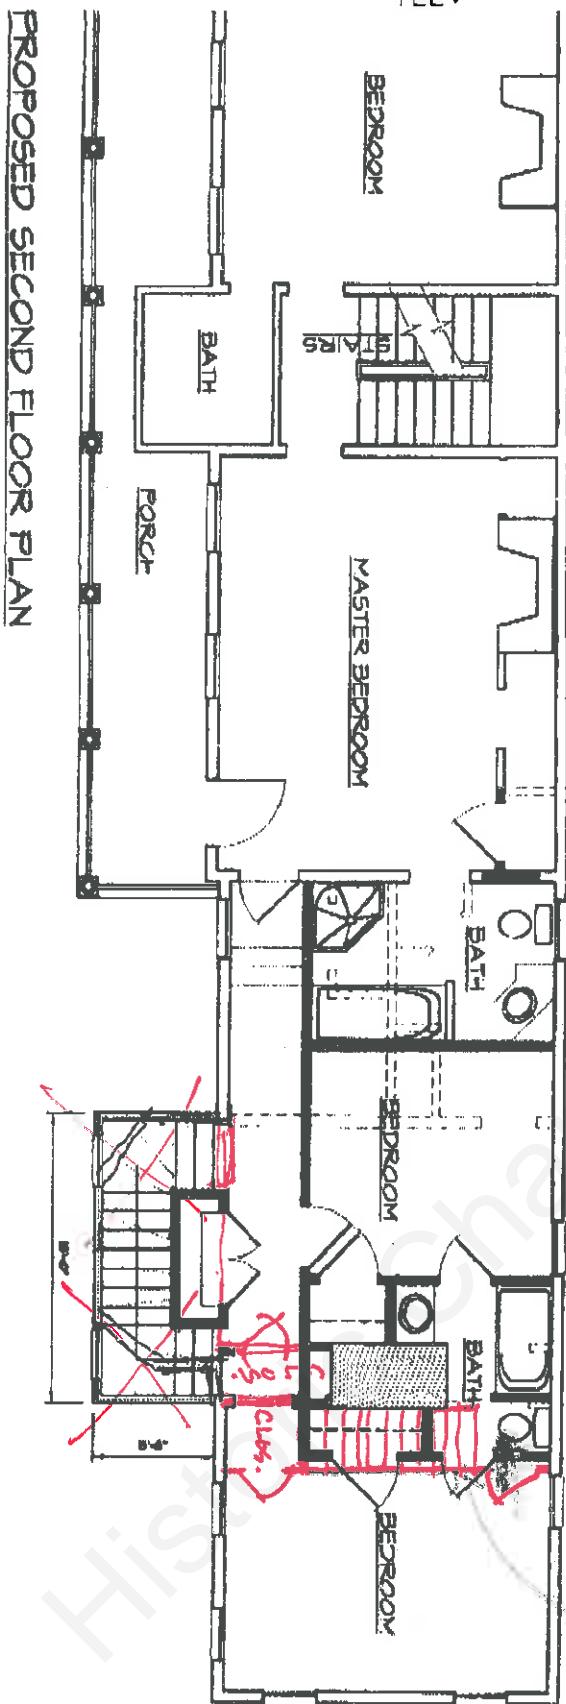
PROPOSED SECOND FLOOR PLAN

BEDROOM
