CharlestonWISE Impact Project Historic House Information

Prepared by: Mariah Schwartz
Prepared for: Sustainability Institute
 Historic Charleston Foundation
Date: July 20, 2011

Location Address: (no name)
 258 Ashley Ave
 Charleston, SC 29403

House Data Sheet

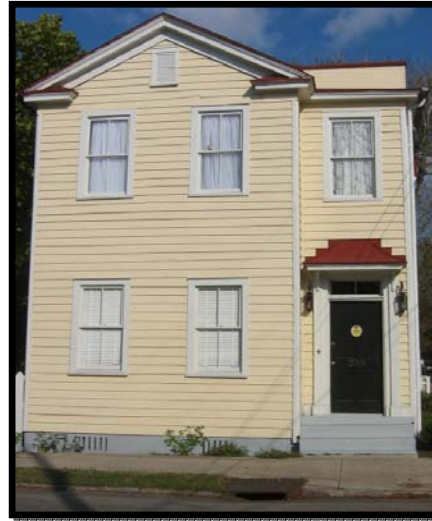
1685 (1653 living, 132 porch, per plans in appraisal report)
Sq. Ft:
No. of Stories: 2
Bldg. Orientation: Ashley Ave
 façade faces SW;
 on NE corner of
 Ashley & Bogard
HCF Easement /
Covenant Property: Yes

System	Material / Type	Notes
Exterior Walls	Wood	Major damage during Hurricane Hugo
Roof	Metal, standing seam	Major damage during Hurricane Hugo
Framing	Wood	
Windows	Wood	Double-hung, 2/2 lite
Foundation	Masonry	Masonry piers with stucco
Piazza / Porch	Wood	Enclosed on south elevation, except for back SE corner
