**13 Pitt Street
Charleston, SC**

An Architectural Description

**Carl Lounsbury
May 27, 2005**

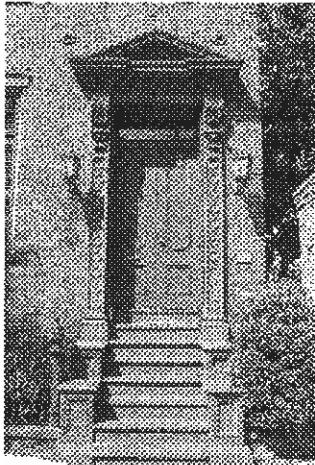
The main house and service wing at 13 Pitt Street is situated against the northern edge of a rectangular lot whose narrow east frontage borders Pitt Street. Windows along the north back wall are few—two lighting the stair passage and a set on either side of the fireplace in the third room in the rear of the main block. The principal entrance is on the shorter, Pitt Street side of the lot and sits back a few feet from the street. The cellar is raised slightly above ground with two windows lighting the east side of the cellar. A brownstone staircase ascends seven steps from the Pitt Street sidewalk to a pedimented modillion frontispiece and double front doors accentuated by bolection moldings with a rectangular transom overhead. The frontispiece pilasters are decorated with a modified guilloche pattern and crowned by richly carved consoles shaped in the form of acanthus leaves.

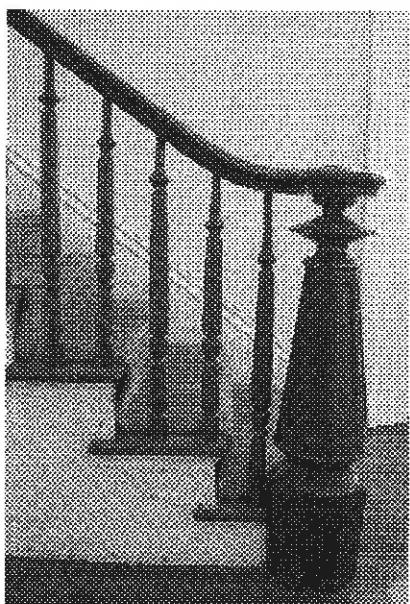
The staircase, which runs up a straight flight to the second floor is 3 feet 6 inches in width. At the base is a large, tapered, octagonal newel post with small decorative beading along the edges of the recessed panel in each of the facets. The newel post is mahogany as are the "breadloaf" shaped handrail and the tapered turned balusters. The stair brackets consisted of applied scrolled and pierced pieces. The area below the stair carriage is framed in and plastered and masks a utilitarian service stair to the cellar that descends below the main staircase. Entrance into the cellar stair is through a paneled door at the back of the staircase.

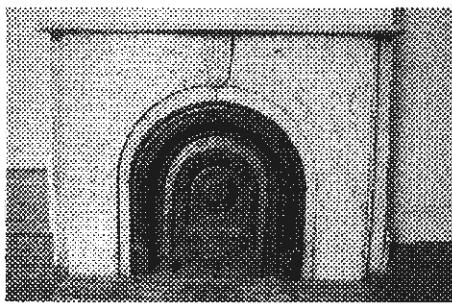
The front two bedchambers have gray Italianate chimneypieces similar to those on the ground floor but with little decorative molding and carving other than a keystone console. The rear bedchamber features a variegated green and tan veined Italianate mantel with a stylized central scalloped console just beneath the shelf. All fireplaces have the cast iron grates and pierced covers as on the ground floor. The one in the back room, however, has been removed. All three bedchambers have service bell cranks located on one of the cheeks of their chimneys. The one in the second, or middle, bedchamber retains its white porcelain knob.

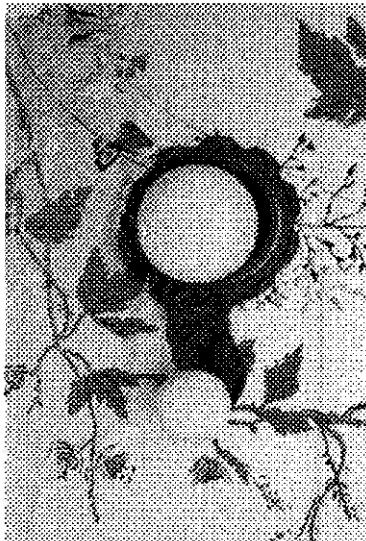
The late antebellum period is also noted for its imported materials and the molded plaster cornices and ceiling ornaments could well have been imported from a northern city to decorate Henry Gerdts' new town house. Imported too are the marble Italianate mantels that appear in all the principal rooms on the main and second floors. The brownstone used for window and door lintels and sills, the staircase at the Pitt Street entrance and the rear service stair, and the frontispiece were probably imported into Charleston from a northern port. The origin of the decorative ironwork that skirts the front façade is not known. It may have been the product of northern manufacture, but given the substantial use of the material in Charleston in the late antebellum period, it may well have been the handiwork of a native smith.
