In Re: 188 King Street

Per your request, we have done a structural inspection of 188 King Street.

188 King is a three-story commercial property, with masonry bearing walls with wood frame infill.

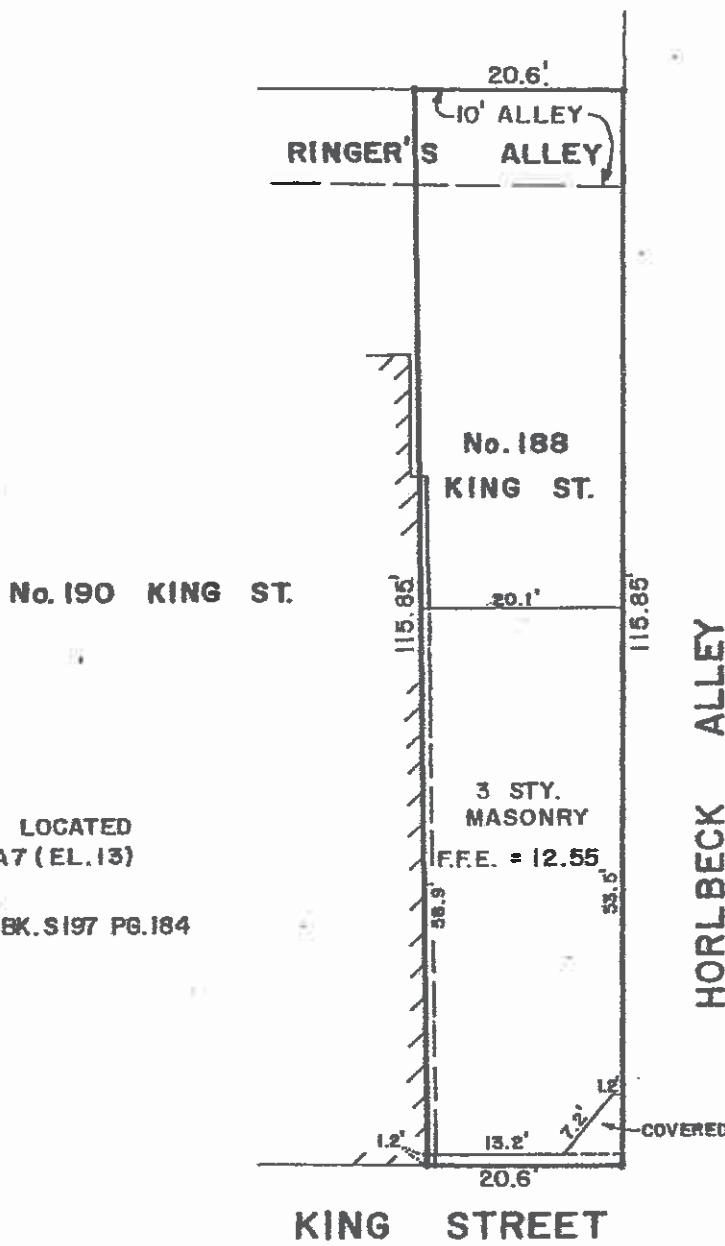
PLAT OF No. 188 KING ST.

HIS PROPERTY IS LOCATED
IN FLOOD ZONE A7 (EL.13)

CITY OF CHARLESTON, CHARLESTON COUNTY, S. C.

Date: JAN. 14, 1991.
SCALE: 1" = 20'
