AND  
ASSOCIATES,  
INC.

- CIVIL/STRUCTURAL DESIGN
- CONSTRUCTION MANAGEMENT/INSPECTION
- FACILITY ASSESSMENT

In Re: 359 King Street  
Pre-Purchase Inspection

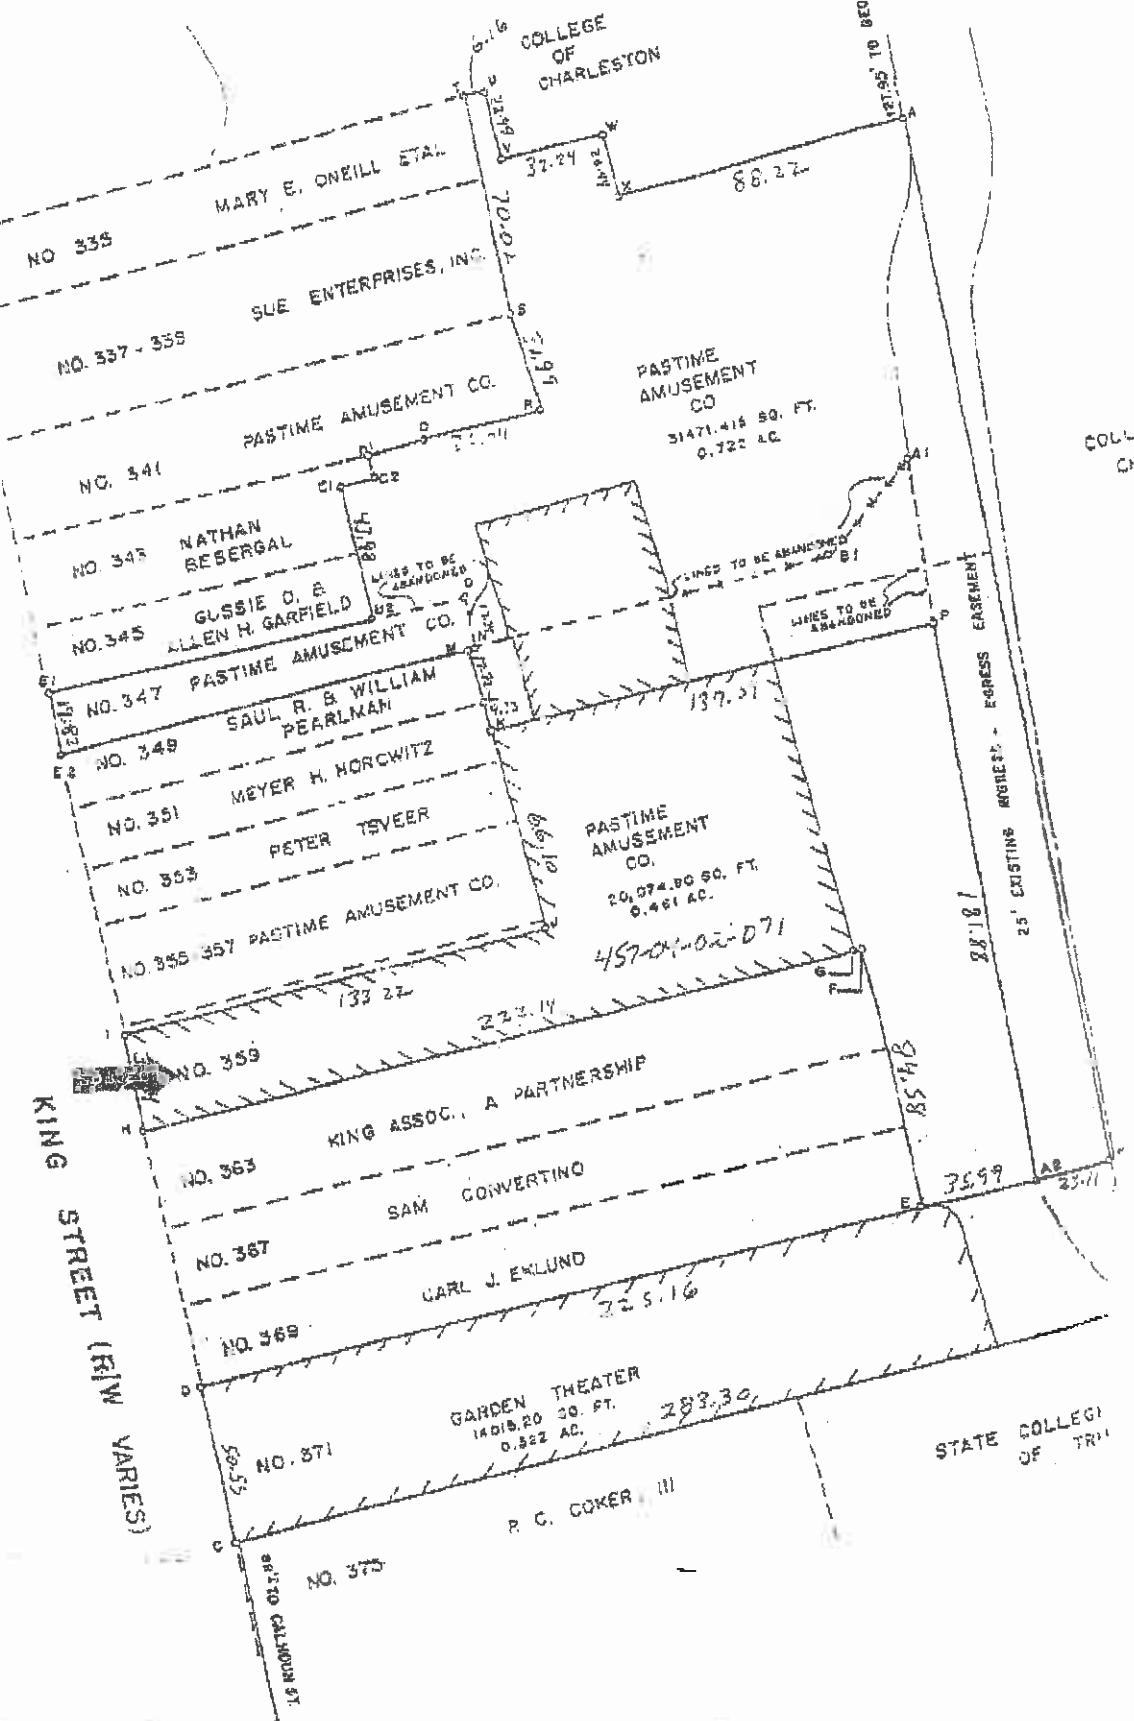
PLAT 86-116

KING  
STREET (E/W  
VARIES)

It is assumed that the alley to the south of 359 King does not convey with 359 property. As part of your due diligence you should obtain survey data with regards to this property.
