AVRO AIRCRAFT LIMITED

ARROW 2 CONTROL BOXES

DEVELOPMENT PROGRAM PROGRESS REPORT

Date: July 11th 1958

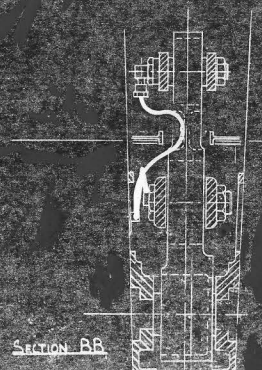
- NOTES
1. ALL SKIN LUBRICATION POINTS ON THIS INVESTIGATION ARE ATTACHED TO EXISTING DETACHABLE PLUGS, THESE WOULD REQUIRE MODIFICATION.
  2. IT SHOULD BE POINTED OUT, THAT AT PRESENT LUBRICATION POINTS IN THE RUDDER CONTROL BOX ARE MODERATLY ACCESSABLE, WITH THE EXCEPTION OF THE POINT AT THE RUDDER JACK (C), WHICH NECESSITATES THE REMOVAL OF RUDDER JACK ACCESS DOOR.
  3. DANGER EXISTS IN THAT THE TUBE MAY BECOME LODGED BEHIND ONE OF THE MANY HISSER PINS USED IN THE CONSTRUCTION OF CONTROL BOX, ALSO AS THE CONTROLS ARE ACTUATED, THE LUBRICATION TUBE WILL IN PLACES, RUB LIGHTLY ON THE STRUCTURE.
  4. THIS METHOD OF LUBRICATION IS SUBJECT TO OBTAINING 1/4 OD FLEXIBLE NYLON TUBE.
